Title: **Everest-Perseus 1 275
kV Tower 389
Refurbishment**

Document Unique Identifier: **LES0606**

Eskom	Everest-Perseus 1 275 kV – Tower 389 Refurbishment	Technology
-----------------------------------------------------------------------------------------	-------------------------------------------------------	------------

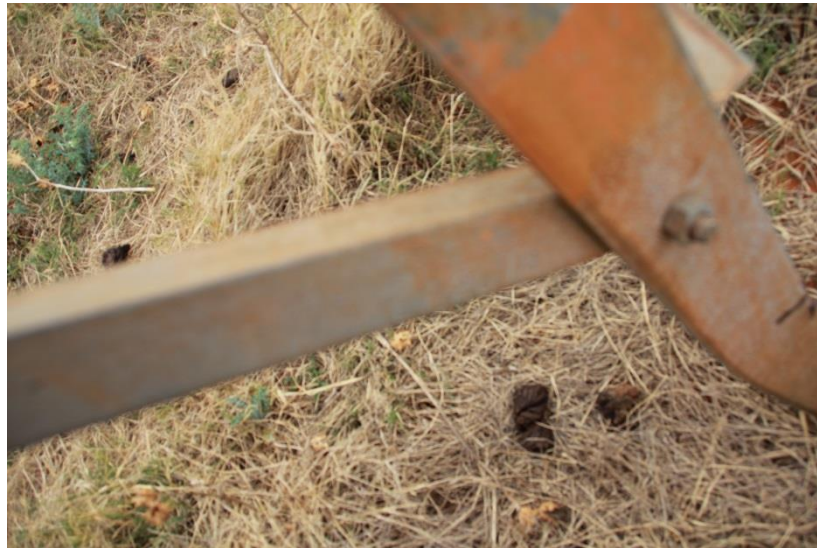
Figure 1: Deformed main member of the leg

As seen on Table 1.2, the wind and weight spans are within the design parameters. This suggests that the tower damage was due to the application of an external load.

- The main member (beam) of the leg was found to have deformed due to the impact with the point of impact visible. The effectiveness of this member has been compromised by the deformation. Any further deformation of this tower member will result in tower collapse.

2. Excavate around the tower leg to expose the foundation cap and to ensure enough space to carry out work.
3. Remove the bent main leg member and replace with a new member. This may be cut and drilled on site in the absence of manufacturing drawings.

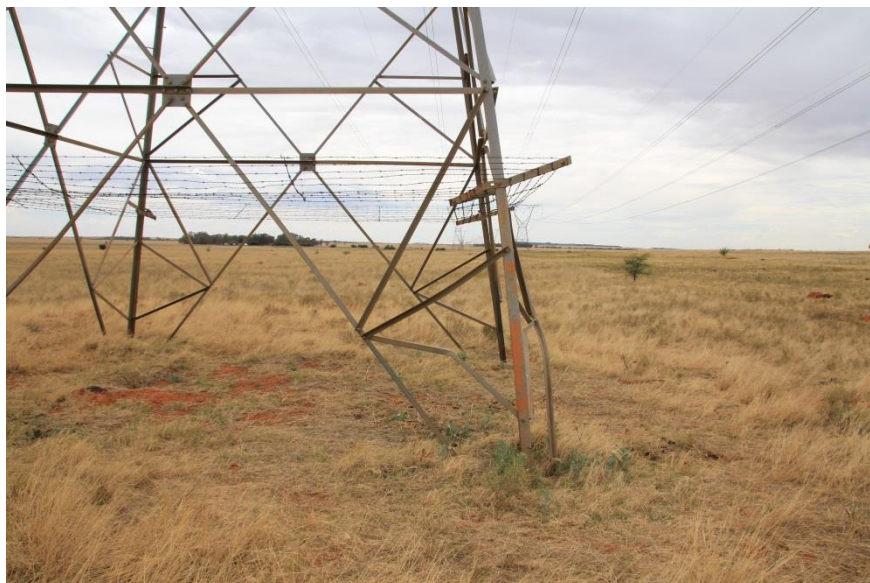
Figure 2: Deformed truss and bracing members

- The truss and bracing members on both the longitudinal and transverse faces were found to have deformed as well with zero effectiveness. The load on this leg is entirely supported by the deformed main leg with the rest of the members wobbling.

4. The truss and bracing members can now be replaced as well.
5. The bent members on the body can now be replaced. All these activities should be carried out with the crane supporting the tower. The crane should be released once all the members are fitted in place.

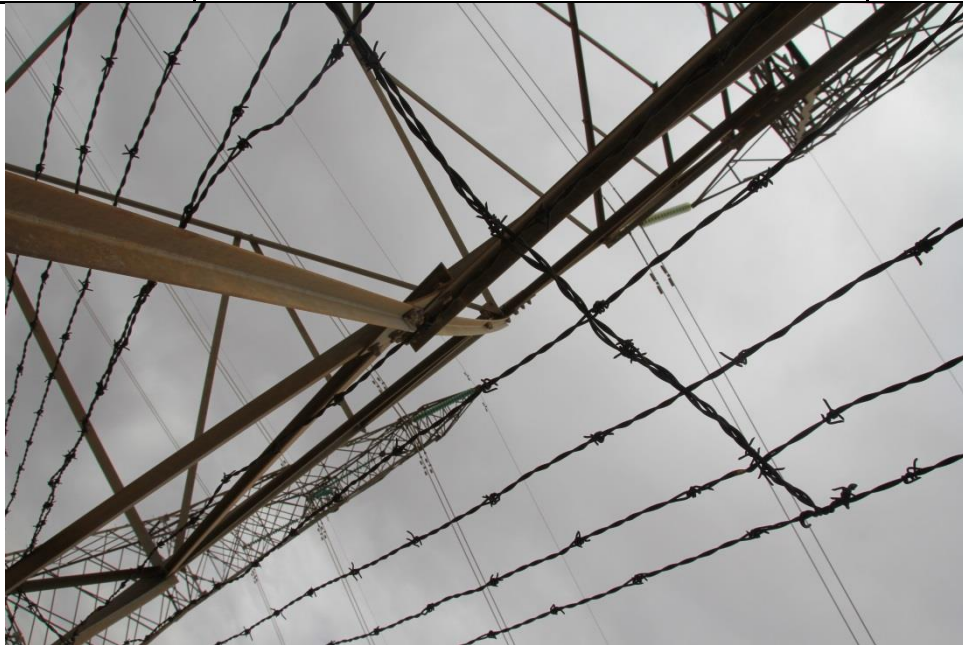
Figure 3: Deformed tower member on the body

- The body was also found to have deformed tower members. The buckled tower members were clearly visible from ground level.
