Title: **Grootvlei-Theseus
1 400kV Tower 226
Refurbishment**

Document Unique Identifier: **LES0606**

Eskom	Grootvlei-Theseus 1 400kV – Tower 226 Refurbishment	Technology
---	--	------------

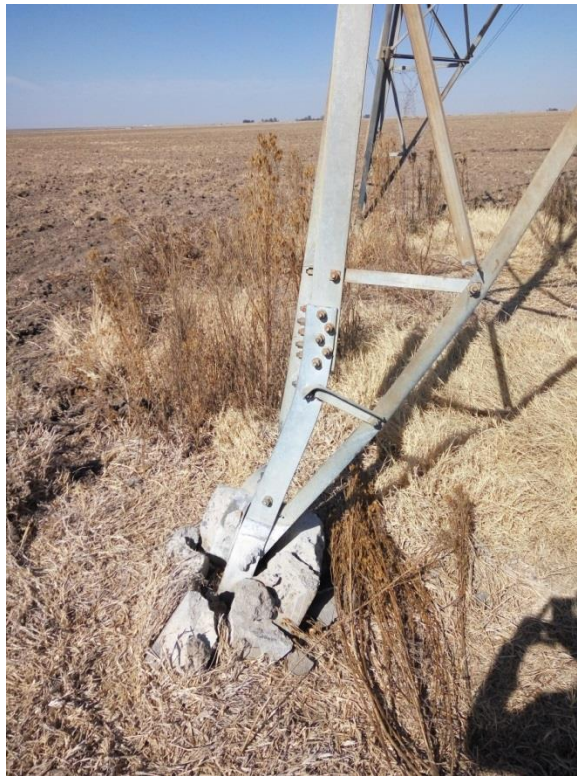
The Free State Grid requested LES to assist with the replacement of damaged tower members on tower 226 on the Grootvlei-Theseus 1 400kV line. LES conducted a ground inspection to establish the extent of the damage and to propose a solution to the problem. The tower is situated in an active farming area and the damage was due to a heavy impact load by farming equipment. Table 1.1 below lists the line details.

As seen on Table 1.2, the wind and weight spans are within the design parameters. This confirms that the tower was damaged due to external loads.

Figure 1.1: Damaged tower members on leg A

Since adding additional bracings to the tower will require a bit of work (modelling of the new bracings on PLS tower to confirm the tower capacity) it is therefore recommended that a suitable contractor is appointed to replace the bent members with new members, hence option 2 is the recommended solution.

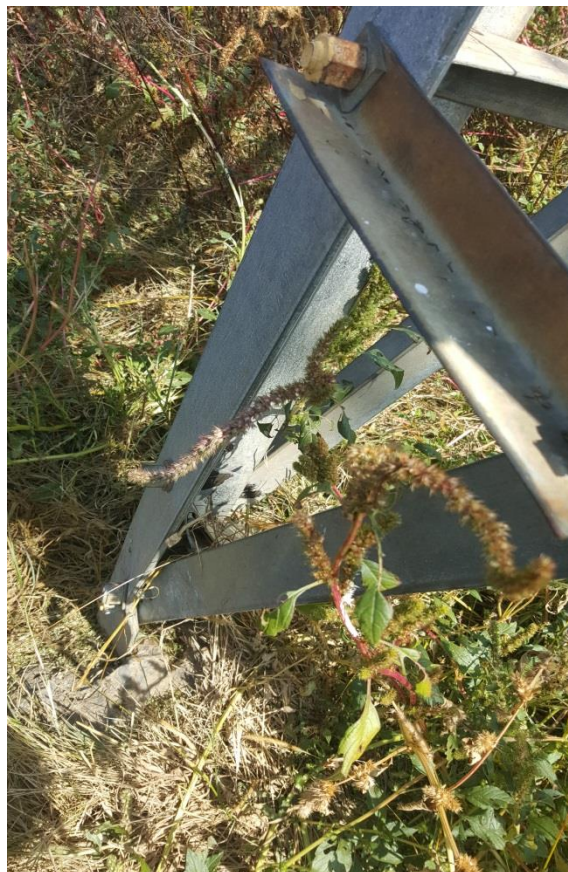
Figure 1.2: Damaged tower members on leg B

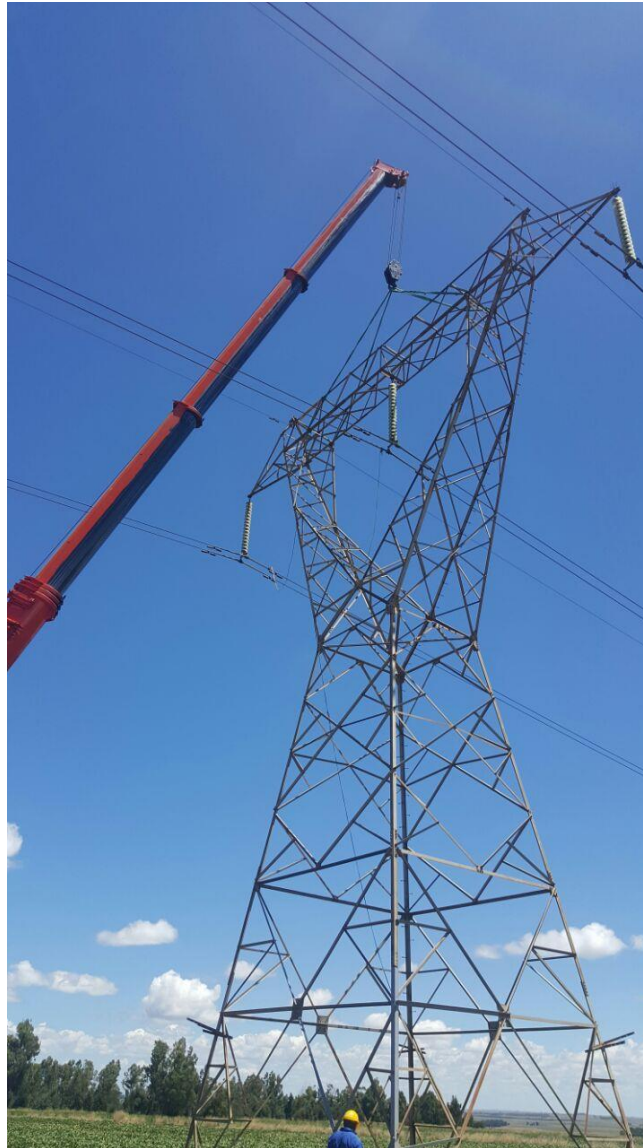
Figure 2.2.1: Tower rigging (For illustration)

This method involves the replacement of the damaged tower members and the reinforcement the affected stubs. A crane would be required to support the tower during the replacement procedure.

The maximum weight as seen on the table above is 15 tons. To account for the construction and wind loads a factor of about 2.5 is applied. A minimum of 38 ton crane is required to temporarily support the structure during refurbishment.

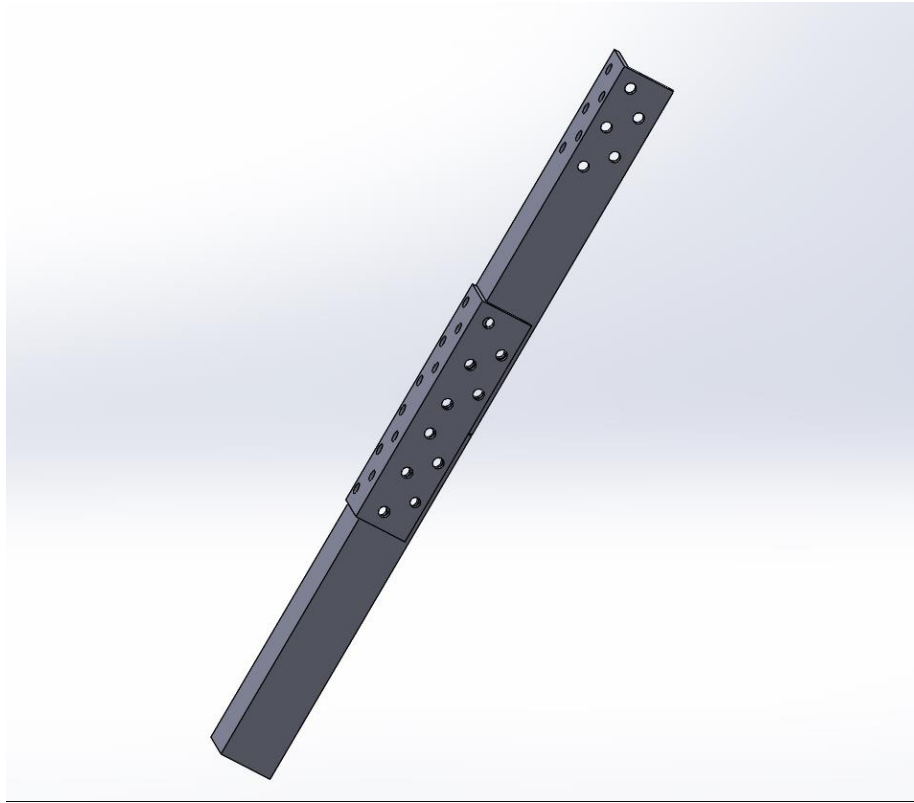
Figure 2.2.2: Proposed stub reinforcement

4. Take measurements, mark off and drill members on site. The hole pattern on the main leg is to be maintained on all the new joints.
5. Where there are no lengths of the members given, the contractor is required to measure the required length on site. The stub must be reinforced first followed by the main leg member, crossing diagonals and ultimately the redundant bracings.
