Title: **Duvha – Kusile (400kV)
Tower 55 and Kusile –
Minerva (400kV) Tower 28
Refurbishment**

Unique Identifier: **240-68108065**

Documentation Type: **Report**

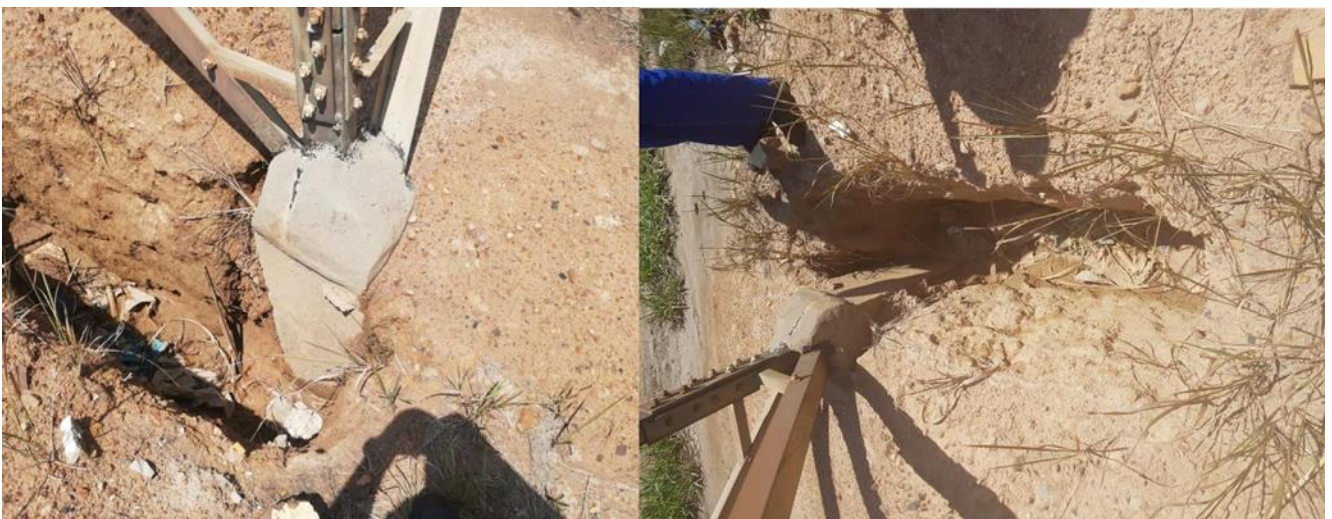
Upon arriving on site, the team noticed the excavations next to the foundations as shown on figure 1. The excavations looked neat and professional, however the grid was not aware of any tests performed on the tower. Furthermore there was no barricading around the foundations which posed a safety hazard. The grid was instructed to backfill and compact the excavations in layers of 300mm soil to a compactive effort of 93% ModAshto.

Figure 1: Digging next to the foundation

Duvha – Kusile 400 kV tower 55 will be refurbished by backfilling the excavated material. The solution for Kusile – Minerva 400kV tower 28 Refurbishment is summarized below:

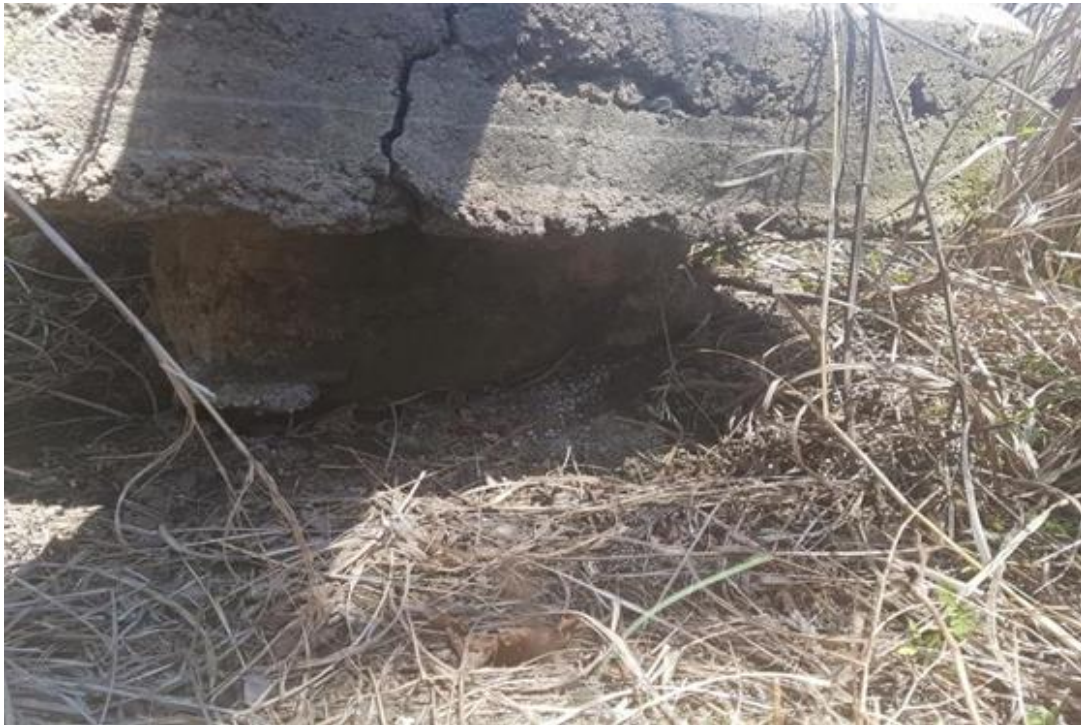
This tower is next to a stream and the water has caused erosion around the tower. The bottom of the foundations has been exposed as shown in figure 2 and the concrete has major cracks. It seems there was previous work done on the foundation but the concrete is badly cracked and falling apart seen in figures 3 & 4. Since the tower is not always submerged in water the solution will look at encasing the tower legs with concrete to protect them from corroding. The repair steps for this tower are listed below.

Figure 2: Soil erosion under the foundation

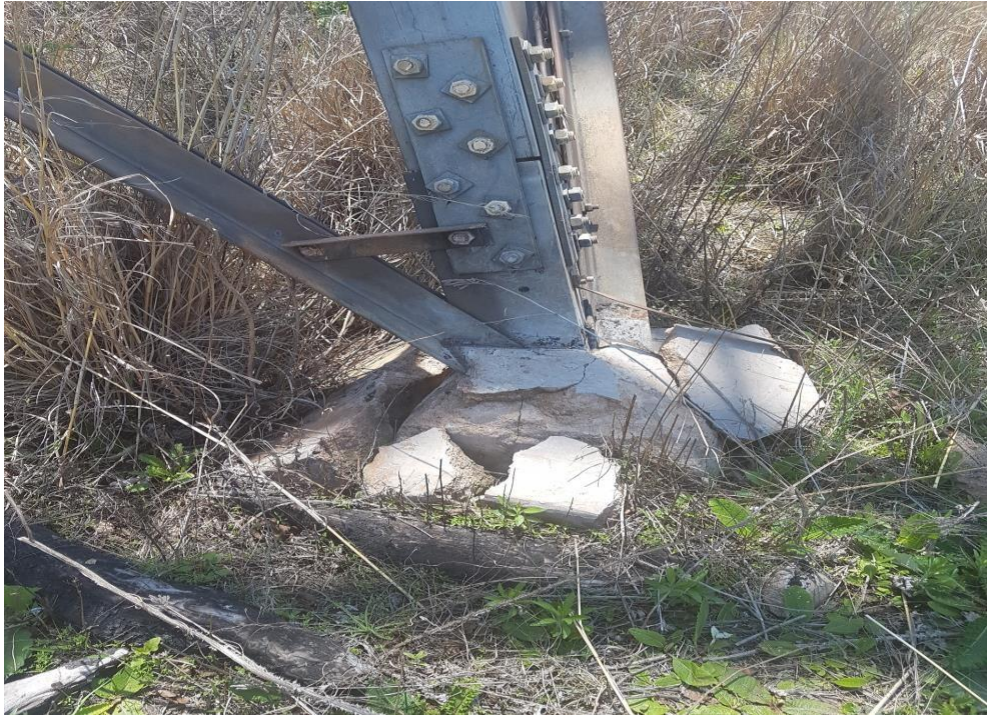
Figure 3: Broken foundation cap

- The concrete cap will then be broken using hand tools or a hand held jack hammer. Care should be taken to make sure that the steel members are not damaged during the process.
- In a case where the concrete cap will not be totally removed it will have to be scabbled to a depth of 25mm to prepare for the bonding with the new concrete cap.
- The bonding between the existing concrete and the new concrete is of vital importance to prevent water (moisture) to penetrate and reach the steel. A cement slurry should be poured on the scabbled area and immediately cast the new concrete. The new concrete must be cast to a watershed and properly cured as per TRMSCAAC 5.2 requirements.

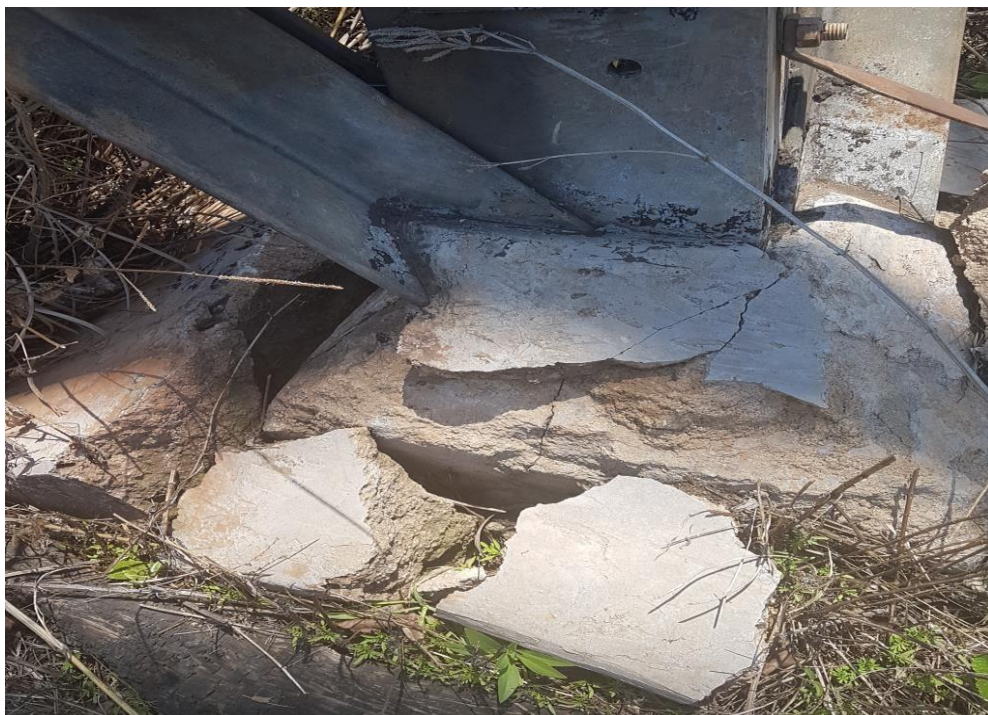
Figure 4: The interaction between the new and old concrete
