17. APPENDIX D: L CHANNEL DETAILS

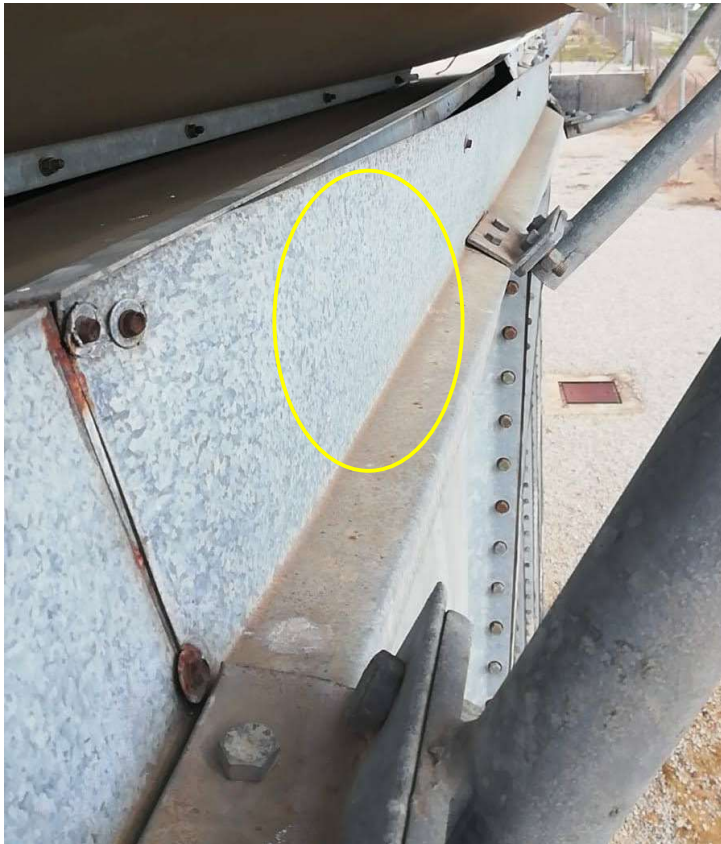
Figure 5 L Channel Details

Notice deformation on L Channel sections. The Cover plates has sheared away from the L Channel and the L Channel itself is plastically deformed due to the bending moment experienced in the stanchions when the roof cover plates pressed against it.
