Title: **SCOPE OF WORKS FOR
REPAIR OF DAMAGED
+38.340M LEVEL PLATFORM
AT SURGE BIN 2**

Area of Applicability: **Kendal Power Station**

Documentation Type: **Scope of Works**

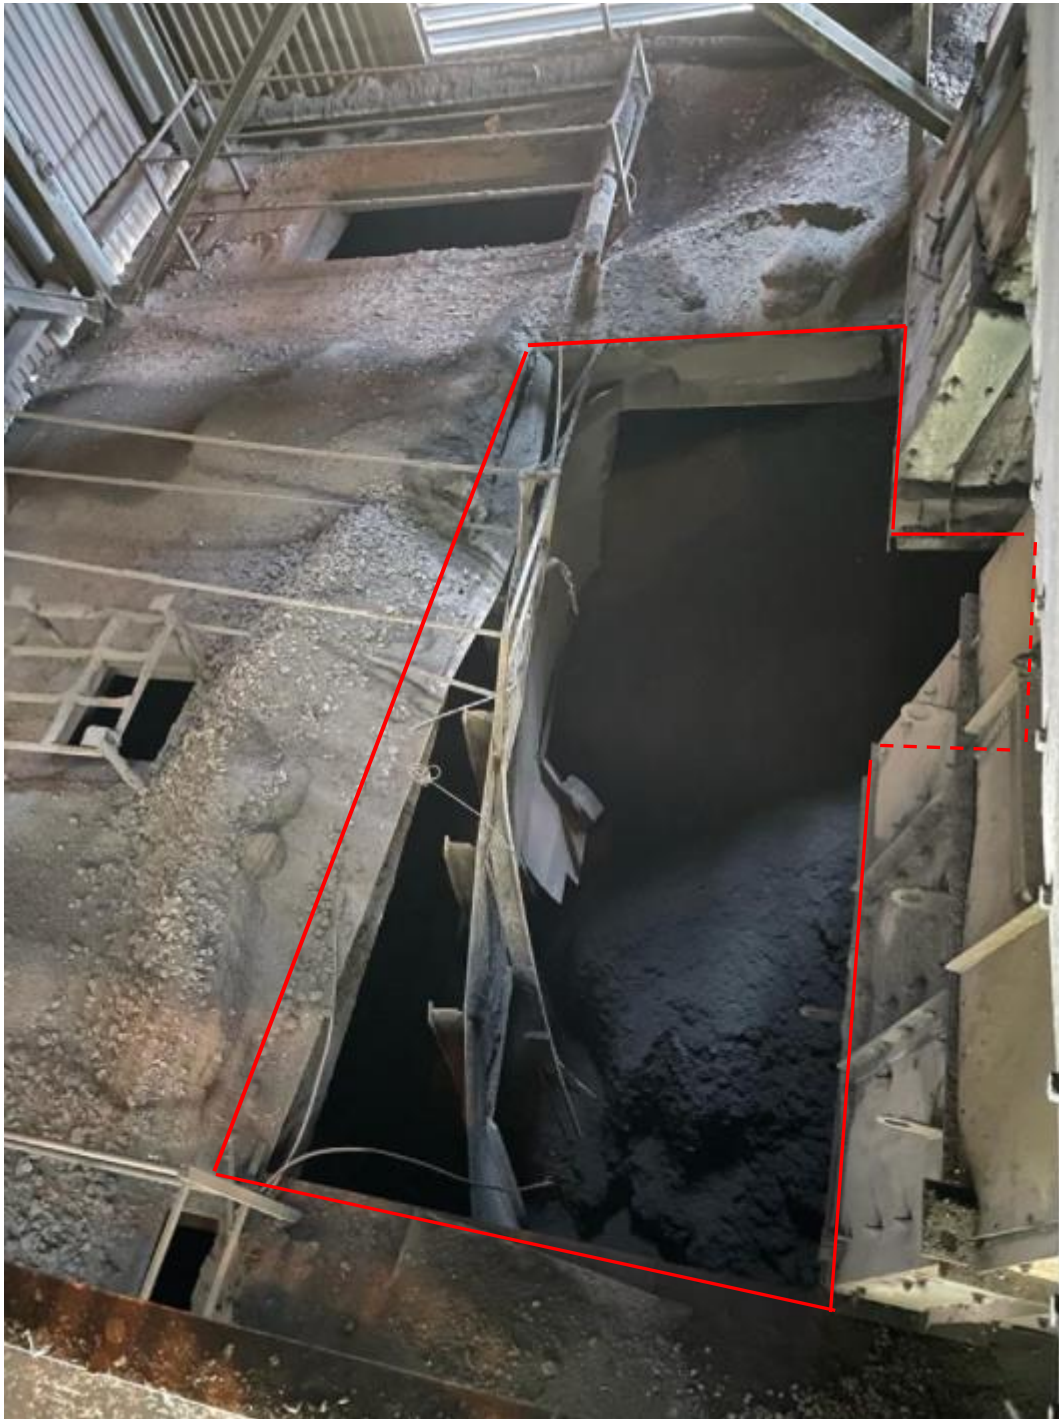
A collapse of a portion of the +38.340m level platform occurred on 05.04.22 due to excessive overloading of coal deposits. The damaged beams and checker-plate has been removed, except 1 x 6.3m beam which is still in place (in a deformed and twisted state) and the area barricaded. This SoW details the safe repair of the platform.

**Figure 1: Outline Damaged Platform****CONTROLLED DISCLOSURE**

- 1 x 6.3m Beam – 406x140x30 UB (still in place, however twisted and deformed state) – Beam no. 2
- 1 x 6.3m Beam – 406x140x30 UB (removed) – Beam no. 2
- 5 x 1.27m Beams – 200 x100 x 22 IPE – Beam no. 4
- 2 x 1.210 m Beams – 152 x 76 channel section – Beam no. 8
- 3 X 1.15m Beams – 203 x133x25 UB – Beam no. 6
- 1 x 1.97M Beam – Beam no. 5
- Checker plate for the affected area
- All affected connections (plates, bolts and welding)

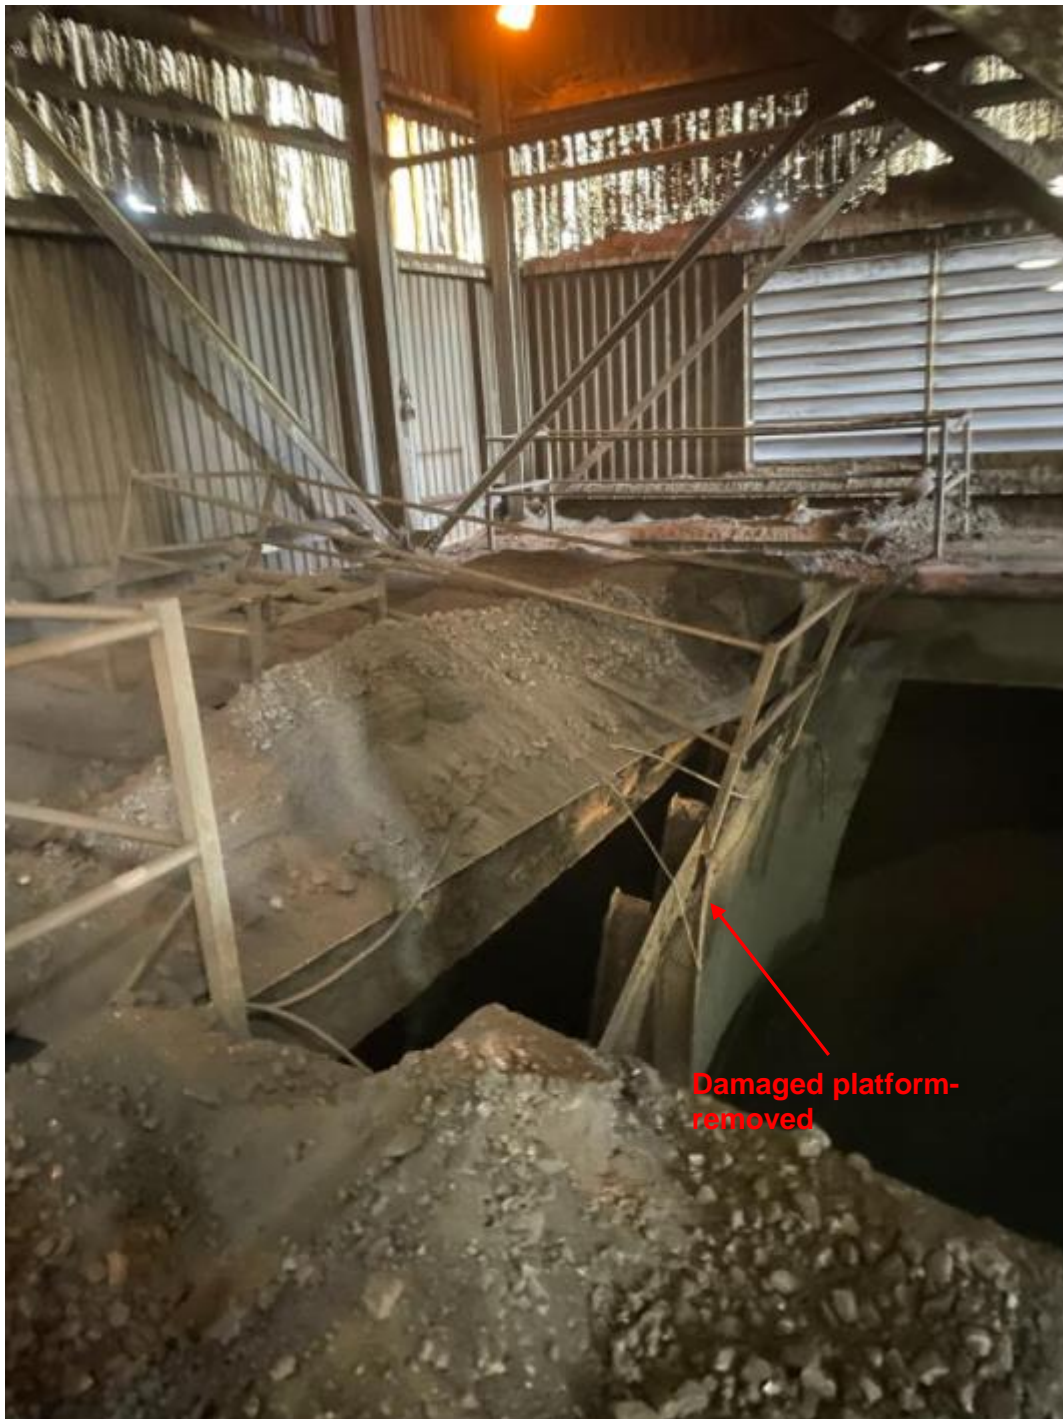
Figure 2: Damaged Platform hanging into Surge Bin hopper

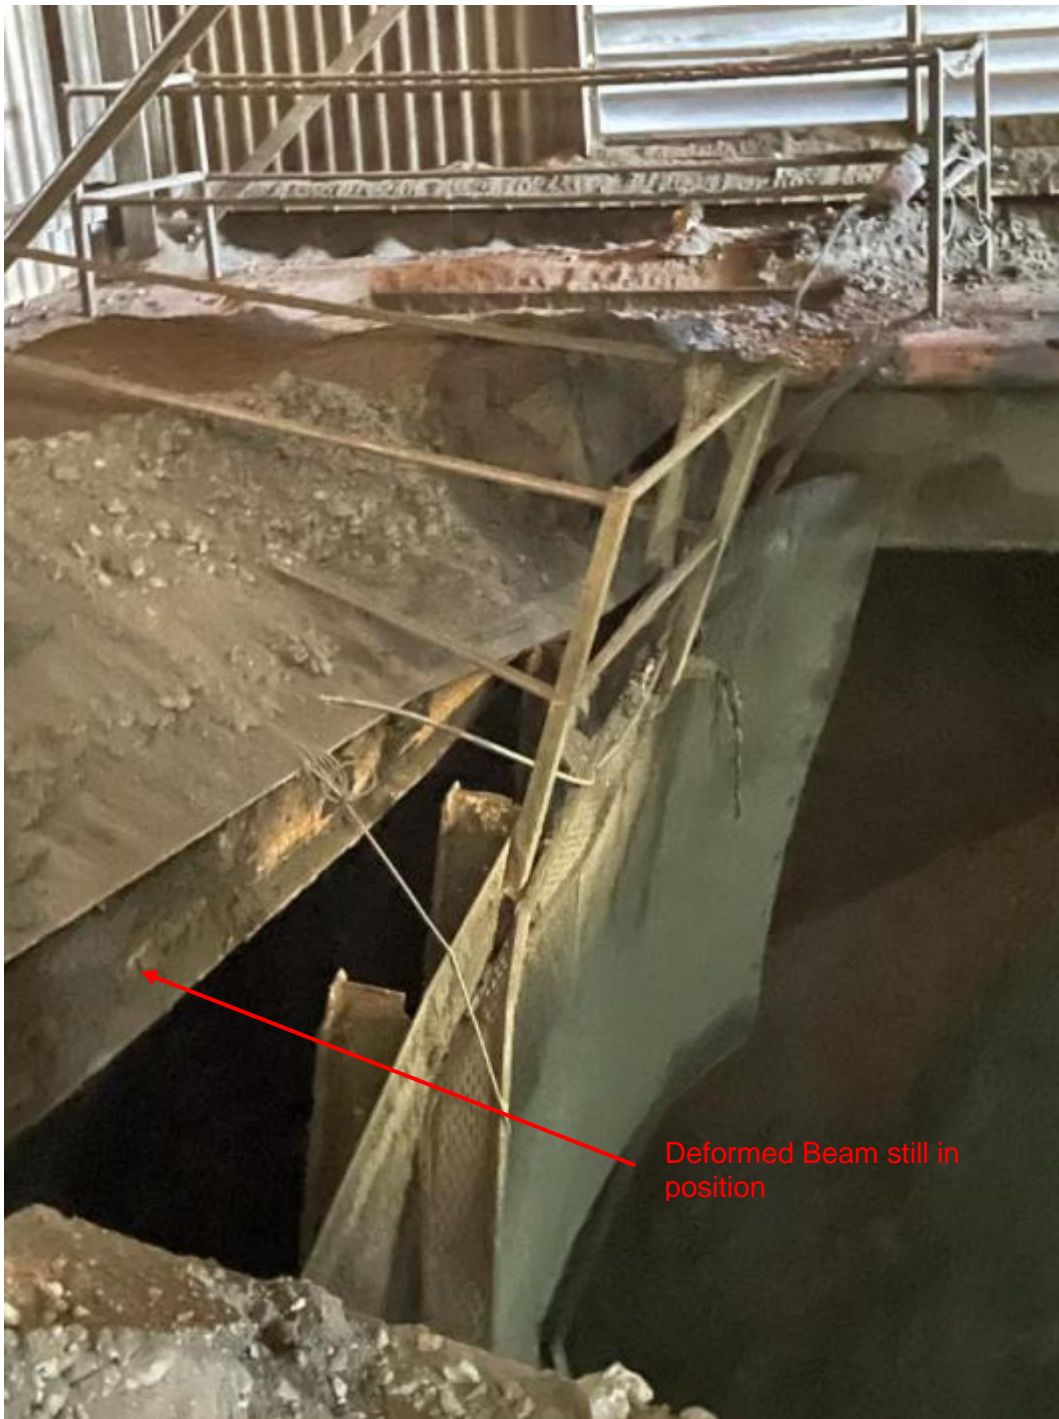
Figure 3: Deformed beam in place and section of platform removed

- e) The *Contractor* is responsible to safely temporarily support the platform, whilst removing the damaged beam still in place and reinstating the platforms to original condition. This is compliant with Construction regulations, and the design responsibility thereof.
