FBC Free State OU and Northern Cape OU INVESTIGATION REPORT	Template Identifier	240-43921804	Rev	6
		Document Identifier	240-136349448	Rev	2
		Review Date	10 April 2018		
		Effective Date	01 March 2022

INVESTIGATION MAINTENANCE AND OPERATIONS DEPARTMENT

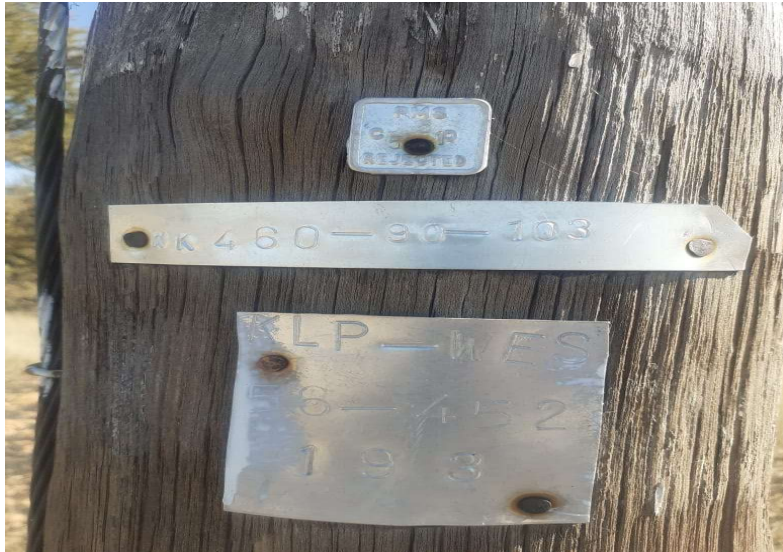
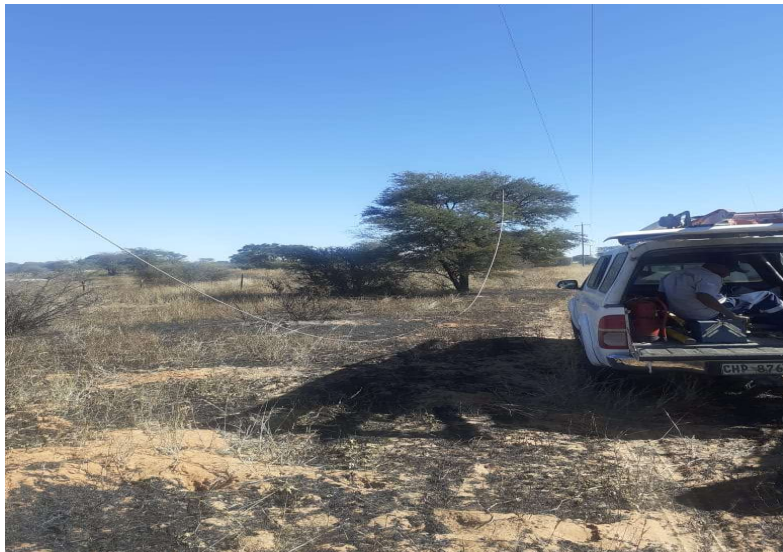
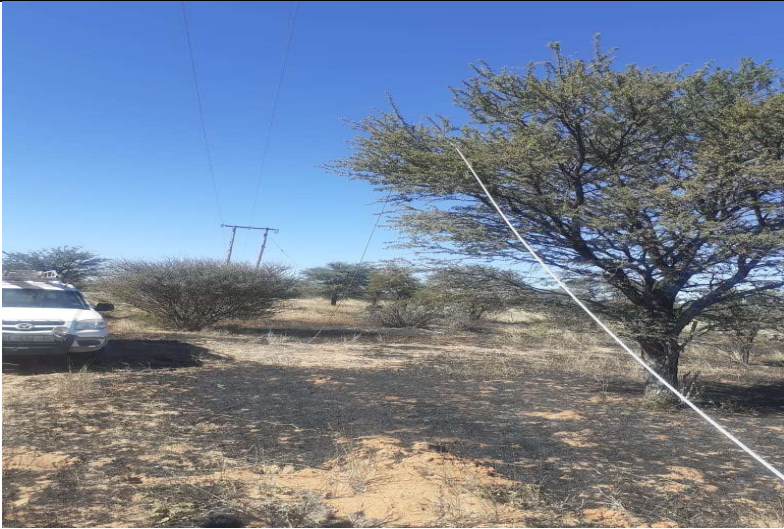
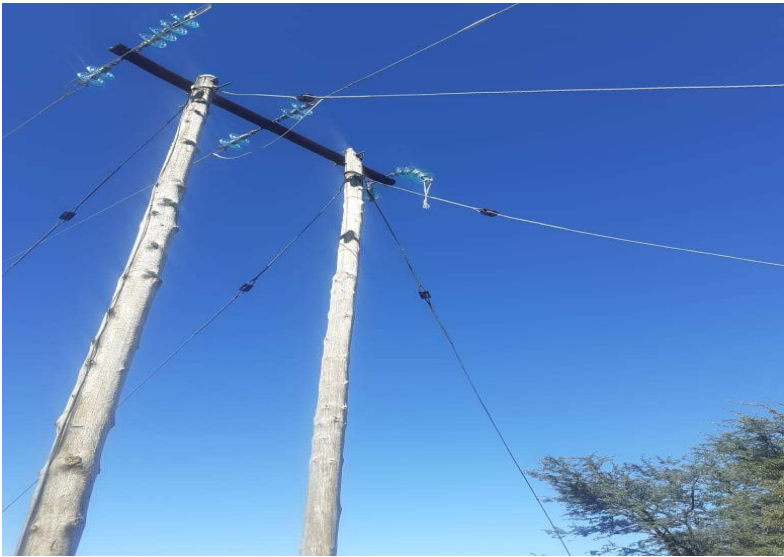
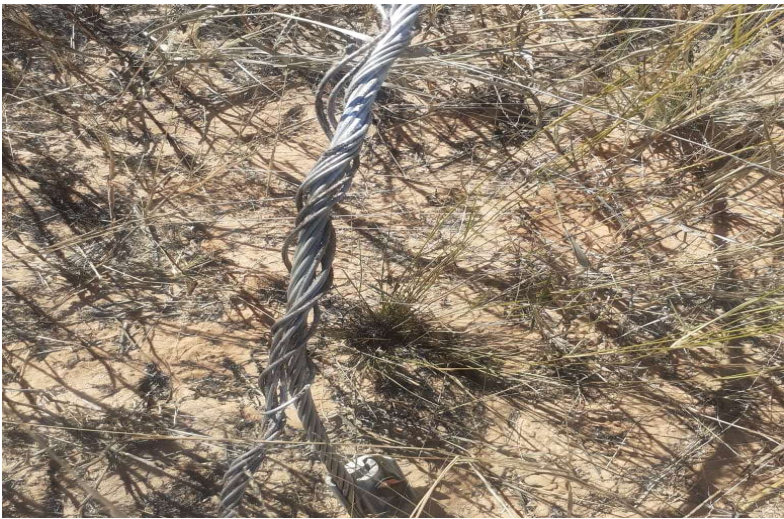
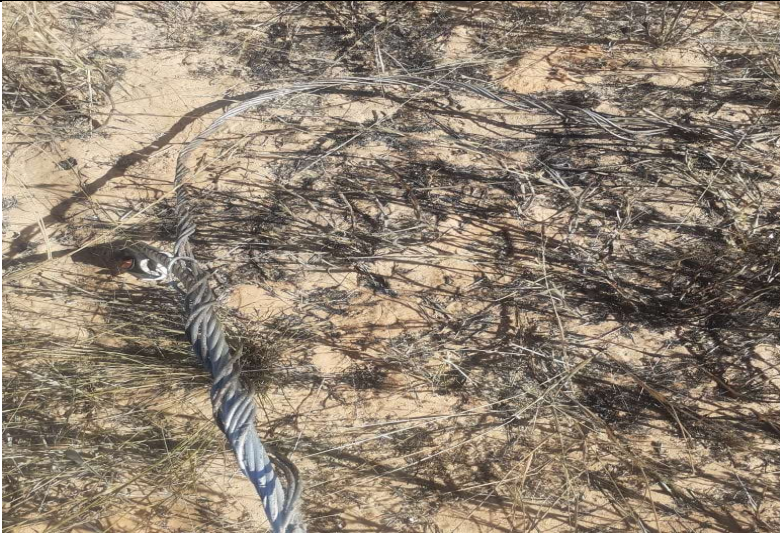
PHOTOS AND ANY OTHER SUBSTANTIATED DOCUMENTATION

Summary of Switching and Actions taken after the Incident	They opened the breaker at WK460-1. Test line for dead at WK460-90-75.
Voltage Regulation within NRS048	N/A
Findings	At WK460-90-103 the conductor had pulled out on both sides of the dead end of the cross arm. It was now hanging low with parts of it lying on both the ground as well as on the tree.
Line Maintenance / Pole Inspection Reports attached (In case of veld fires)	The report is too big to attach. Line patrol was done on the line in 2019. Based on the report it looks like they started on the 26 th of February 2019 at pole number WK957-86-17 and finished the inspection on the 28 th of June 2019 at pole number WK1. The main line and some T-Offs were patrolled but not all T-Offs were done. The T-Off at WK460 was not patrolled.
Proposed Recommendations to prevent recurrence	<p>If the operators had patrolled this section of line first before switching on the breaker, they would have seen the conductor lying on the tree before it fell to the ground and started the fire. This is a very old line and suffers a lot from wear and tear.</p> <p>It is recommended that the CNC requests assistance from across the Sector and have this whole line inspected and identify any critical structures. Thereafter the defects must be cleared.</p> <p>This line should form part of the line refurbishment program.</p>
