**KLIPGAT RADIO MAST  
GEOTECHNICAL REPORT**

**FEBRUARY 2020**

Report presenting the results of a geotechnical investigation undertaken for the proposed construction of a radio mast at the Klipgat Radio Site.

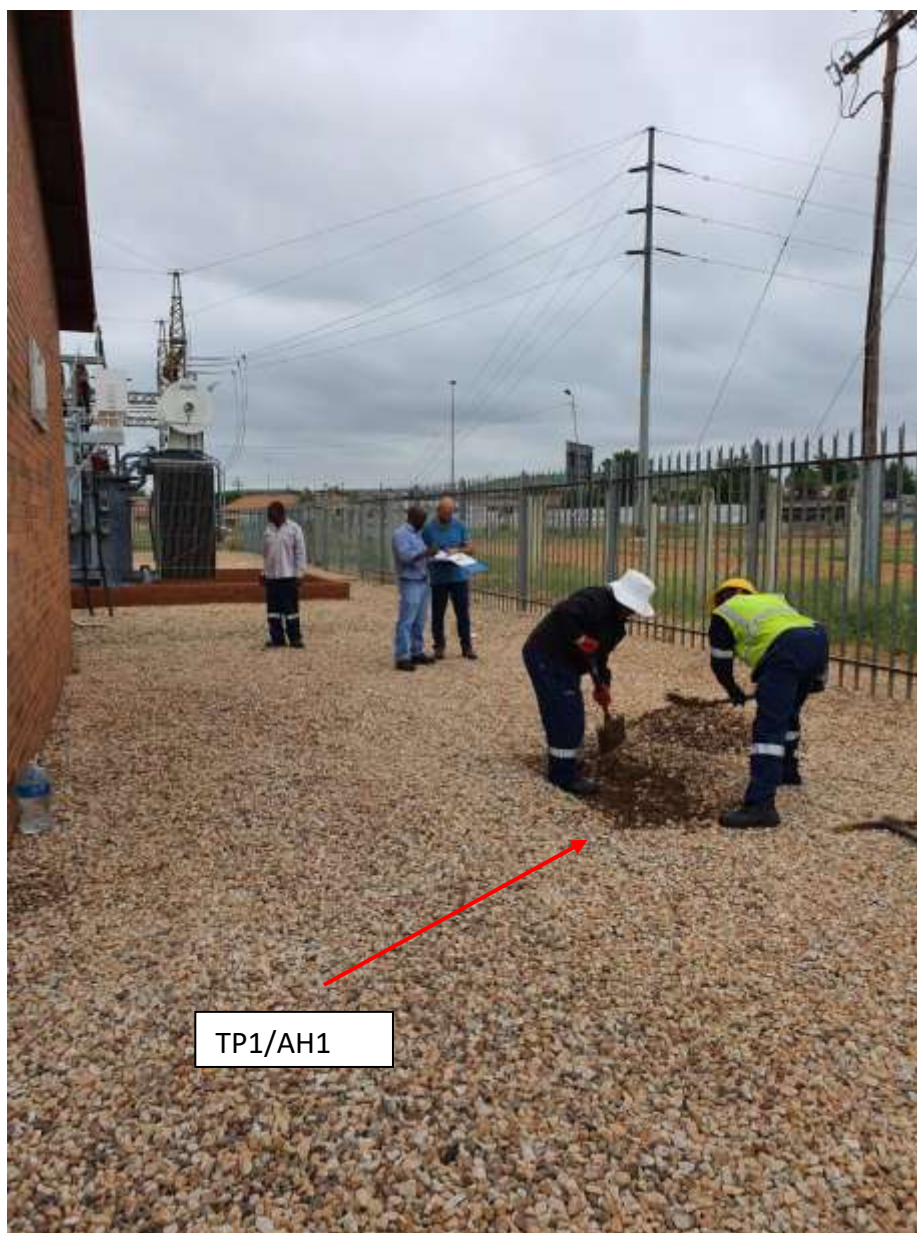
*Figure 4: Location of TP1 /AH1*

One test pit, designated TP1 was excavated using hand tools to a depth of 1,20 m, before a hand auger was used to advance it further until refusal was met at 2,30 m.

The pit was terminated due to refusal of the auger in dense ferricrete material.

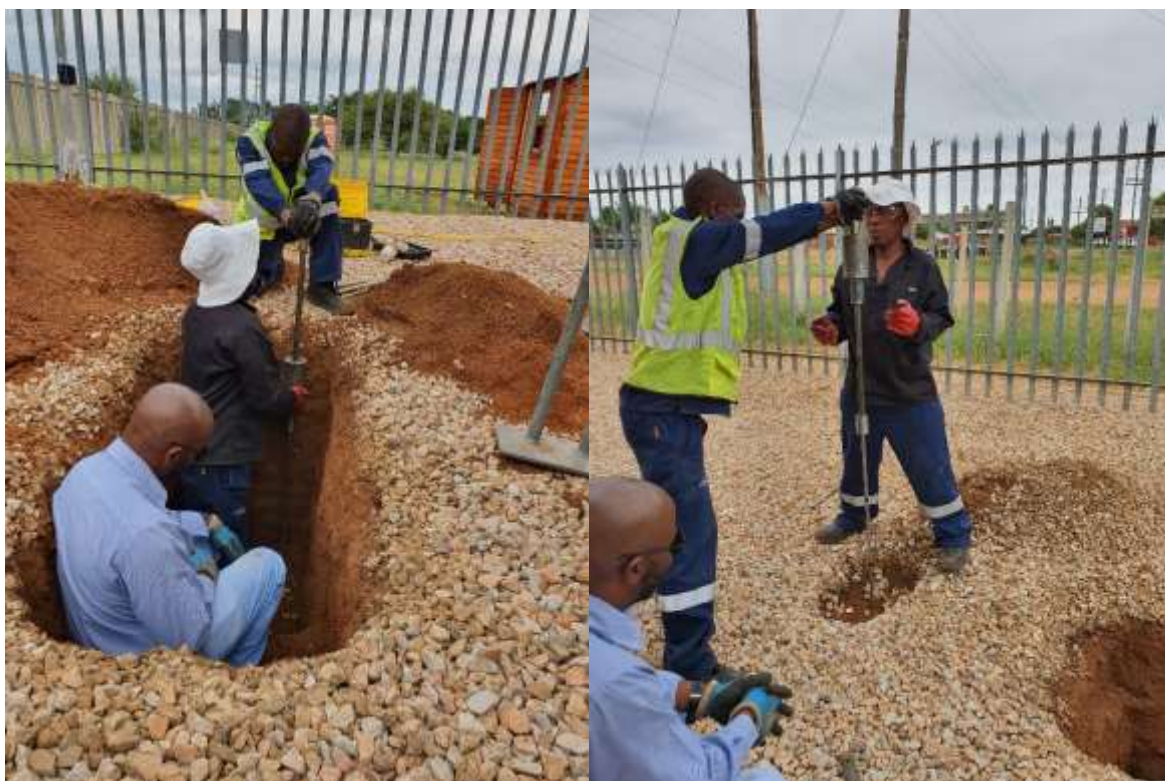
Figure 5: Locations of DCP1 & DCP2

- DCP1 was undertaken from the TP1 / AH1 from a depth of 1,20 m
- DCP2 was undertaken to the south of the TP1 / AH1, from, from 0,20 m depth, just below the gravel layer (see Figure 2).

Refusal of the DCP test occurred at similar depths of between 1, 95 m (DCP2) and 1,99 m (DCP1).

- **Pedogenic soils** between **0,20 and 0,80 m** depth have very low EASPBs, of **24 - 56 KPa**.
- **Pedogenic soils** between **0,80 and 2,30 m** depth have EASPBs of **171 - 237 KPa**.
- Both DCPs refused at approximately 2,00 m depth on what is suspected to be cemented ferricrete horizon or possibly bedrock.

Below approximately 1,80m depth, the bearing capacities of the subsoils obtained from the DCP tests increased significantly to over 400KPa. This corresponds to the refusal of all equipment in what is believed to be either cemented pedogenic soils or potential bedrock. Founding the proposed tower at approximately 1,80 m depth is recommended.

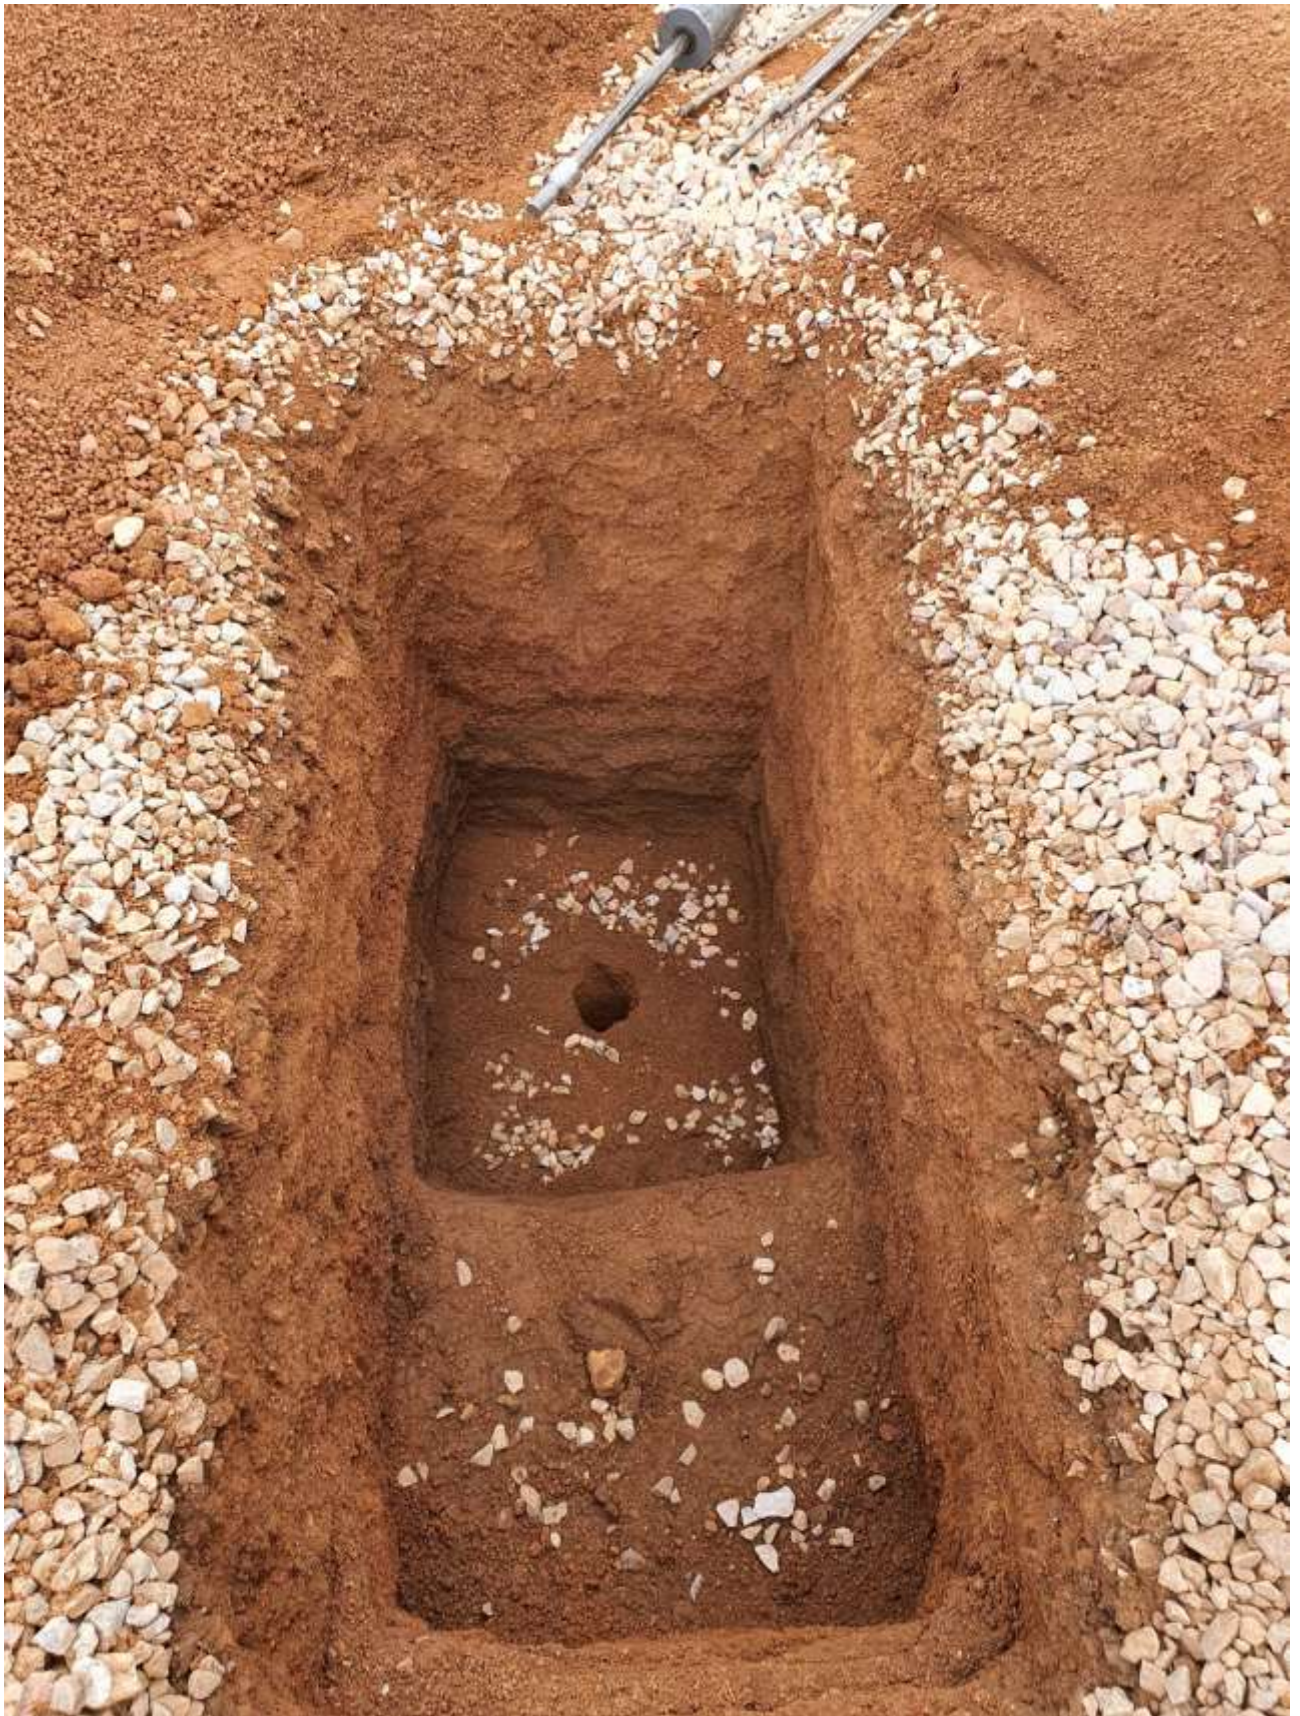
TP1 /AH1\_Note gravel ferricrete recovered from TP1

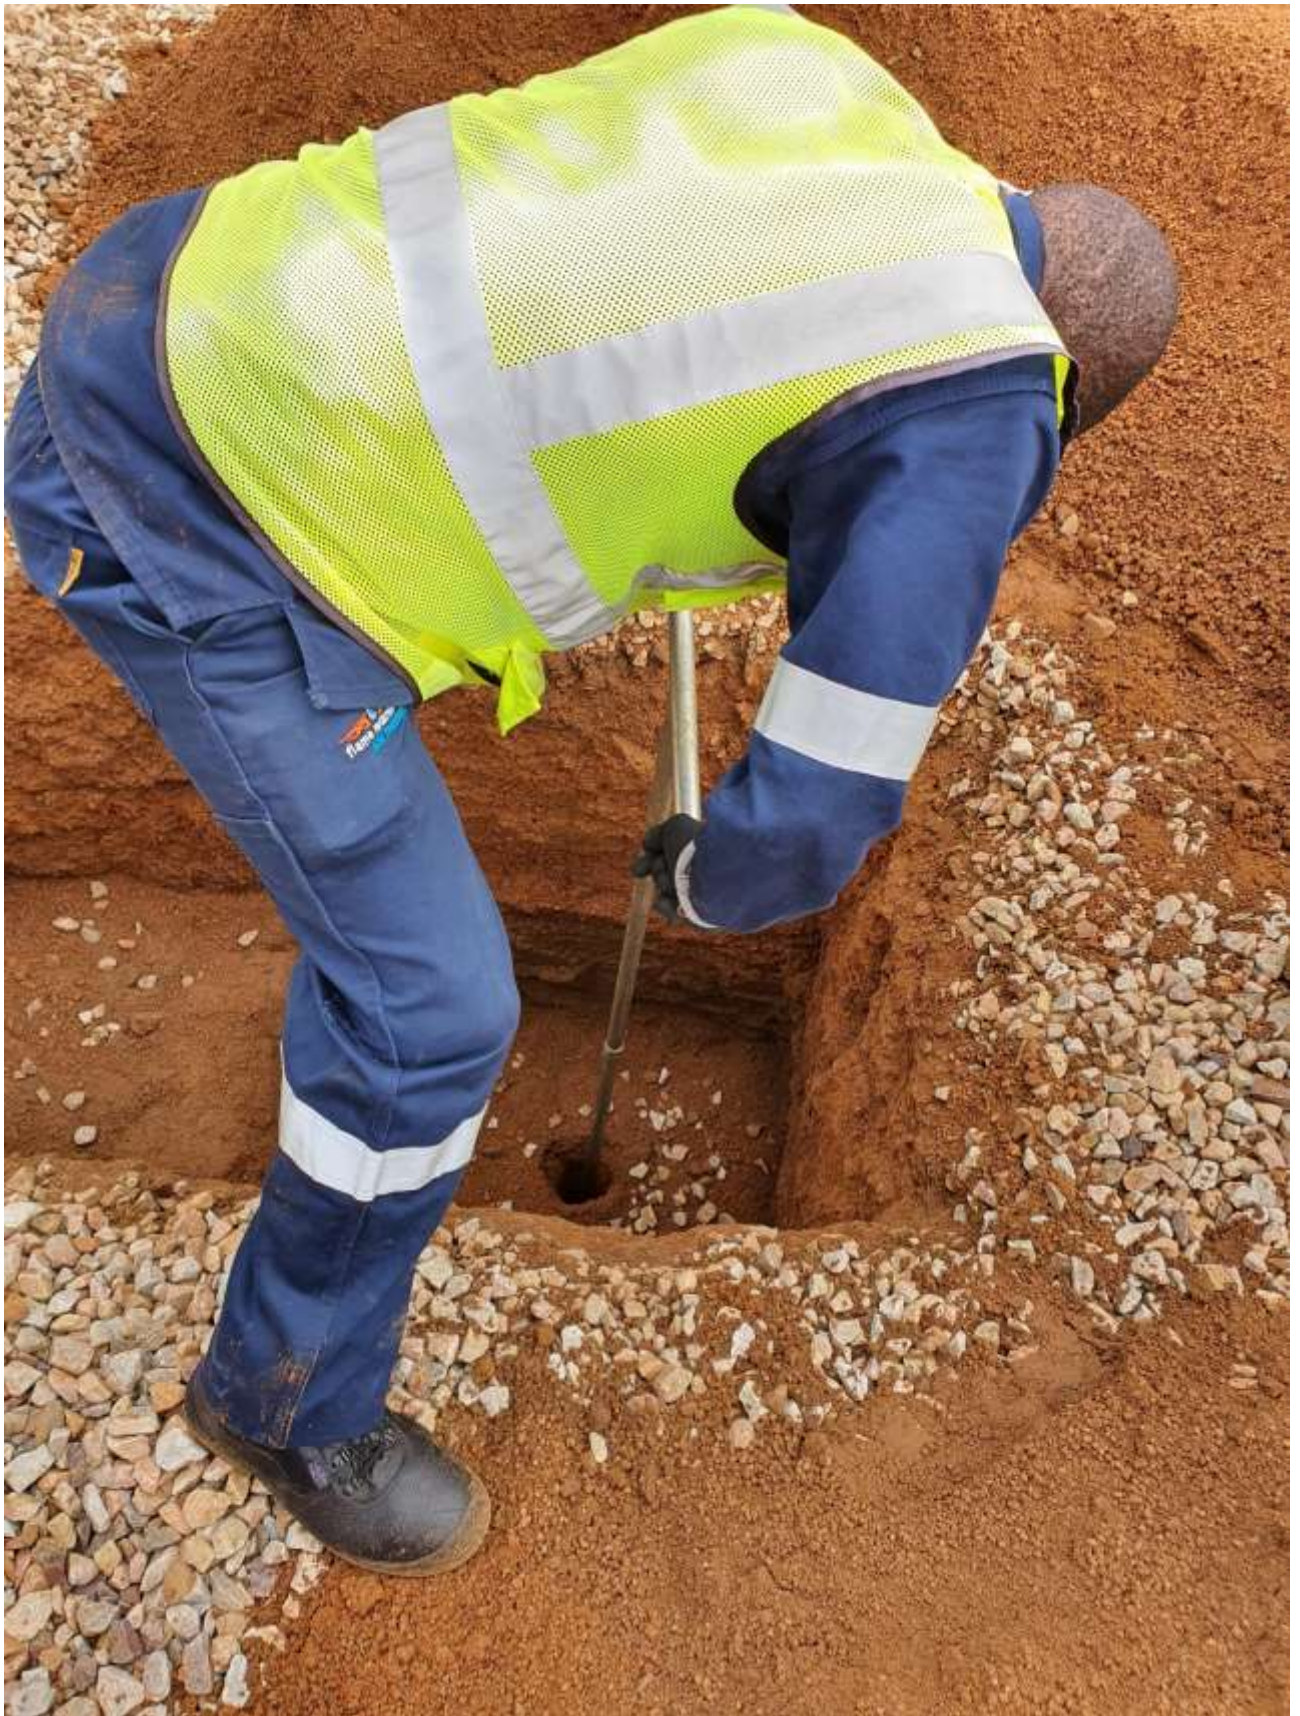
Undertaking of Auger hole at 1,2 m depth.

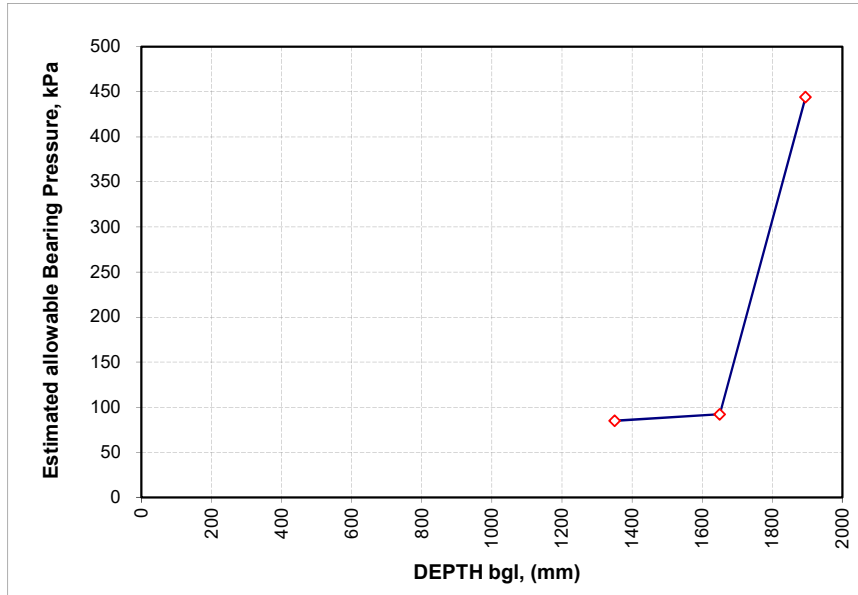
Remarks : Refusal at 1.99 m

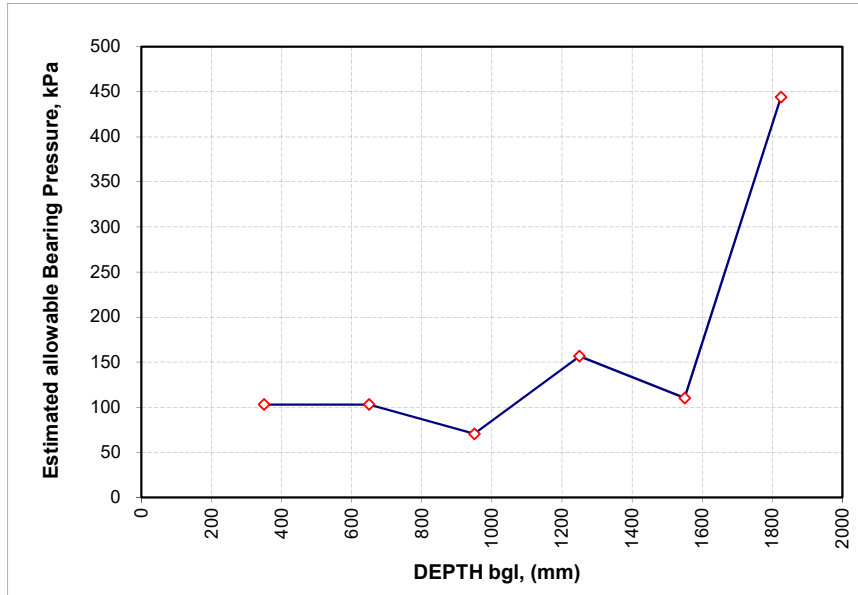
DCP No: 2

Remarks : Refusal at 1.95 m
