## **NONYANE RADIO MAST GEOTECHNICAL REPORT**

**FEBRUARY 2020**

Report presenting the results of a geotechnical investigation undertaken for the proposed construction of a radio mast at the Nonyane Substation, in Soshanguve, Gauteng Province.

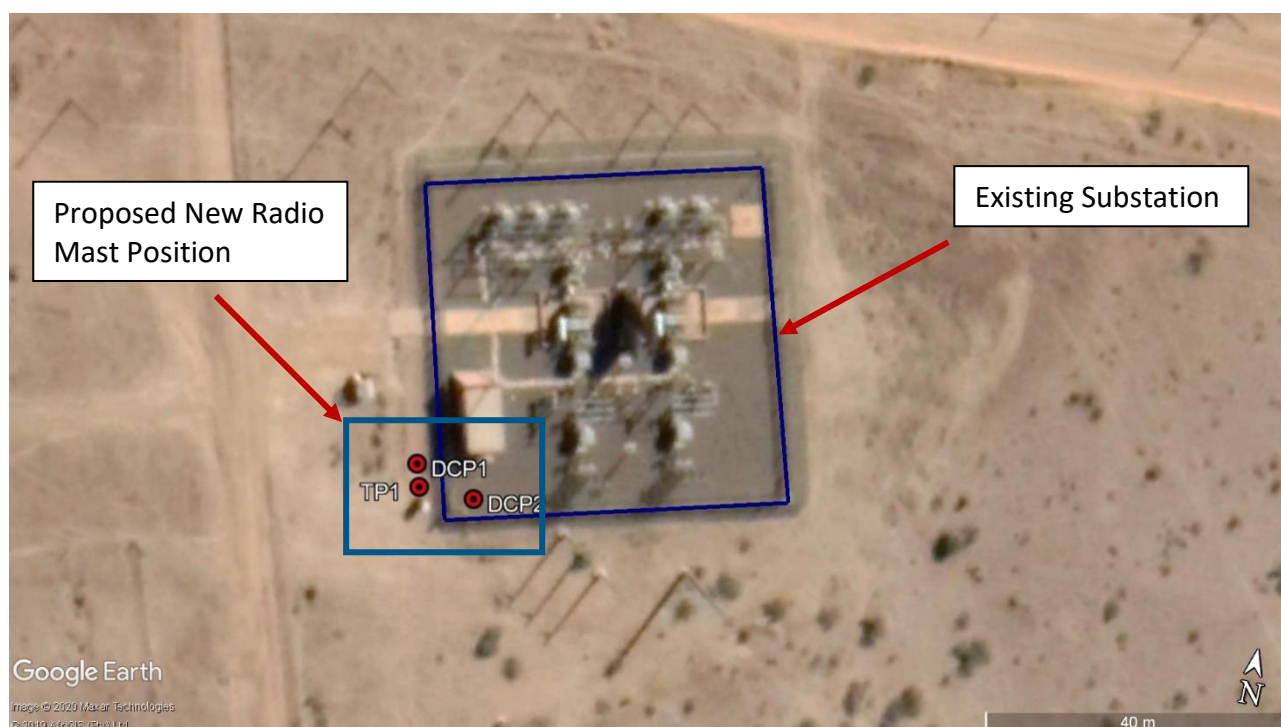
*Figure 2: Test Pit Layout Plan*

A Locality Map and a Site Layout Plan are provided in Figures 1 and 2.

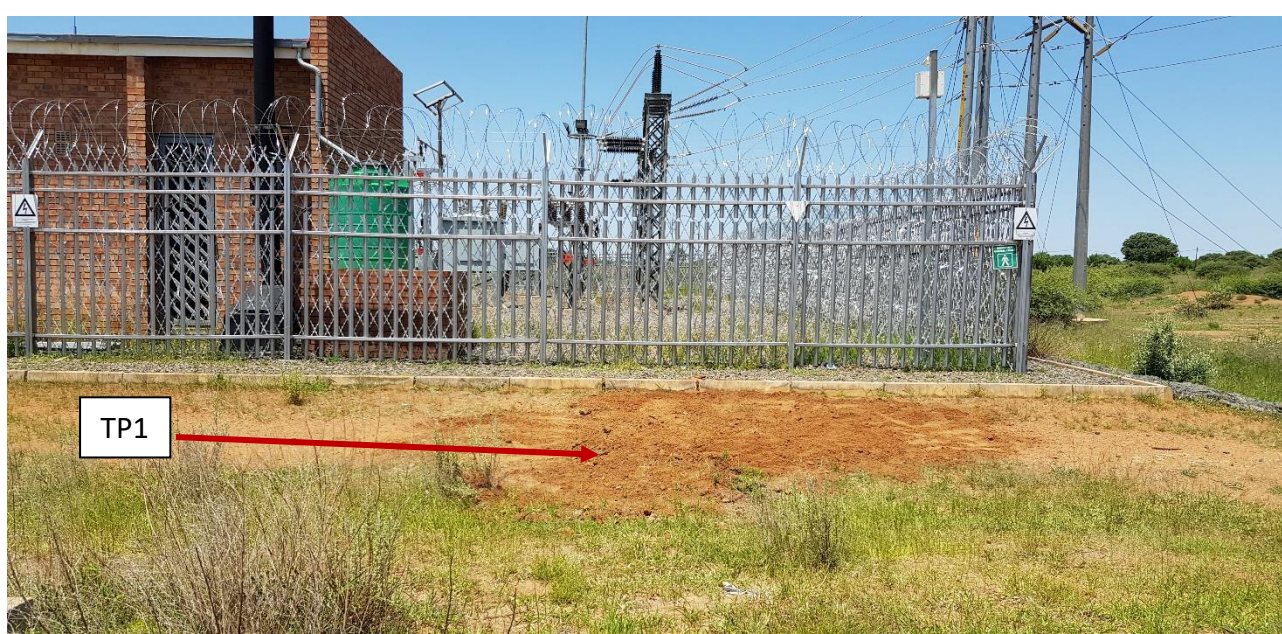
Figure 4: Location of TP1 & TP2

One test pit, designated TP1, was excavated using hand tools to a depth of 1.50 m below ground level. The test pit was then advanced by hand auger to a depth of 2.80 m, below existing ground level before refusal occurred. The test pit and auger hole spoils were profiled and photographed by a professionally registered engineering geologist in accordance with “*Guidelines for Soil and Rock Logging in SA, 2<sup>nd</sup> Impression, Brink & Bruin, 2002*”. The test pit was loosely backfilled after profiling. The test pit log and photographs can be found in Annexure A. The location of the hand excavated TP1 is indicated in Figure 4.

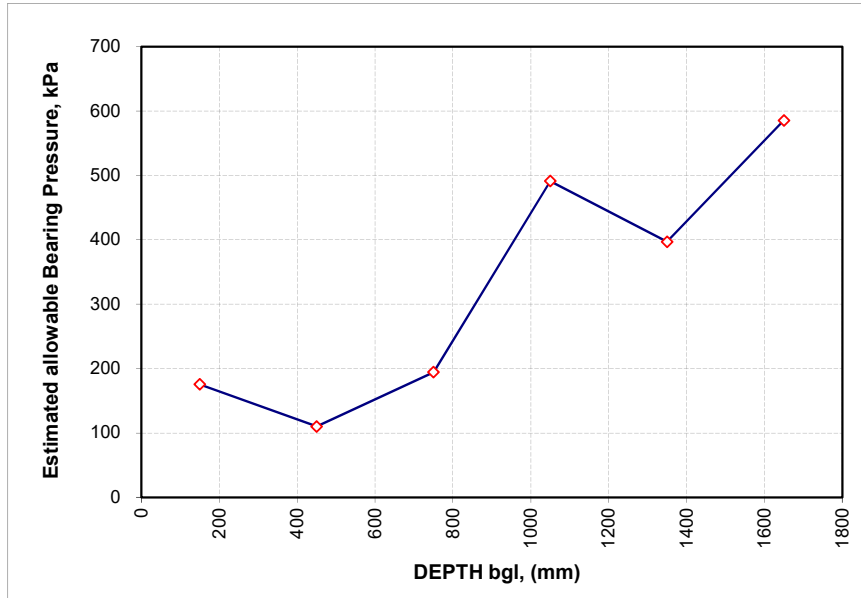
DCP No: 1 Location: Adjacent to TP1

note: EASBP from Terzaghi & Peck p4 for 25mm settlement

Reading No.	Layer From	Layer To	Average Layer Depth	DCP DN blows/300mm	Level Below NGL mm	DCP Enetratic mm/blow	Equiv. SPT N Value	Approx In-situ CBR	Approx EASBP kPa
1	0	300	150	33	150	9	13	26	175
2	300	600	450	25	450	12	10	18	110
3	600	900	750	37	750	8	14	30	194
4	900	1200	1050	100	1050	3	38	110	491
5	1200	1500	1350	80	1350	4	30	82	397
6	1500	1800	1650	120	1650	3	46	110	585

- Fill soils between 0.00 and 0.60 m depth have EASBPs of **110 - 175 KPa**.

- **Hillwash** between **0.60 and 1.00** m depth have very low EASPBs, of **110 - 194 KPa**.
- **Residual soils** between **1.00 and 2.80** m depth have EASPBs of **56 - 585 KPa**

The high EASBP values obtained for the residual layers are considered overstated, mainly due to the gravelly nature of the soil profiles and of the apparatus striking gravel or boulders. **Therefore, the DCP results shall be interpreted with caution.**

Based on the DCP test results from DCP1 and DCP2, the Estimated Allowable Safe Bearing Pressure (EASPB) for the residual soils between 1.00 to 2.80 m depth range between 56 kPa to 585 kPa. The values of 56 kPa and 114 kPa, obtained from DCP2 between depths 0.90 m and 1.50 m, are considered an untrue representation of the residual soil horizon and may be attributed to a weaker horizon overlying more competent residual soil horizons.

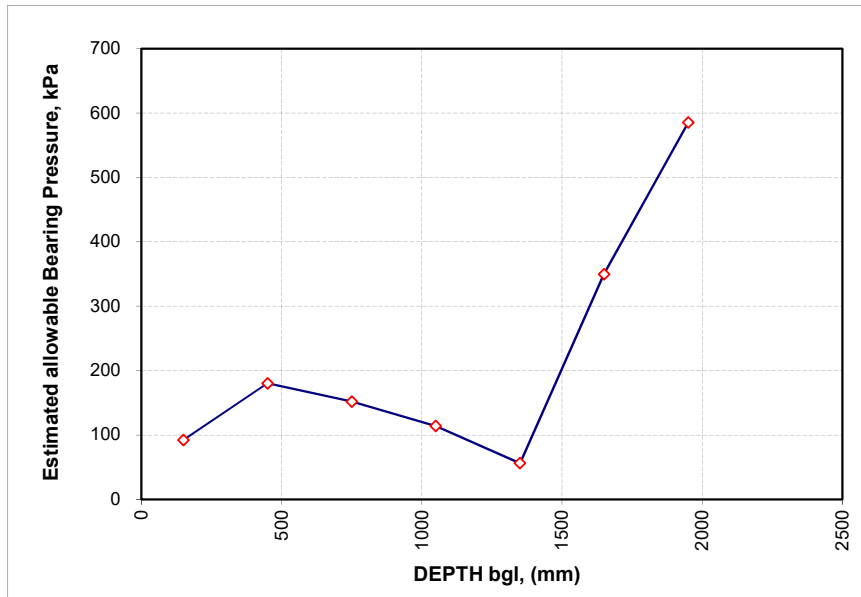
DCP No: 1 Location: Adjacent to TP1

note: EASBP from Terzaghi & Peck p4 for 25mm settlement

Reading No.	Layer From	Layer To	Average Layer Depth	DCP DN lows/300mi	Level Below NGL mm	DCP Penetratic mm/blow	Equiv. SPT N Value	Approx In-situ CBR	Approx EASBP kPa
1	0	300	150	20	150	15	8	13	92
2	300	600	450	34	450	9	13	27	180
3	600	900	750	28	750	11	11	21	152
4	900	1200	1050	26	1050	12	10	19	114
5	1200	1500	1350	10	1350	30	4	5	56
6	1500	1800	1650	70	1650	4	27	69	350
7	1800	2100	1950	120	1950	3	46	110	585

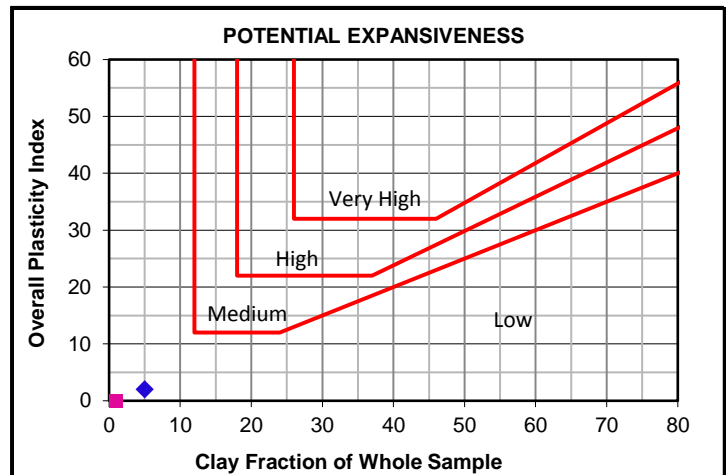
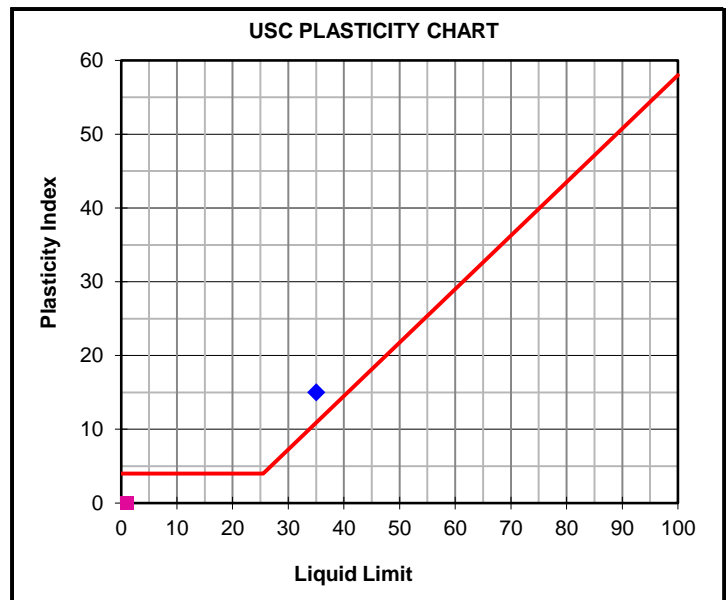
Laboratory Number	1	
Field Number	TP1/AH1	
Client Reference		
Depth (m)	1.00 - 2.10	
Position		
Coordinates	X	
	Y	
Description		
Additional Information		
Calcrete / Crushed		
Stabilizing Agent

Percentage Passing	100 mm	100	
	75 mm	100	
	63 mm	100	
	50 mm	100	
	37.5 mm	100	
	28 mm	100	
	20 mm	100	
	14 mm	100	
	5 mm	87	
	2 mm	42	
	1 mm	24	
	0.425 mm	12	
	0.250 mm	11	
	0.150 mm	11	
0.075 mm	10		
Grading Modulus		2.36

Percentage Passing	0.060 mm	9	
	0.040 mm	9	
	0.020 mm	8	
	0.006 mm	6	
	0.002 mm	5	
Gravel	%	58	
Sand	%	33	
Silt	%	4	
Clay	%	5

HRB (AASHTO)	A-2-6(0)	
Unified (ASTM D2487)	SP-SC	
Weston Swell @ 1 kPa

Pit No	Depth (m)	Description	Particle Size (%)				Atterberg Limits (%)			Soil Classification AASHTO
			Gravel	Sand	Silt	Clay	LL	PI	LS	
TP1	1.00 – 2.10	Sandy GRAVEL Residual	58	33	4	5	35	15	7.5	A-2-6 (0)

The results of the soil grading test indicate that the soil consists predominately of gravel. It is therefore recommended that the soil be classified as non-cohesive for engineering evaluation purposes. The laboratory test results indicate that the soils have a liquid limit of 35, a PI of 15 and a linear shrinkage of 7,5. The AASHTO soils classification is A-2-4(0). The soil sample was also assessed to have a “low” potential for expansiveness, as per the van der Merwe Method.
