CLIENT: Eskom

PROJECT: Bravo

FIGURE 4: Stability analysis -15m cut in tillite

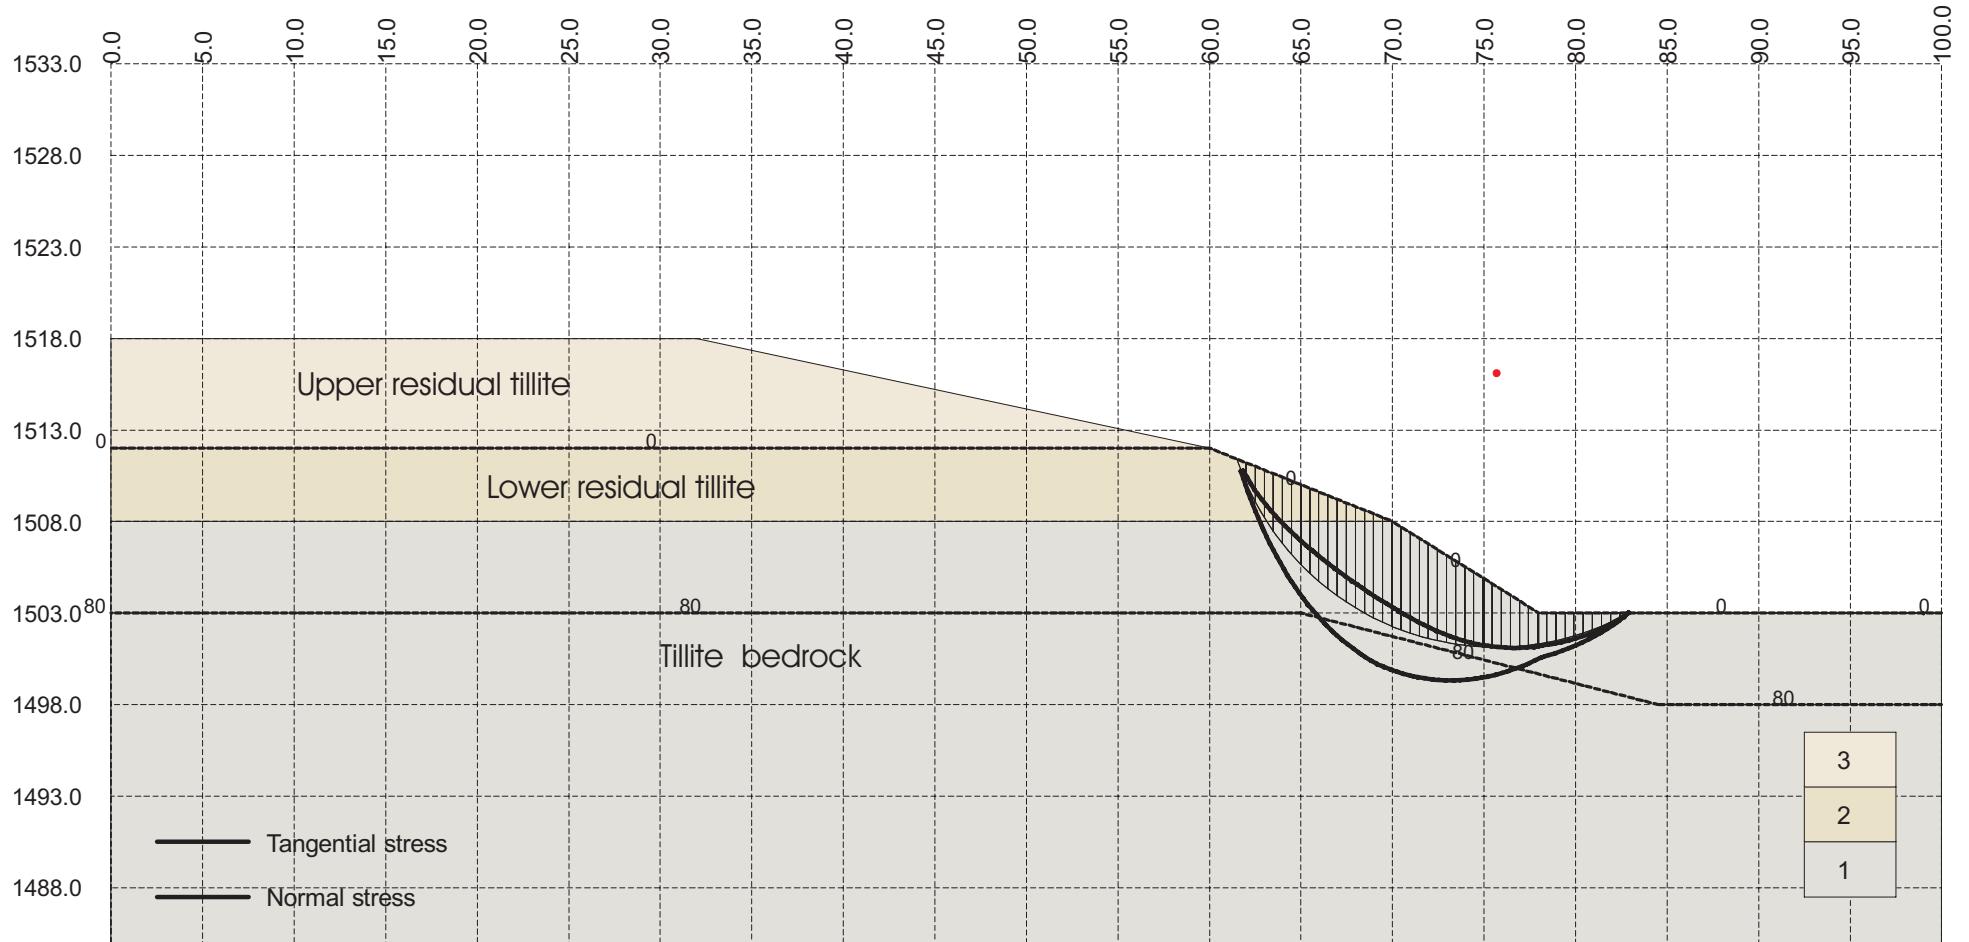
Factor of Safety: 1.03
