CLIENT: Eskom		
PROJECT: Bravo		
FIGURE 5: Stability analysis -15m cut in tillite - drained		
COMPILED BY: HJS	Date: October 2007	Drawing No.
DRAWN BY: HJS	Scale : n/a	
CHECKED BY: HJS		
Partridge, Maud and Associates		PO Box 1050 Portlands 2121 Tel: (011) 646 3324 email: hcp@kafica.com
Consultants in the Earth Sciences

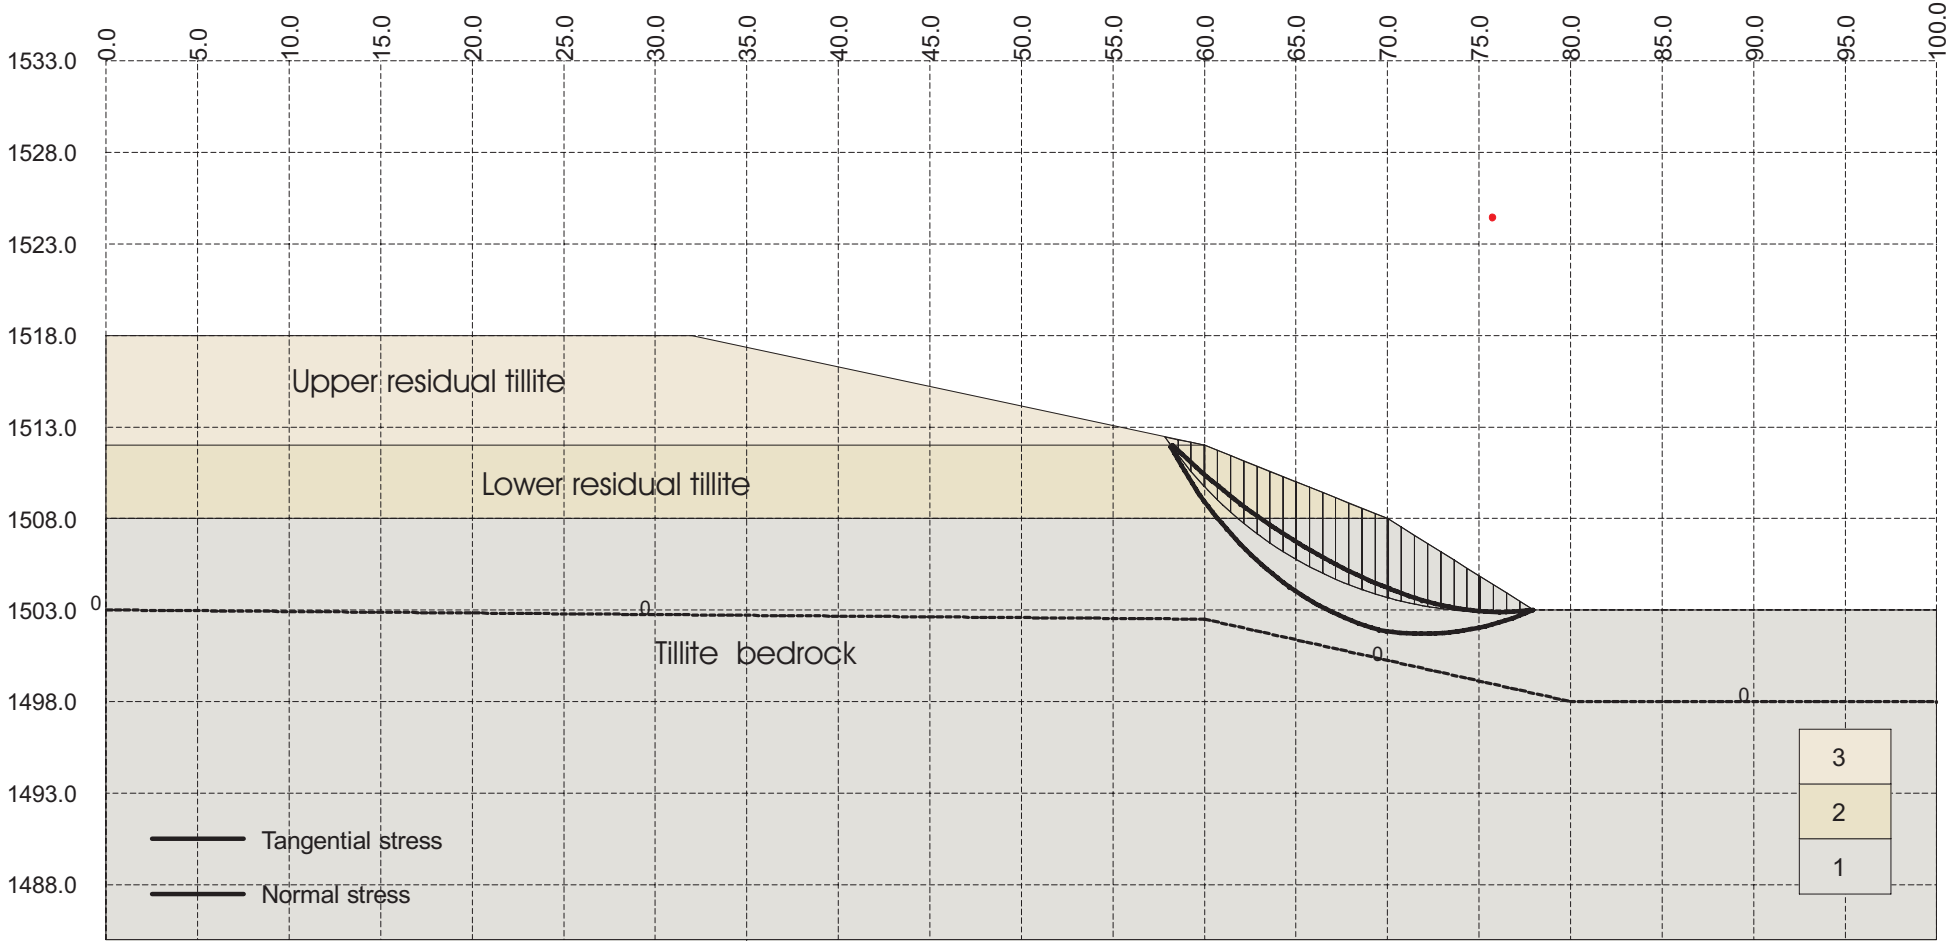
Factor of Safety: 1.89
