CLIENT: Eskom		
PROJECT: Bravo		
FIGURE 6b: Stability analysis -fill overlying diabase		
COMPILED BY: HJS	Date: October 2007	Drawing No.
DRAWN BY: HJS	Scale : n/a	
CHECKED BY: HJS		
Partridge, Maud and Associates		
Consultants in the Earth Sciences

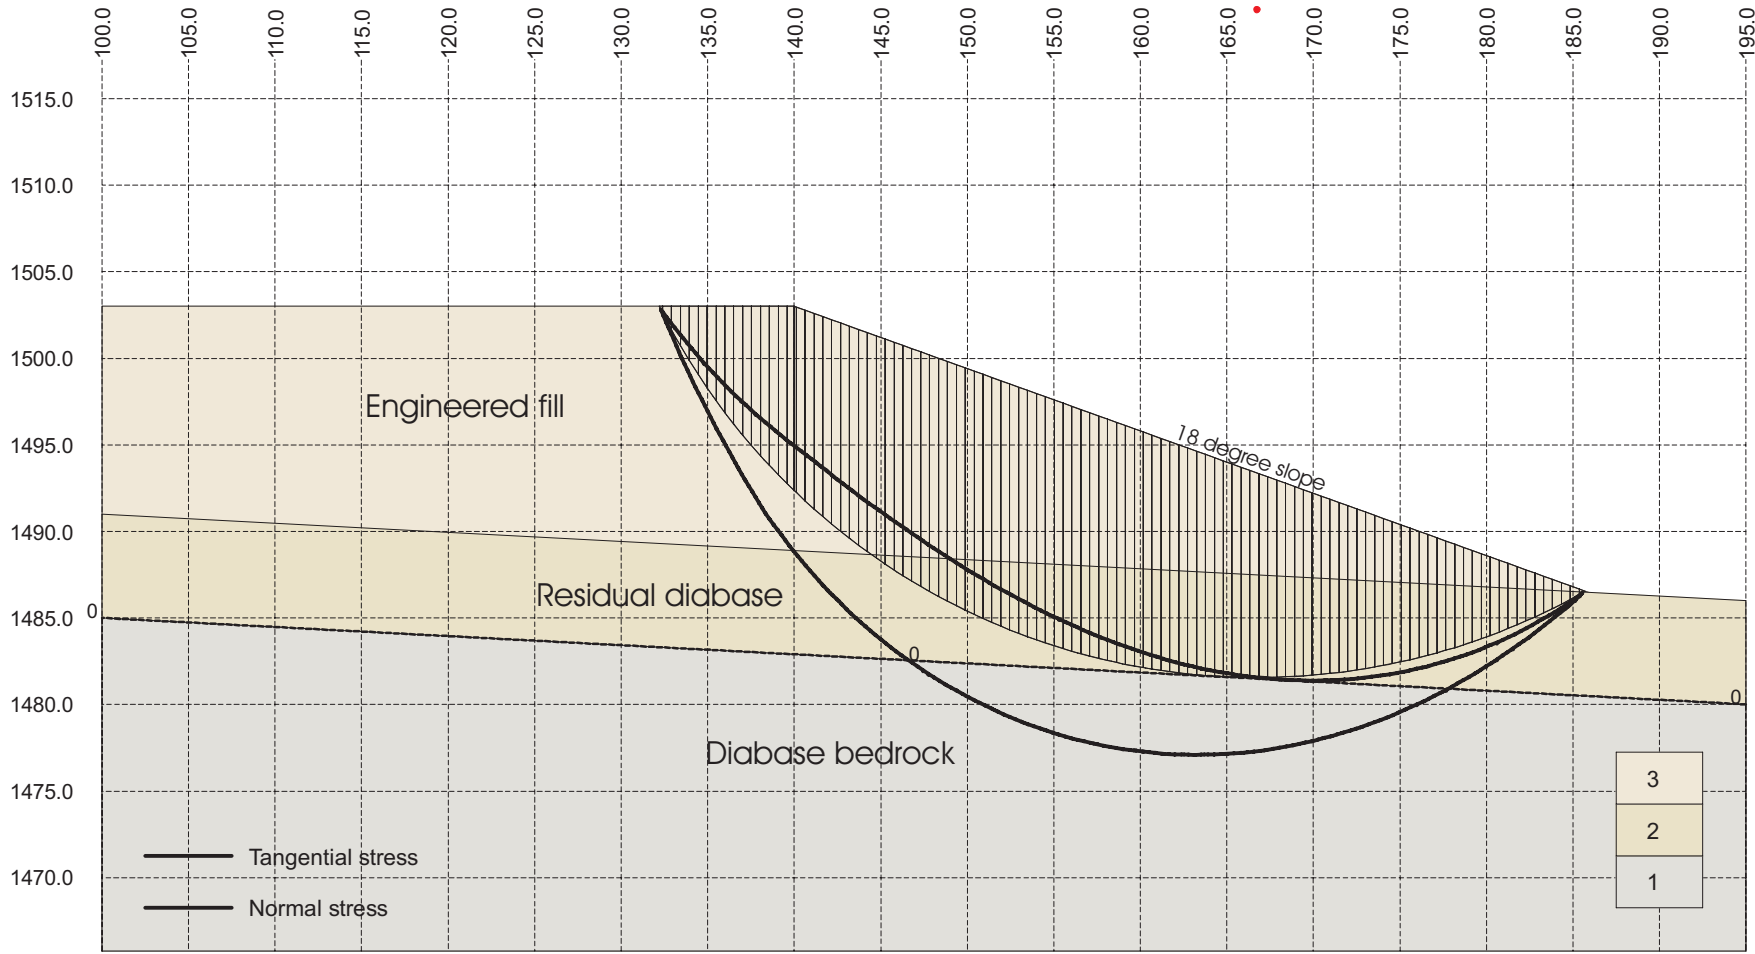
Factor of Safety: 1.53
