CLIENT: Eskom		
PROJECT: Bravo		
FIGURE 7: Stability analysis -fill overlying diabase		
COMPILED BY: HJS	Date: October 2007	Drawing No.
DRAWN BY: HJS		
CHECKED BY: HJS	Scale : n/a	
Partridge, Maud and Associates		PO Box 1050 Parklands 2121 Tel: (011) 646 3324 email: hcp@jafica.com
Consultants in the Earth Sciences

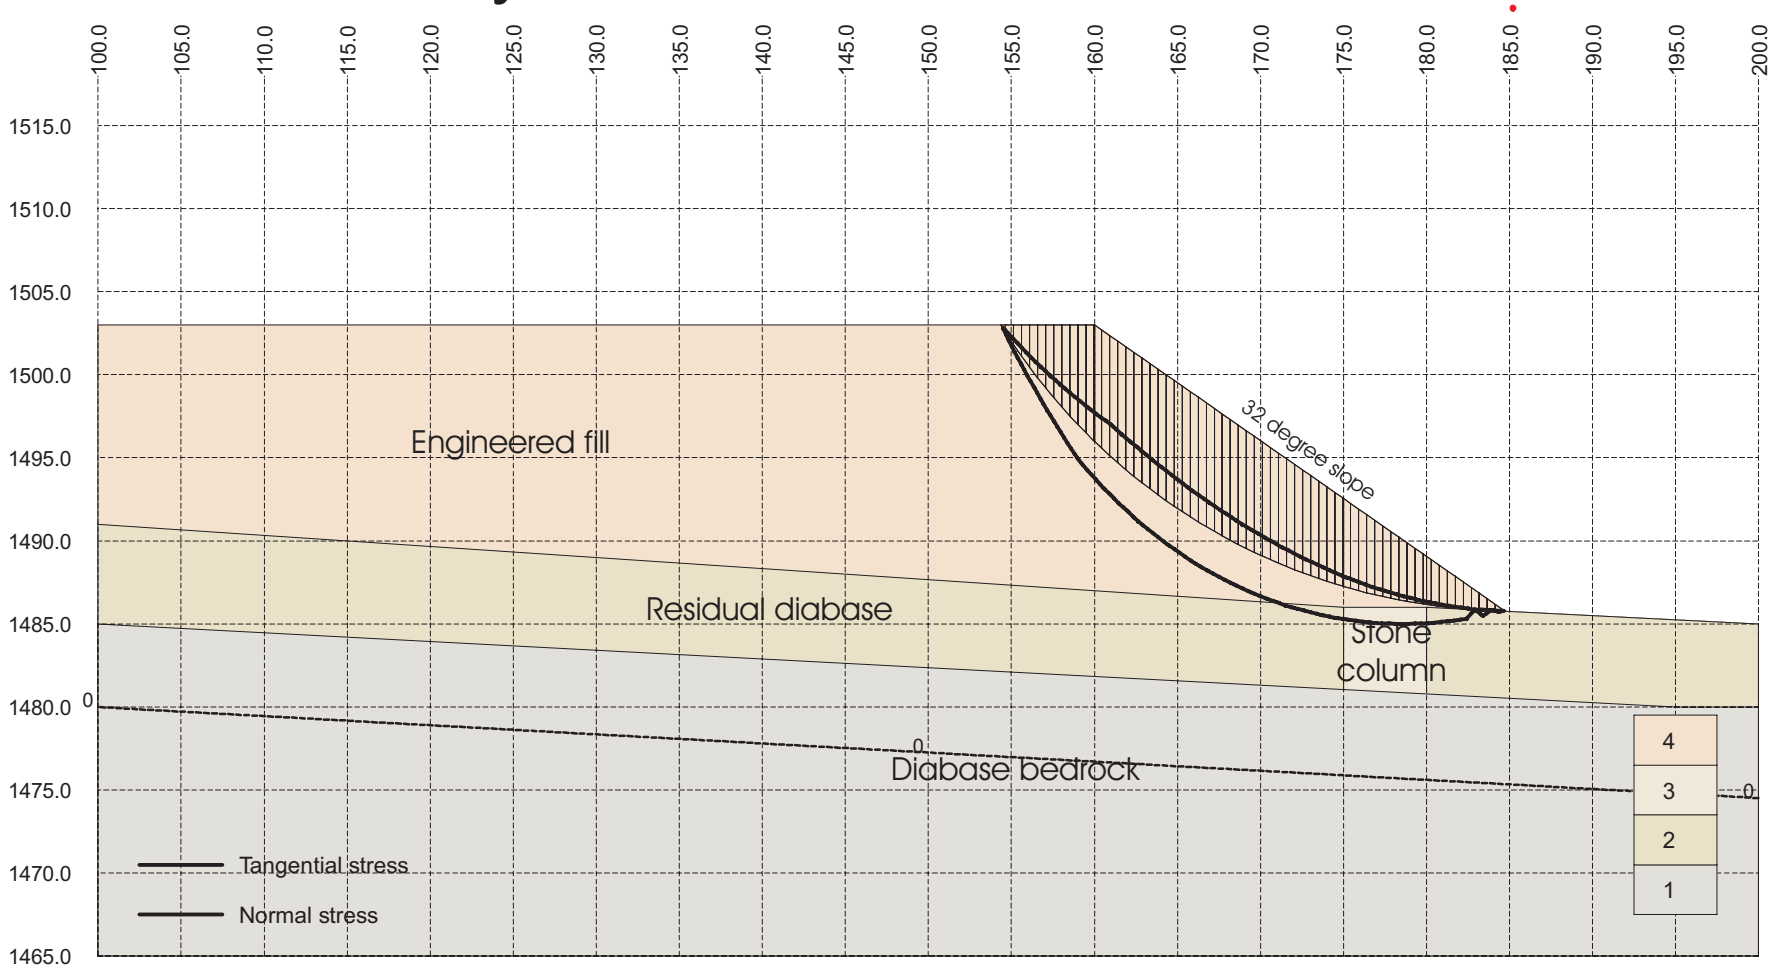
Factor of Safety: 1.44
