Eskom	Matimba ACC General Maintenance Contract SOW	Doc. no. NA
		Rev. 1
		Total pages 1 of 30
Matimba Power Station		Reference Document: NA

Outage type	MO/GO/IR	Outage start date	As Per Outage Philosophy
Department	Engineering	System	Air Cooled Condenser

This scope contains the detailed scope of work for the Air Cooled Condenser for execution during MO's, GO's and IR's. The outage commencement date and duration will be according to the outage philosophy.

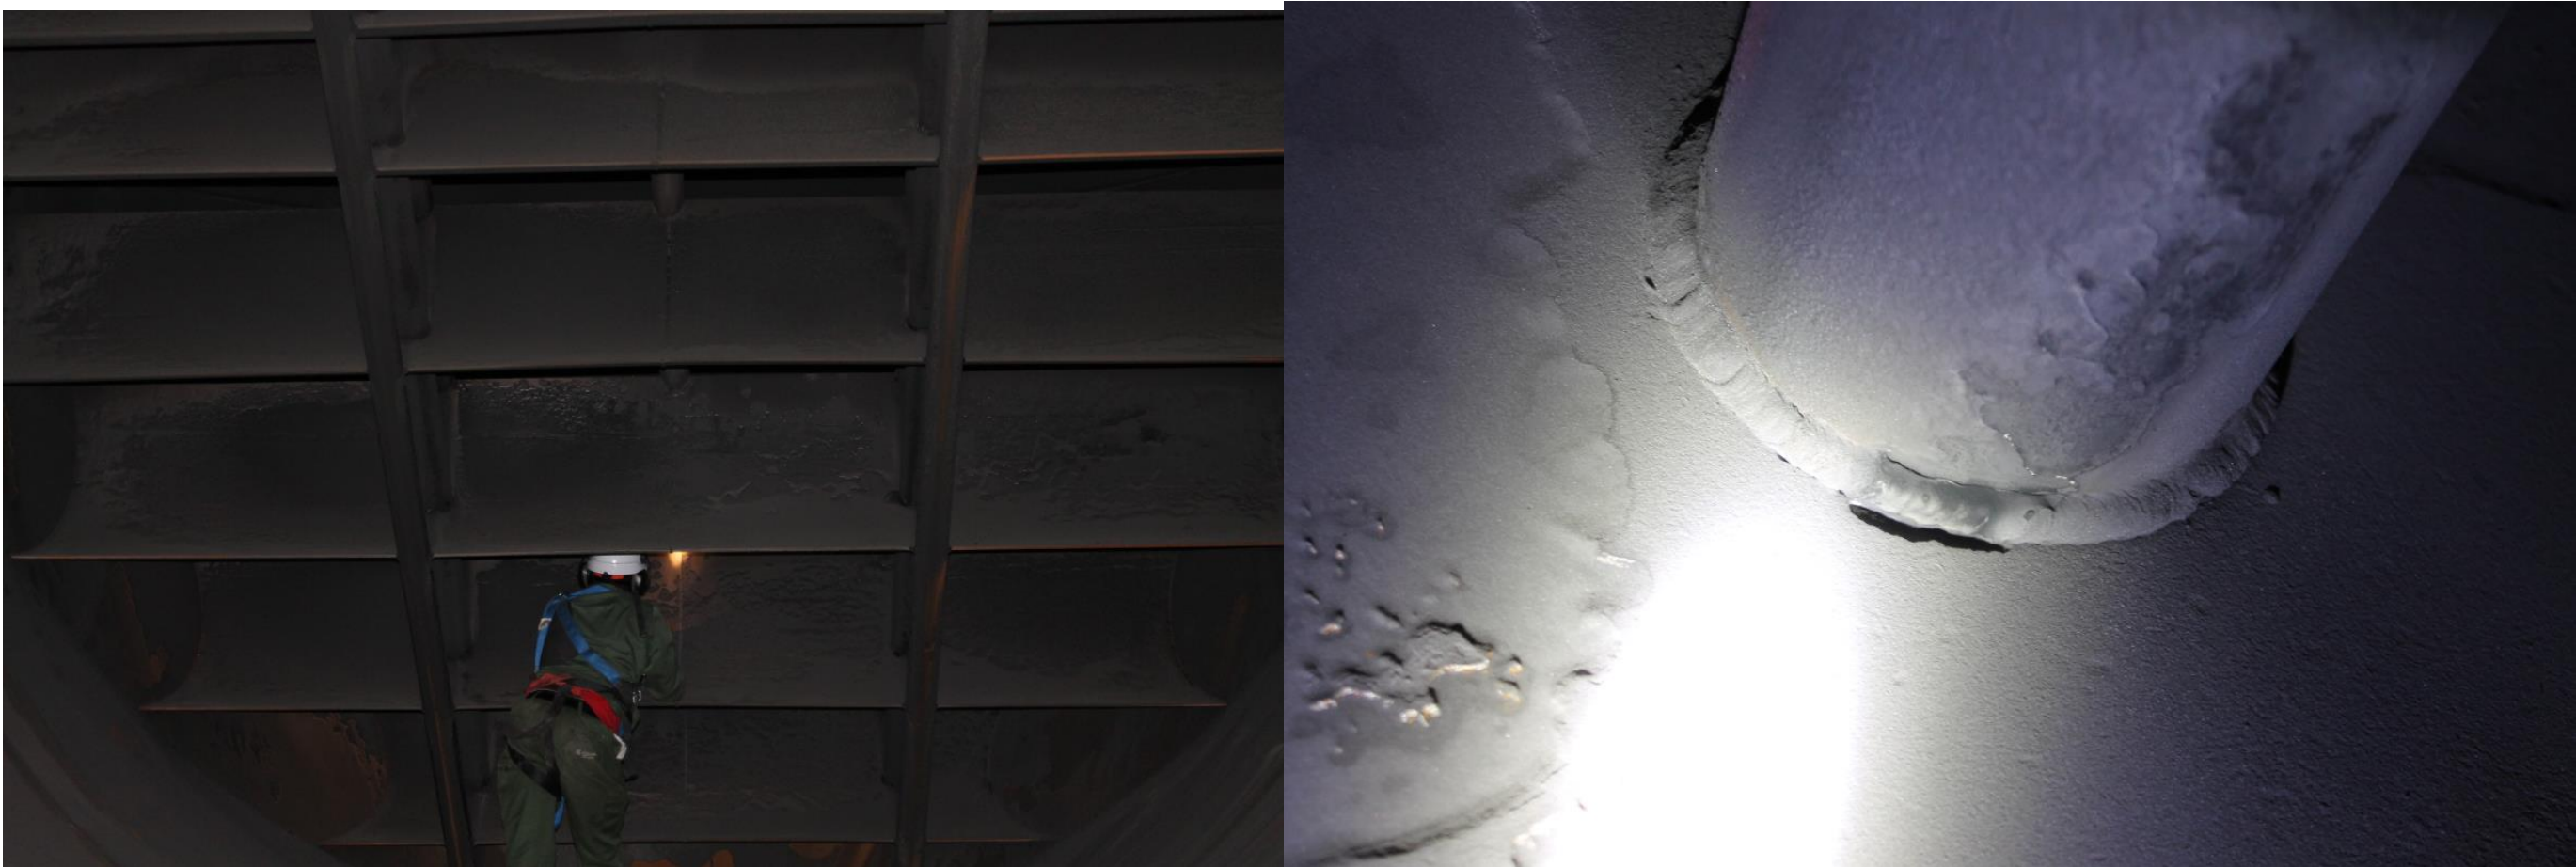
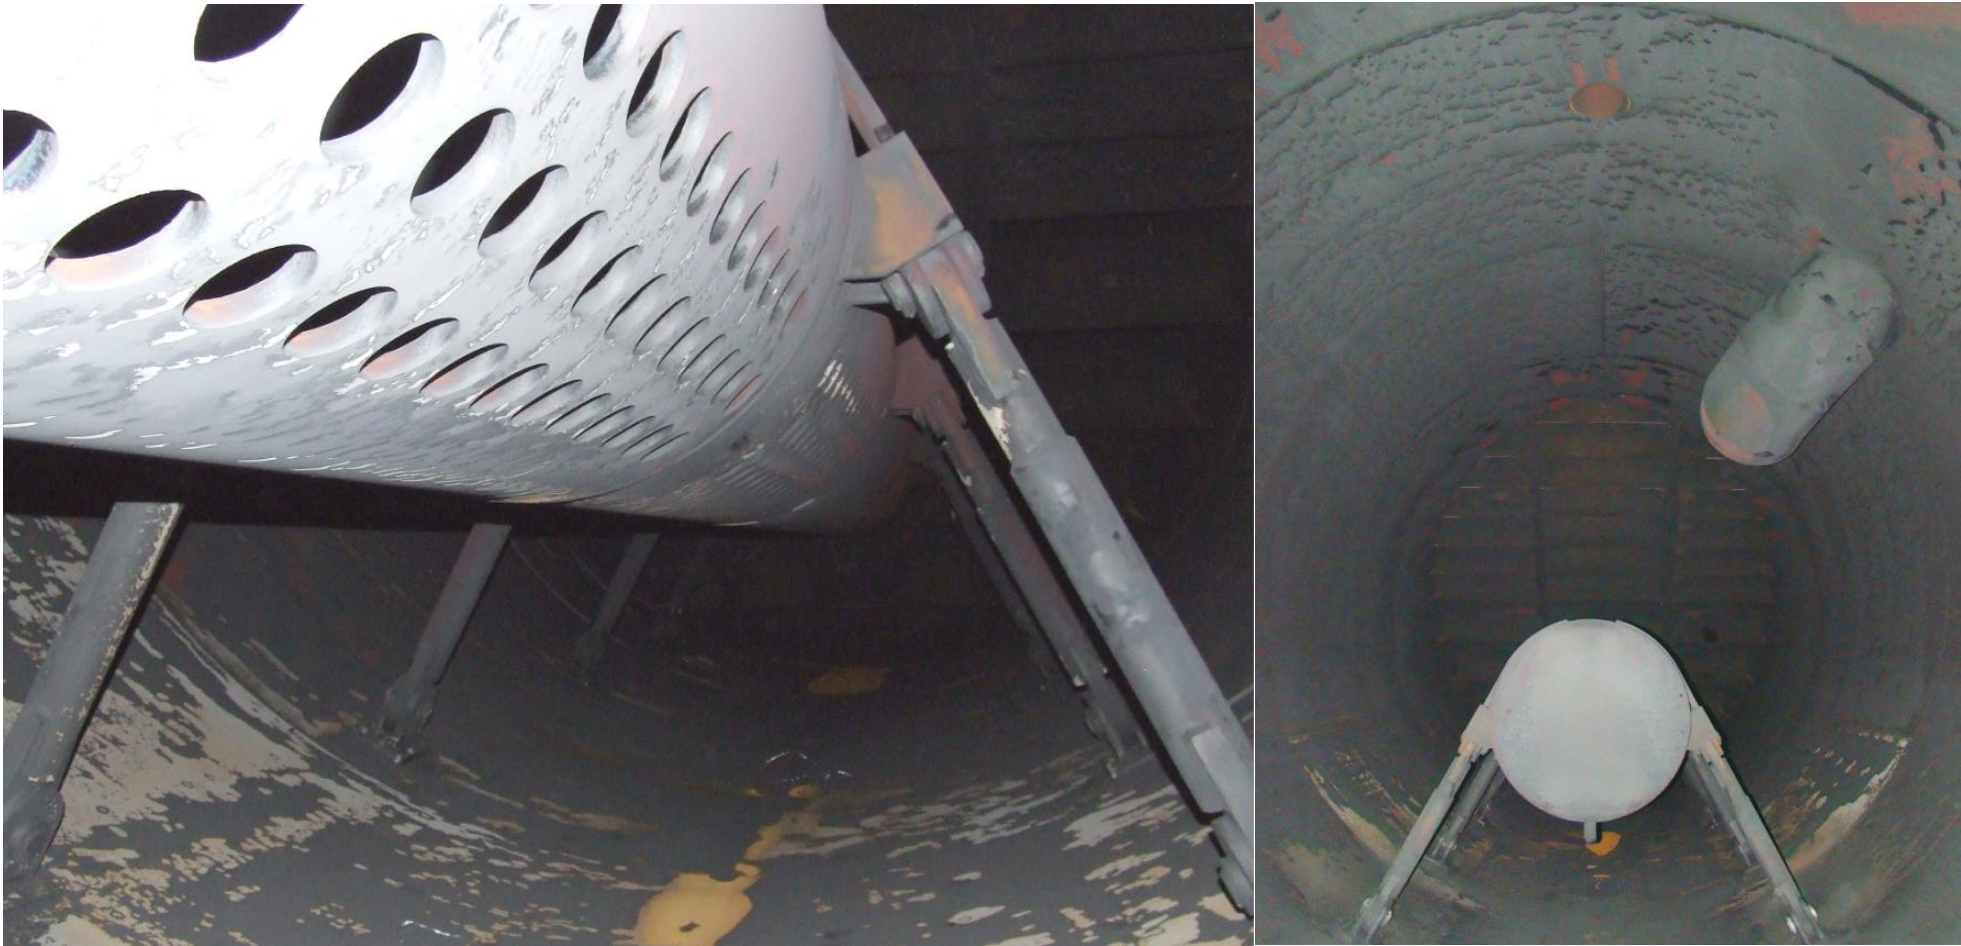
1.1	Inspection of LP exhaust steam ducts	Erect scaffolding at 0m level below the LP exhaust steam ducts manhole cover	Allow workers to safely open, gain access into the ducts and close the manhole covers	NA	Outage Coordinator	NA	NA	NA
		Open manhole covers at 6m level. Remove old gasket and clean gasket seats with a scraper	Access gained to exhaust steam ducts. New gasket must be able to seal adequately	NA	Outage Coordinator	NA	NA	NA
		Do gas test	Occupational Health and Safety Act 85 of 1993		Outage Coordinator	Gas test to form part of contractors QCP – Hold point for contractor	Eskom	3
		Inspect ducting – use torch to identify any indentations which could weaken the structure. Shine torch parallel to the ducting walls	Check that there is no excessive active corrosion on the ducts. Check for any silver/white marks which indicates active corrosion	Sufficient illumination – adequate torches must be used	Contractor	Report with photographs to be submitted	X2 SAIW welding inspector	1

Check the condition of the hot-well grid, drains and condition of hot-well itself	Check that hot-well drain is free from any foreign materials.	Sufficient illumination – adequate torches must be used	Contractor	Report with photographs to be submitted	X2 Artisans	1
			Check the condition of the hot well grid. If grid is severely corroded, it should be replaced during the next outage and the contractor must indicate as such.					
			Ensure that the hotwells and drains are all drained and that there is not an accumulation of water which is not draining					
		Inspect guide vanes at front and back – Inspect each vane at the welds. Identify any critical areas using a white spray paint. Note them and inform system the engineer	Ensure that the guide vanes are all firmly secured. Ensure there is no severe active corrosion on the welds as well as the vanes	Sufficient illumination – adequate torches must be used	Contractor	Report with photographs to be submitted	X2 SAIW welding inspector	2

Inspect LB bypass distribution ducts – Identify all active corrosion.	Ensure bypass distribution duct has no foreign objects inside.	Sufficient illumination – adequate torches must be used	Contractor	Report with photographs to be submitted	X2 SAIW welding inspector	0.5
		Inspect bypass support, hinges and retainer pins – Identify active corrosion; inspect all welds for corrosion as well as cracks. Ensure retainer pins are not lose or missing.	Ensure that the bypass support does not fail during operation	Sufficient illumination – adequate torches must be used	Contractor	Report with photographs to be submitted	X2 SAIW welding inspector	1
			Be sure to thoroughly inspect the bottom support welds for cracks. Replace all damaged/missing pins – Inform system engineer prior to replacement					
		Check for any loose objects in the duct. Inform system engineer of all suspicious items	This work must be done at the start so as to do the necessary repair work if required				X2 Artisans	0.5

Clean ducts after LP casing/inspection manhole covers has been closed	Remove all foreign objects such as wire, sand etc. after LP turbine manhole covers are closed	Brooms and Sufficient illumination – adequate torches must be used	Contractor	The contractor is to liaise with Rotek just before the LP ducts are closed so that the ducts can be cleaned	X2 Semi-skilled	1
		Inspect pressure measurement taping points	Ensure that the holes are free from any foreign objects and or scaling accumulation if any. It is critical that these lines are not blocked as this will result in inaccurate pressure measurements	Sufficient illumination – adequate torches must be used	Contractor		X2 Artisans	0.5
		Remove hotwell drain flanges at .05m level and remove any foreign objects. Clean drain pipe. Close flange covers with new gaskets. (x4 Flanges)	Ensure hotwell drain pipe is thoroughly cleaned so as to prevent any blockages in sampling lines	Sufficient illumination – adequate torches must be used	Contractor	Report with photographs to be submitted	X2 Artisans	2

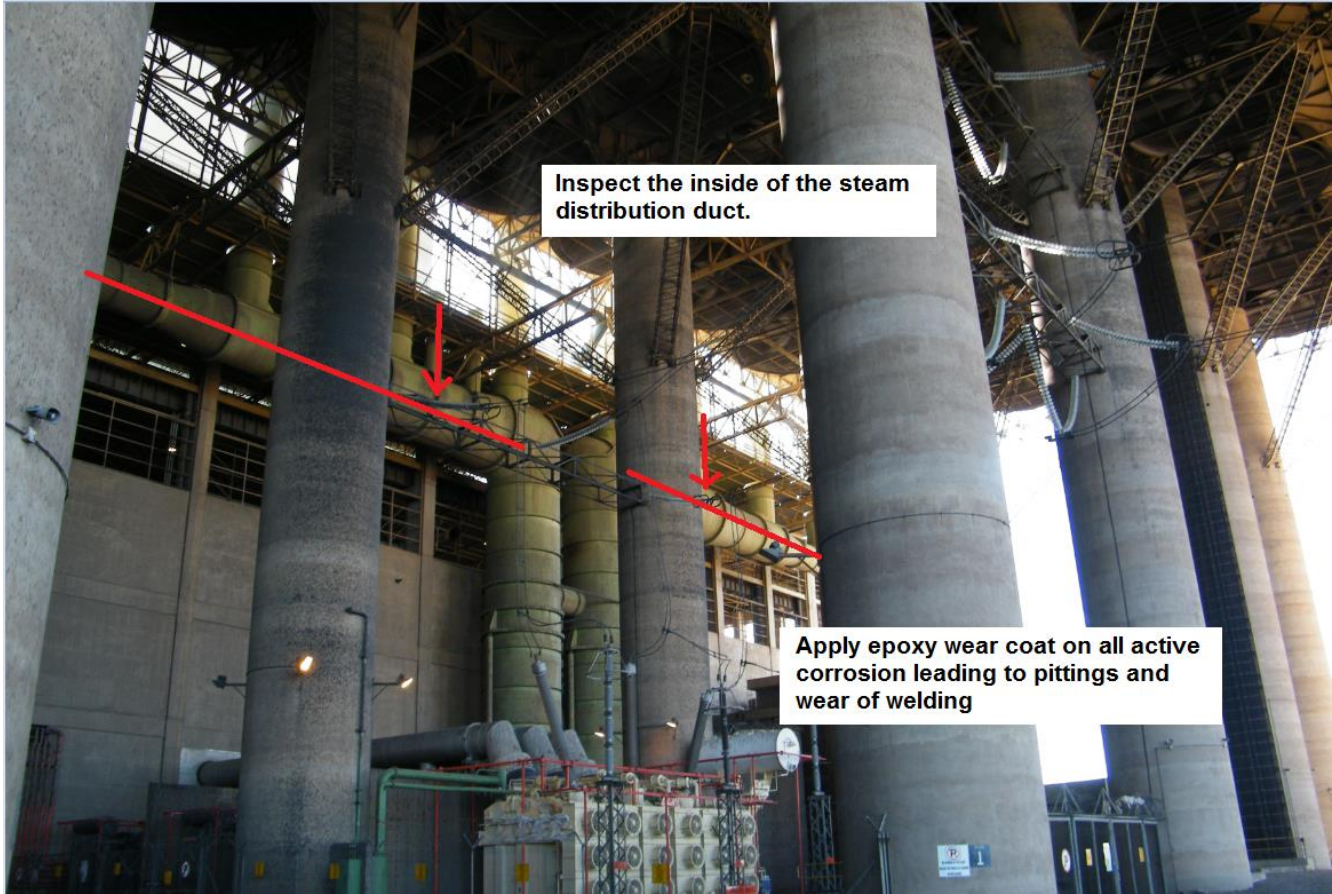
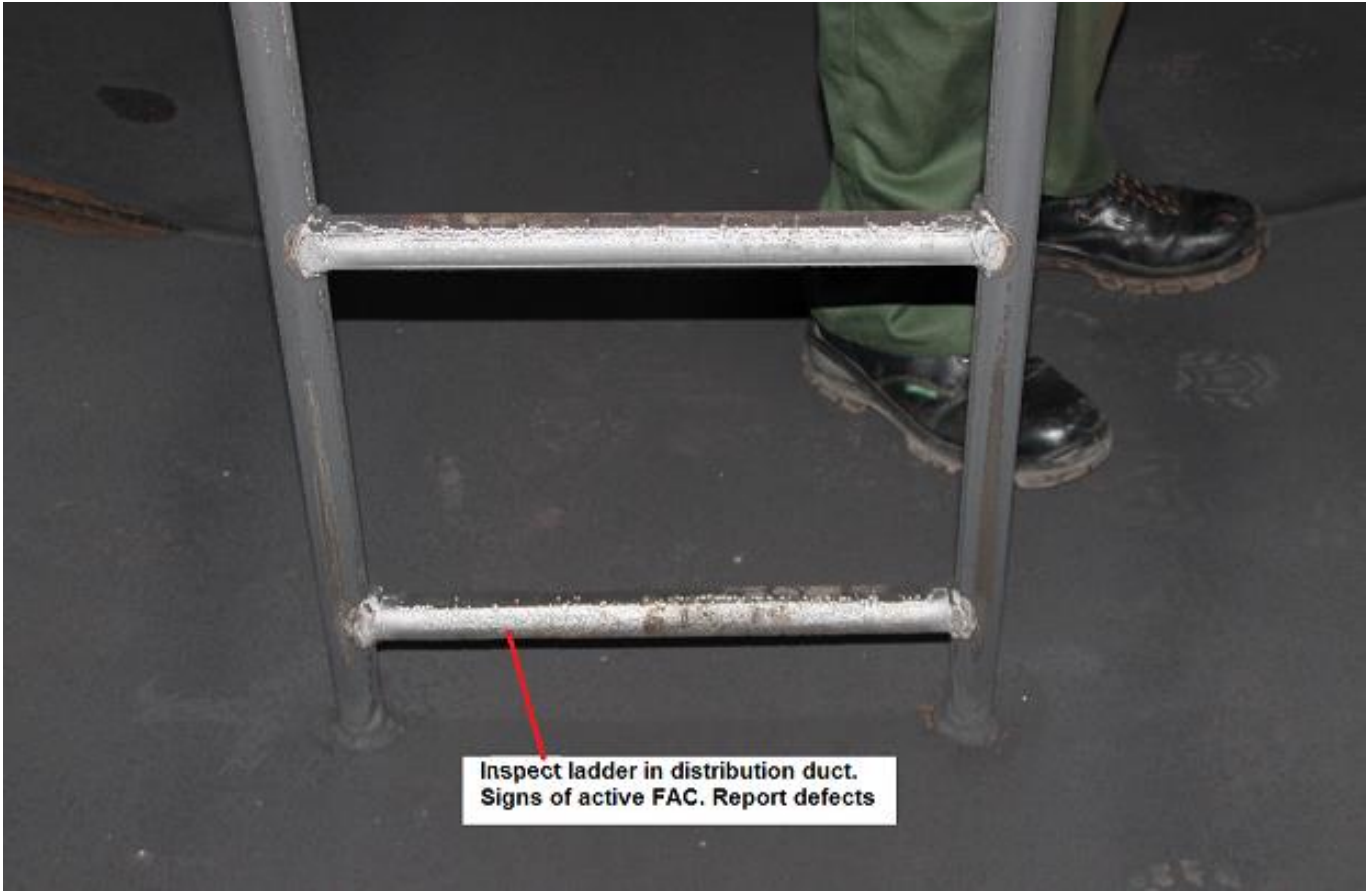
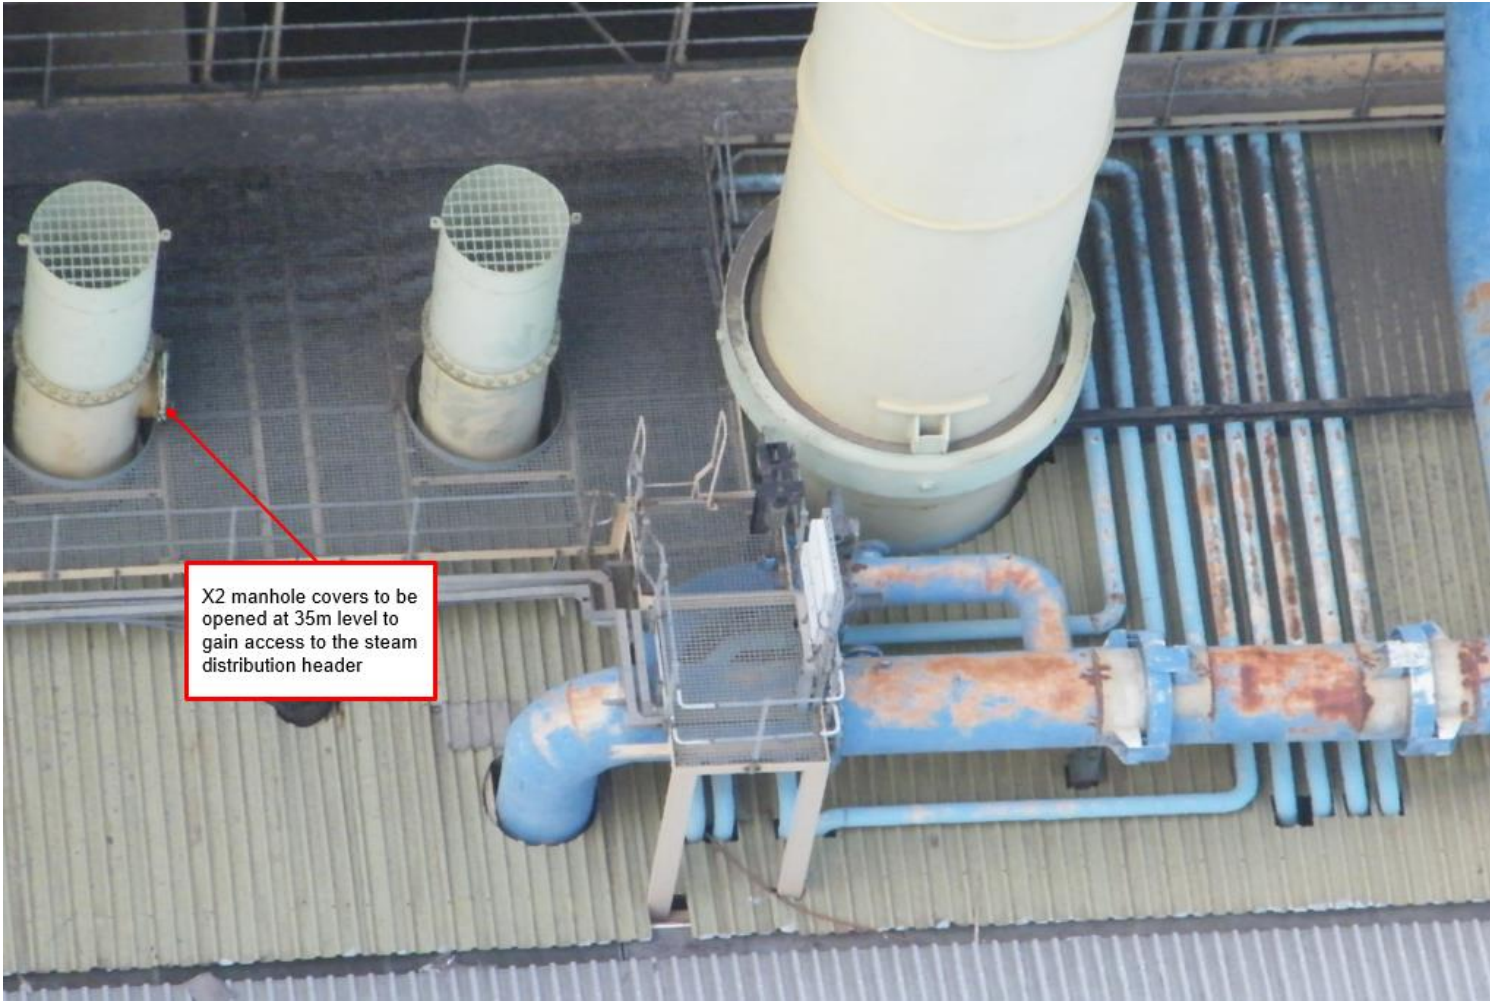
2.1	Inspection of distribution duct	Open manhole covers at 35m level	Open manhole covers to gain access to the distribution duct	Wrenches, hammer	Contractor		X2 Artisans	3
		Do gas test	Occupational Health and Safety Act 85 of 1993		Outage Coordinator	Gas test to form part of contractors QCP – Hold point for contractor. Must be arranged in advance	Eskom	3
		If ladder is damaged due to FAC, repair damaged ladder. If ladder becomes unsafe, report to system engineer	Ensure ladder is safe to use and will not come loose during operation. No welding may be done on the ducts without approval of the system engineer	Safety harness and Sufficient illumination – adequate torches must be used	Contractor	Report with photographs to be submitted	X2 SAIW welding inspector	1
		Inspect distribution duct ladders and guide vanes. Report any active corrosion as well as cracks on the welds. Inspect all welds on the guide vanes.	Ensure that all guide vanes are secure and not suffering from localised corrosion.	Sufficient illumination – adequate torches must be used	Contractor	Report with photographs to be submitted	X2 SAIW welding inspector	2

Scrape off any debris left behind from the gaskets. Use sand paper to ensure a fully cleaned surface	Mating faces must be cleaned and there may not be any high spots on the flanges	Scraper, 100 fine sand paper	Contractor		X2 Semi-skilled	2

Replace manhole gaskets and cover	Gasket must not leak during operation	Wrenches, hammer – Contractor to make own arrangements to cut the gaskets	Contractor		X2 Artisans	3
--	--	-----------------------------------	---------------------------------------	---	------------	--	-------------	---

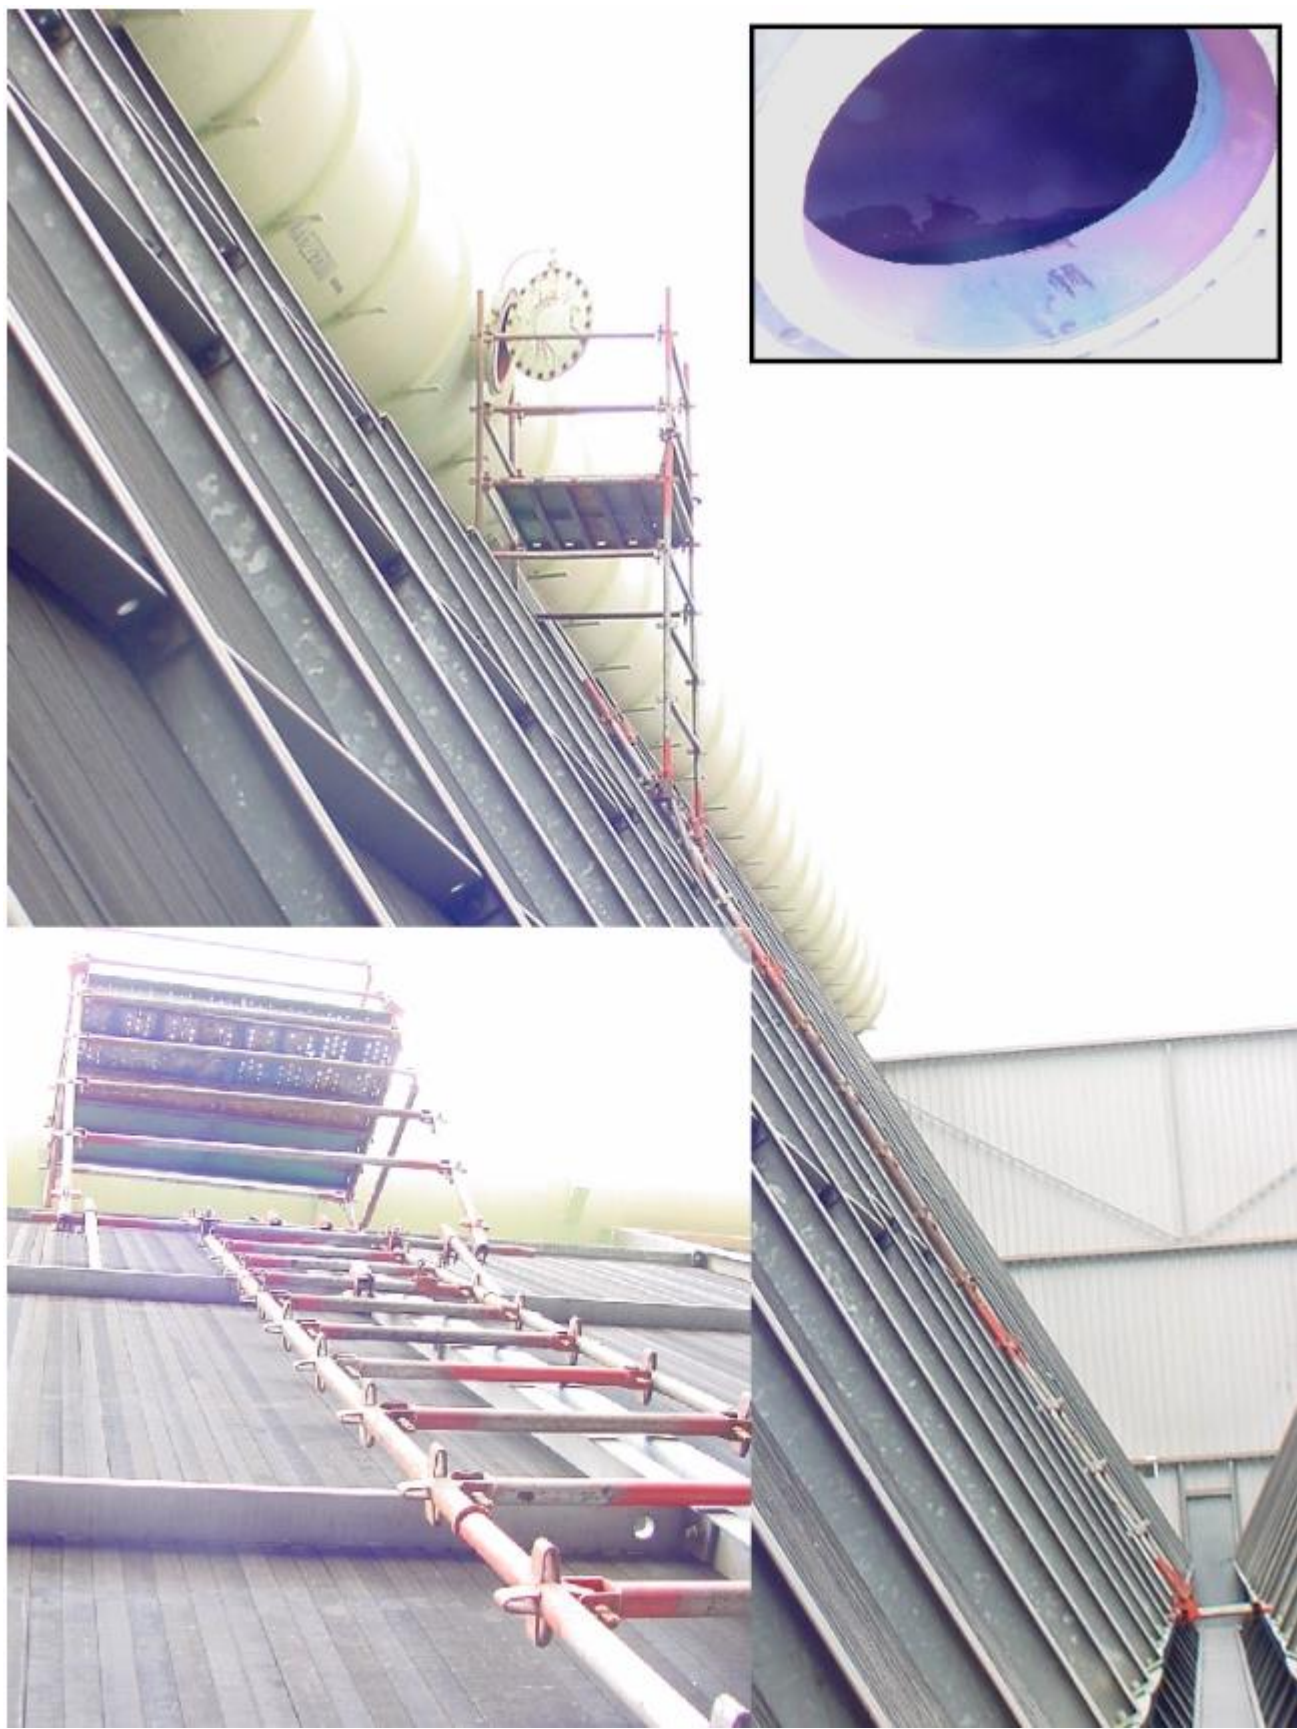
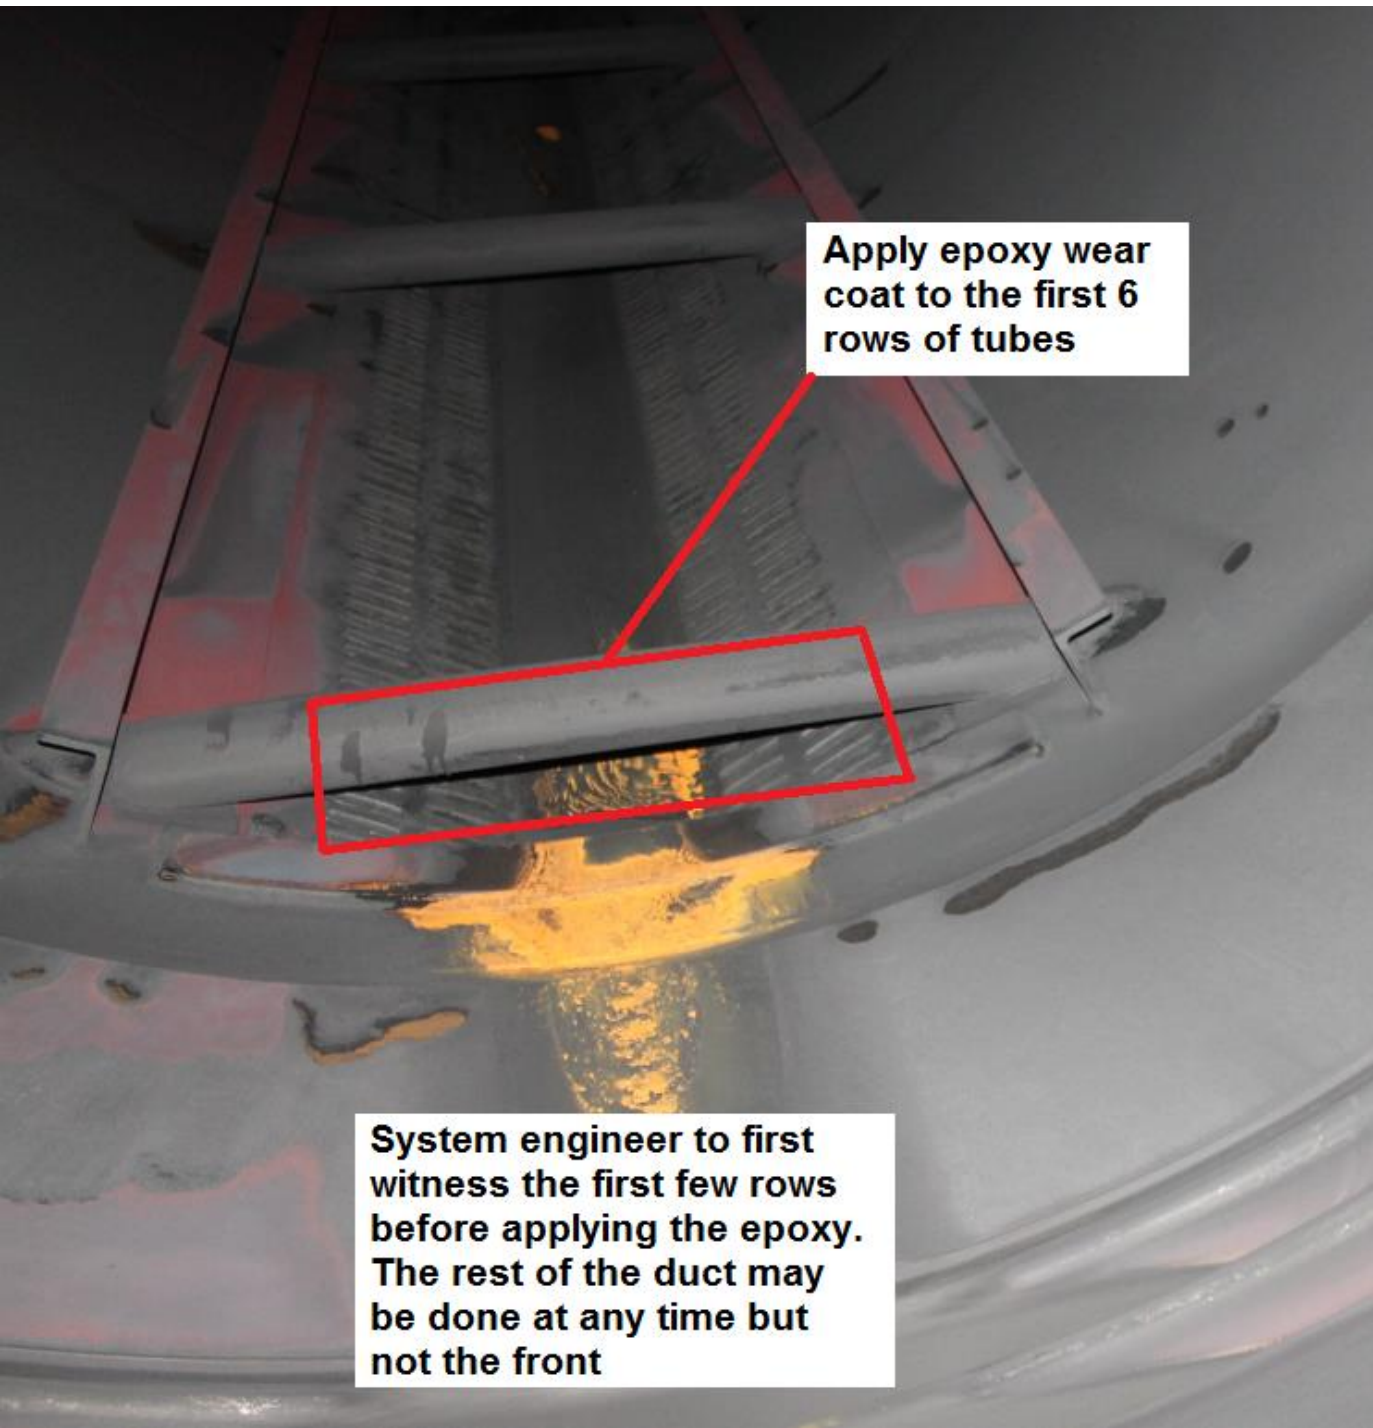
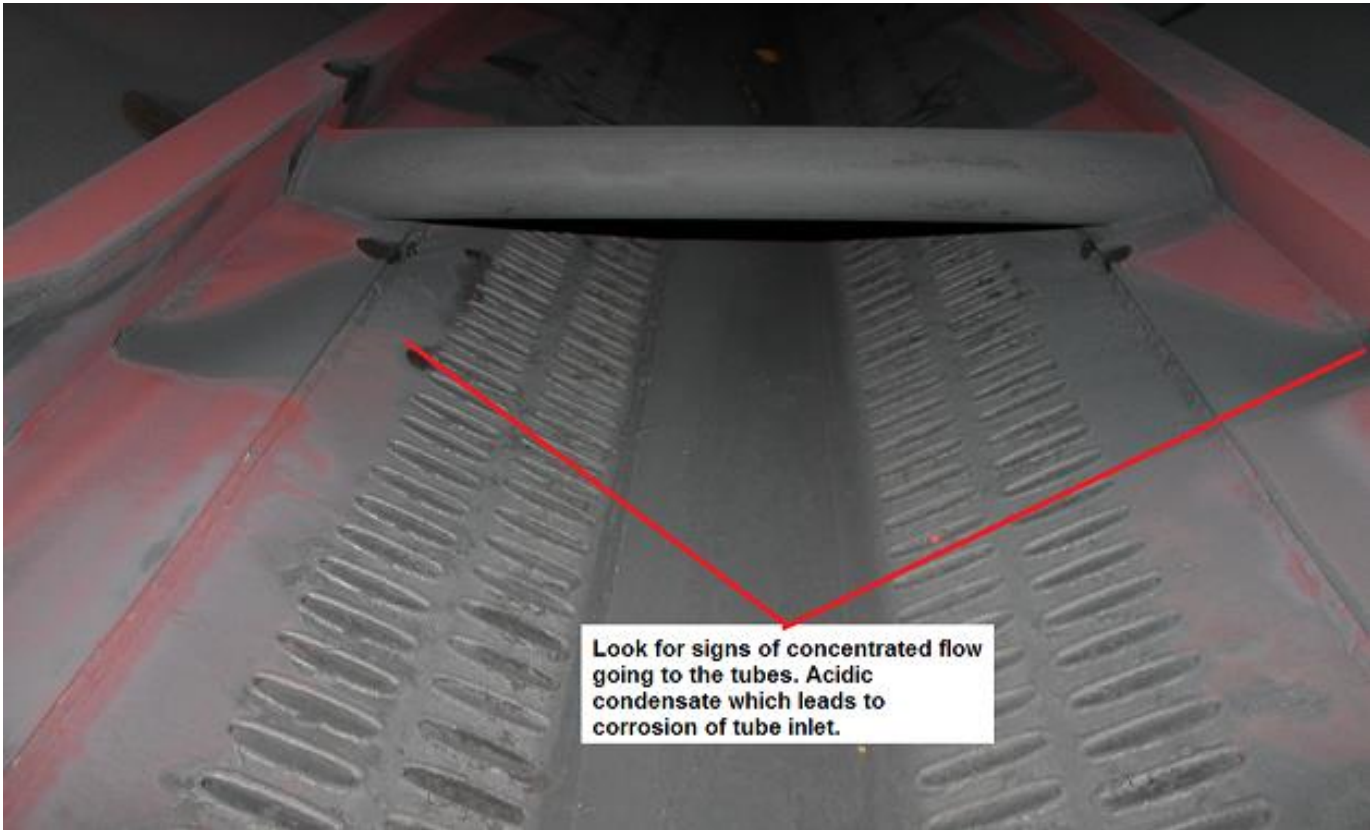
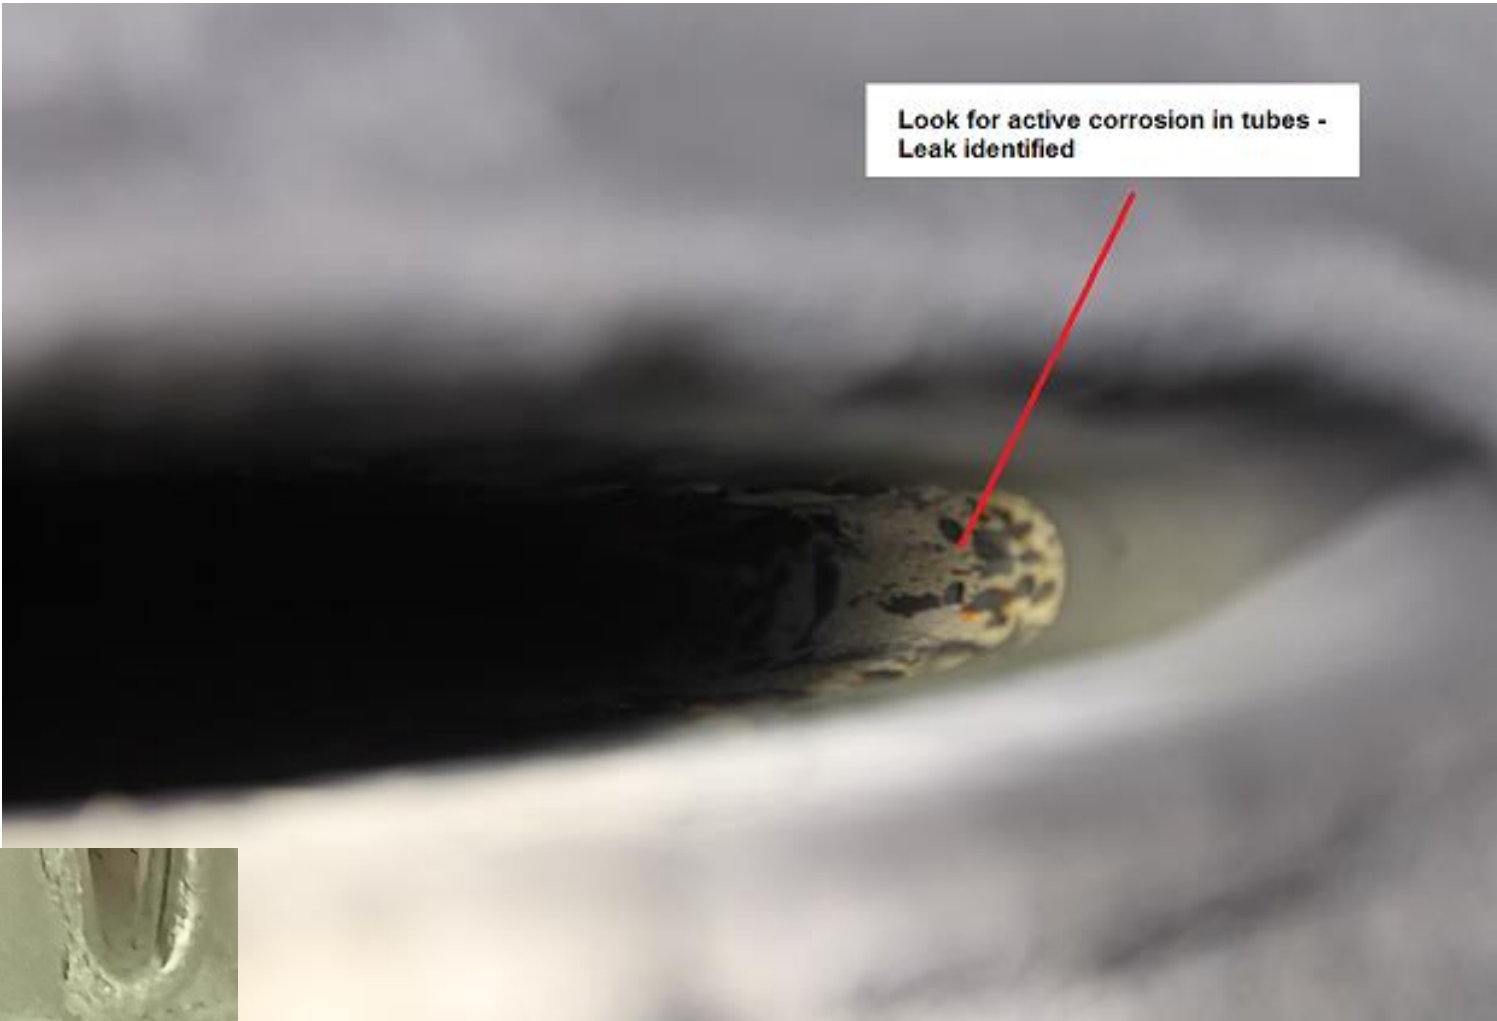
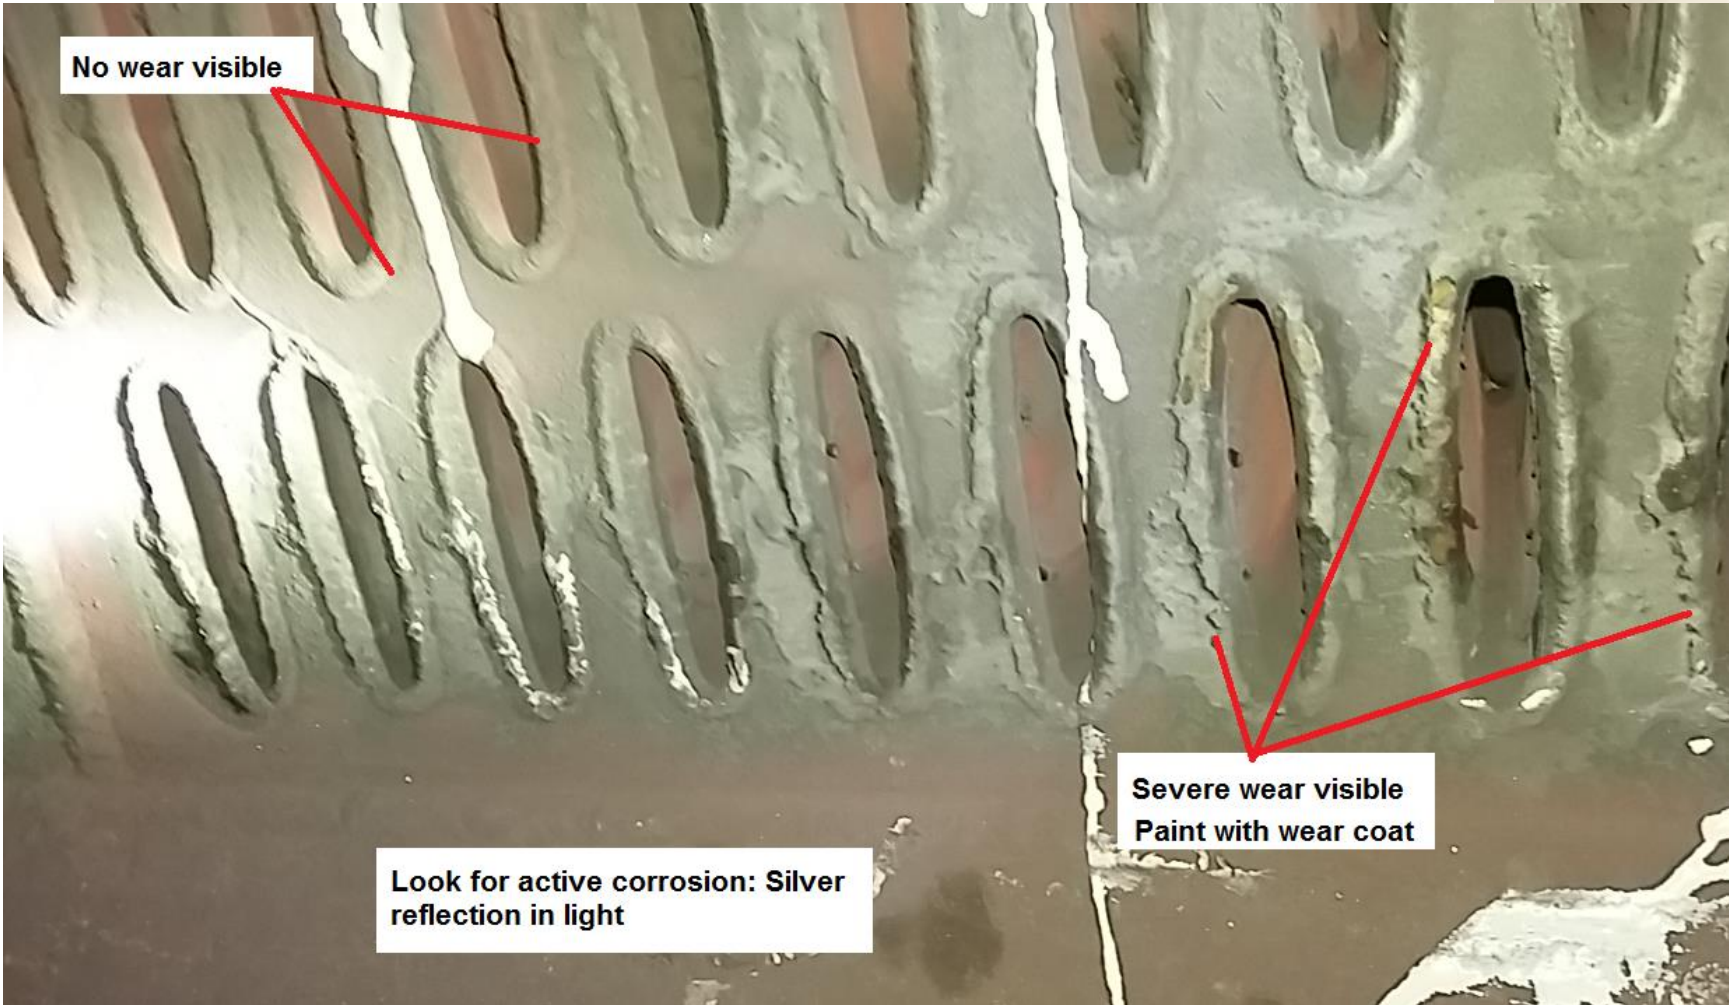
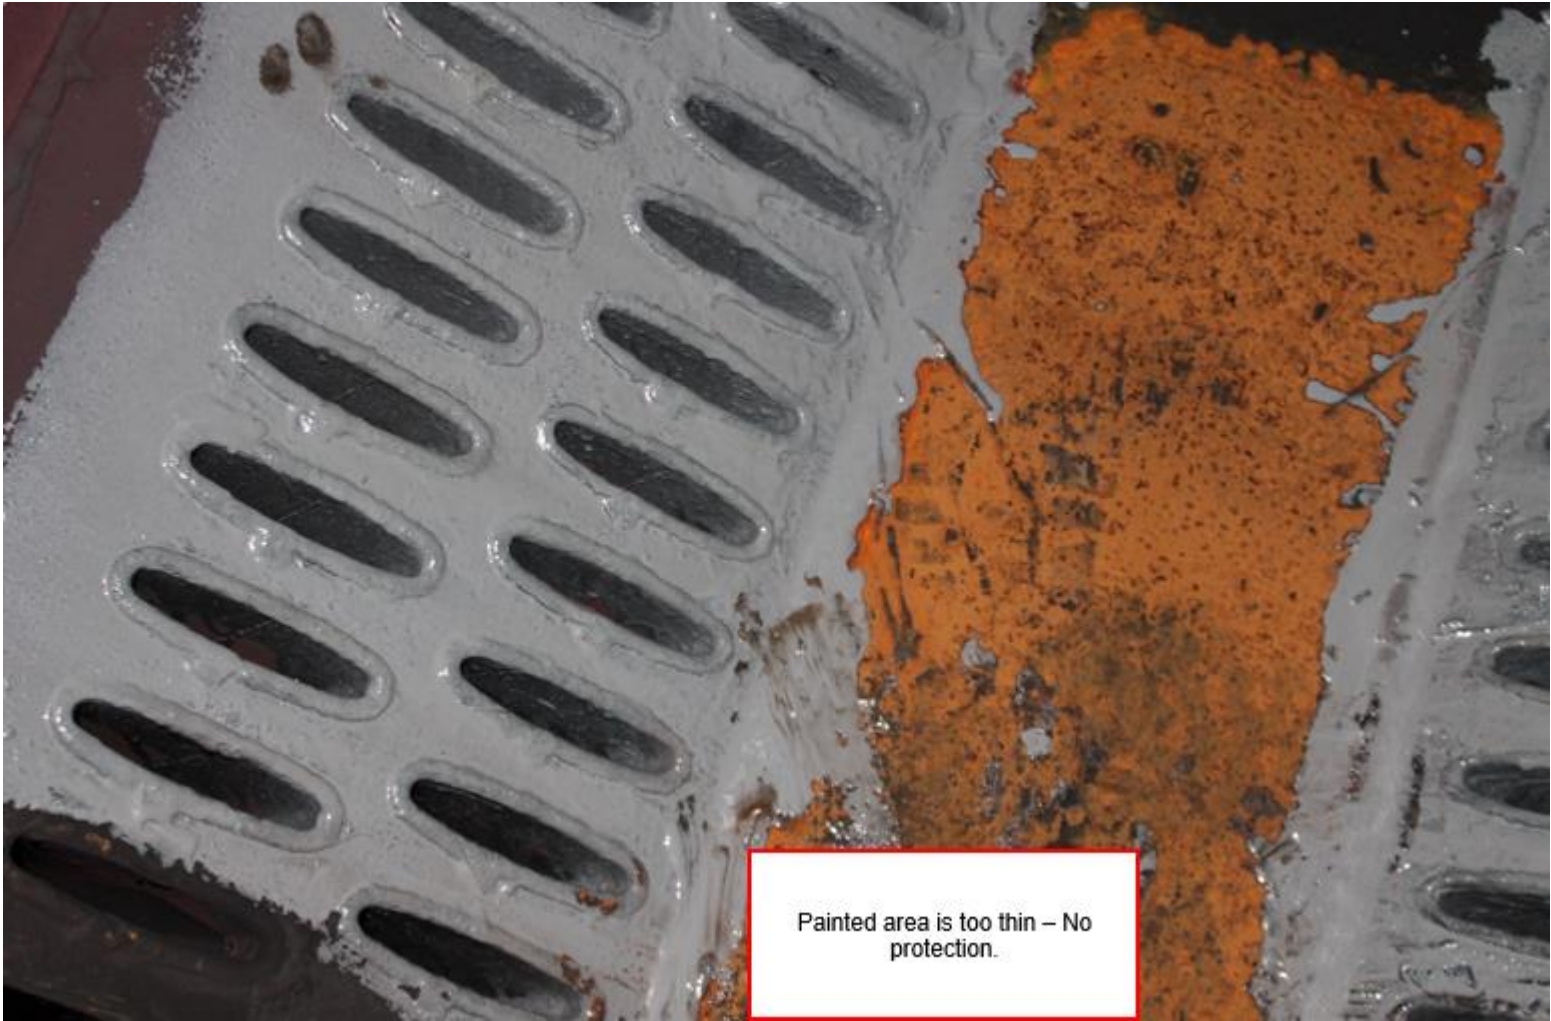
3.1	Inspect and repair damages to ACC distribution ducts	Erect scaffolding at 42m level on each one of the ACC distribution ducts (8 rows)	Allow workers to safely open, gain access into the ducts and close the manhole covers	NA	Outage Coordinator	NA	NA	NA
		Open manhole covers at 50m level above the dephlagmator fans	Gain access	Wrenches, hammer	Contractor		X2 Artisans	8
		In the presence of the system engineer, use a 200mm x 200mm x 5mm plate and paint one side surface with the epoxy as per the correct ratio. With a thick layer +-0.5mm thick and give to the SE for verification once cured within 24h.	To verify that the contractor mixes the epoxy paint to the correct specification	Paint brushes	Contractor	No painting inside the ducts will be allowed unless the sample plate has been accepted by the system engineer	All people that will be painting including the site manager and relevant QC personnel	1

Inspect distribution duct guide vanes in the front of each row (8 Rows). Report any active corrosion as well as cracks on the welds. Inspect all welds on the guide vanes.	Ensure that all guide vanes are secure and not suffering from localised corrosion.	Sufficient illumination – adequate torches must be used Employees must be kept hydrated and no person is allowed to work alone inside the ducts	Contractor	Report with photographs to be submitted	X2 Artisans	8
		After ducts have been opened, the system engineer is to inspect the frontal tubes of each row for corrosion. This area must be painted only after the system engineer has signed this section off	There are often leaks on the first few tubes. If painted, the paint could cover the hole.		Contractor and System engineer		System engineer with QCP personnel from contractor	3
		Take note of previous point. Hold point. Paint all areas of active corrosion, white or silver marks. Use epoxy paint and ensure the whole area is covered	Ensure epoxy is mixed to correct ratio. Use a good torch to identify all the areas with corrosion. Be sure to inspect underneath each support brace as well as runoff that drains into tubes (Request system engineer to indicate all the possible areas which should be considered )	Sufficient illumination – adequate torches must be used Employees must be kept hydrated and no person is allowed to work alone inside the ducts	Contractor	Report with photographs to be submitted. Paint only 1 duct and then the SE must verify and review. It is the responsibility of the contractors QC to ensure that the work is done adequately. It is not the work of the system engineer to indicate shortcomings.	X4 Artisans/general labourers	35

Remove any foreign material such as plastic, wires etc inside the ducts as well as at the walkways.	Foreign material reduce the streamflow	Sufficient illumination – adequate torches must be used Employees must be kept hydrated and no person is allowed to work alone inside the ducts	Contractor	Contractor will sign off that the ducts are all cleaned and can be closed	X2 Semi-skilled	4
		Scrape off any debris left behind from the gaskets on the manhole flanges. Use sand paper to ensure a fully cleaned surface	Mating faces must be cleaned and there may not be any high spots on the flanges		Contractor		X2 Semi-skilled	4
		Replace manhole gaskets and cover – Ensure gaskets are not too large to damage the rupture disc when tightening the bolts.	If the gaskets do not seal, the system will suffer load losses due to leaks. Intervention point for the QC personnel to verify all bolts	Wrenches, hammer	Contractor	QC to sign that all bolts were checked to be tight.	X2 Artisans	16
