Eskom	Matimba ACC General Maintenance Contract SOW	Doc. no. NA
		Rev. 1
		Total pages 1 of 30
Matimba Power Station		Reference Document: NA

Outage type	MO/GO/IR	Outage start date	As Per Outage Philosophy
Department	Engineering	System	Air Cooled Condenser

This scope contains the detailed scope of work for the Air Cooled Condenser for execution during MO's, GO's and IR's. The outage commencement date and duration will be according to the outage philosophy.

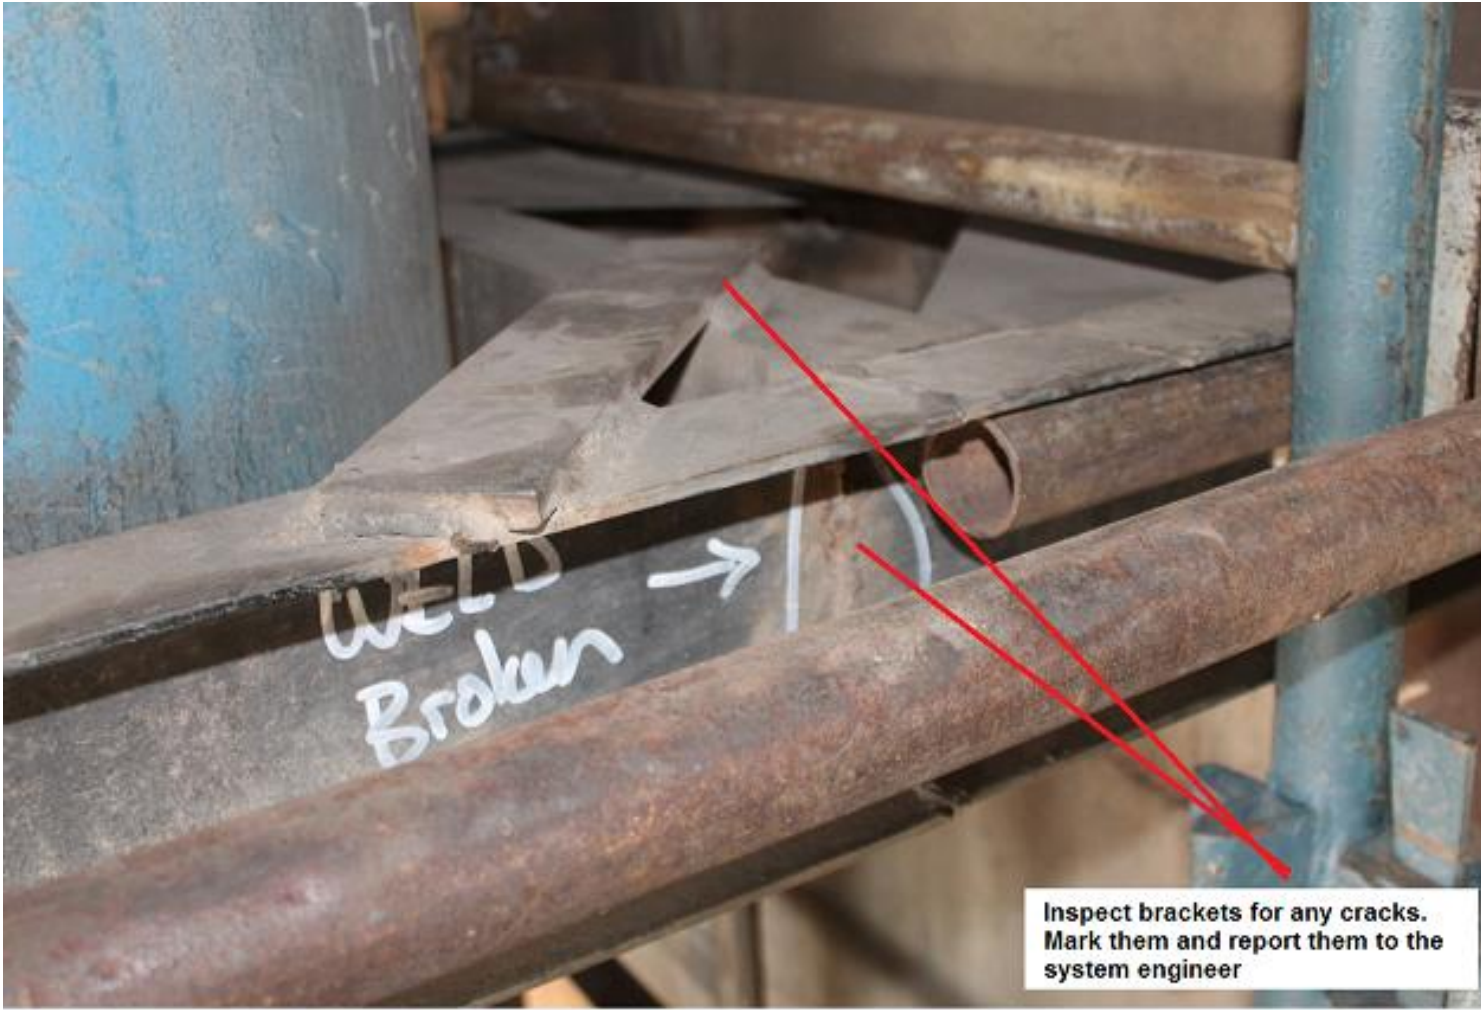
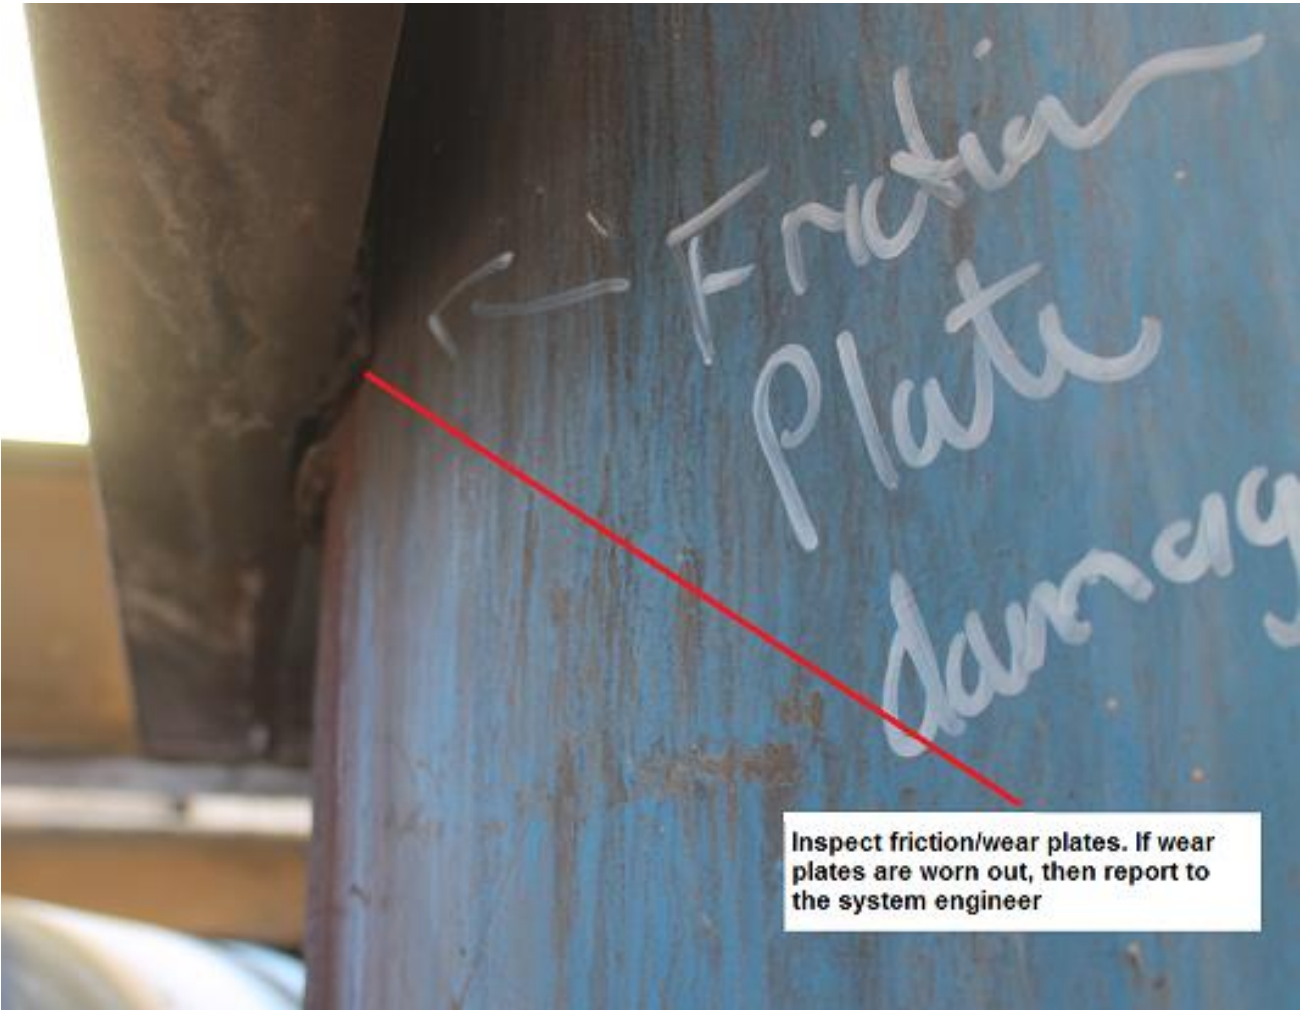
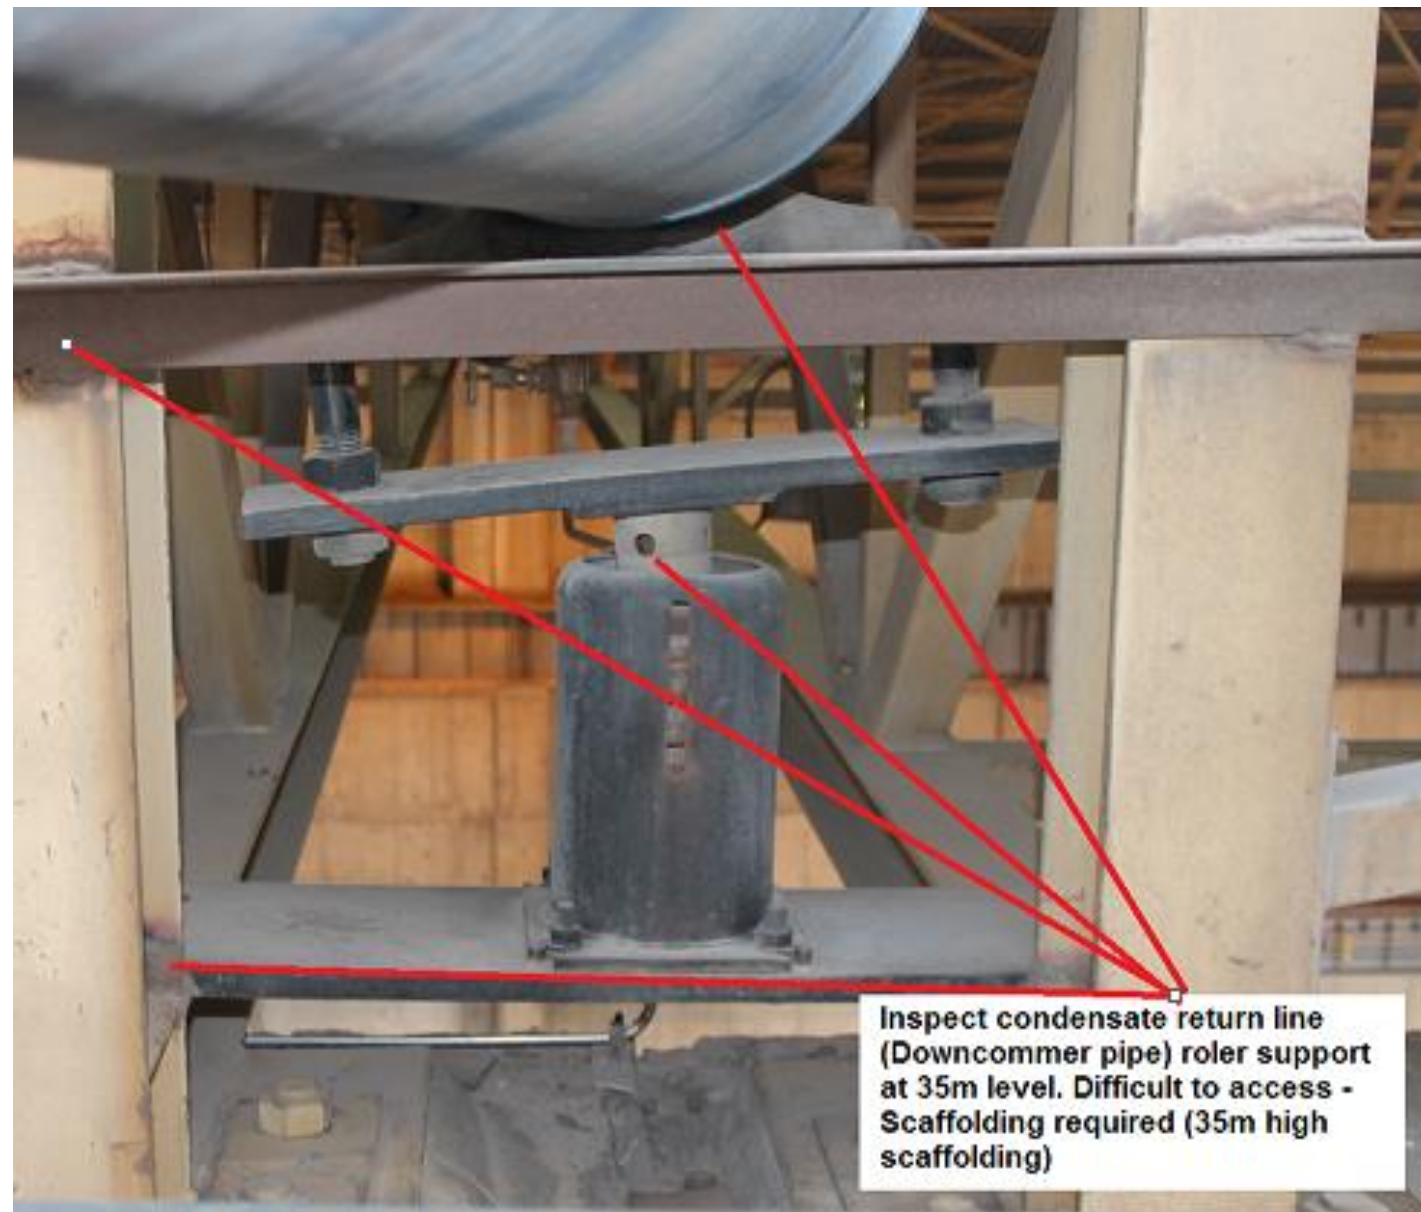
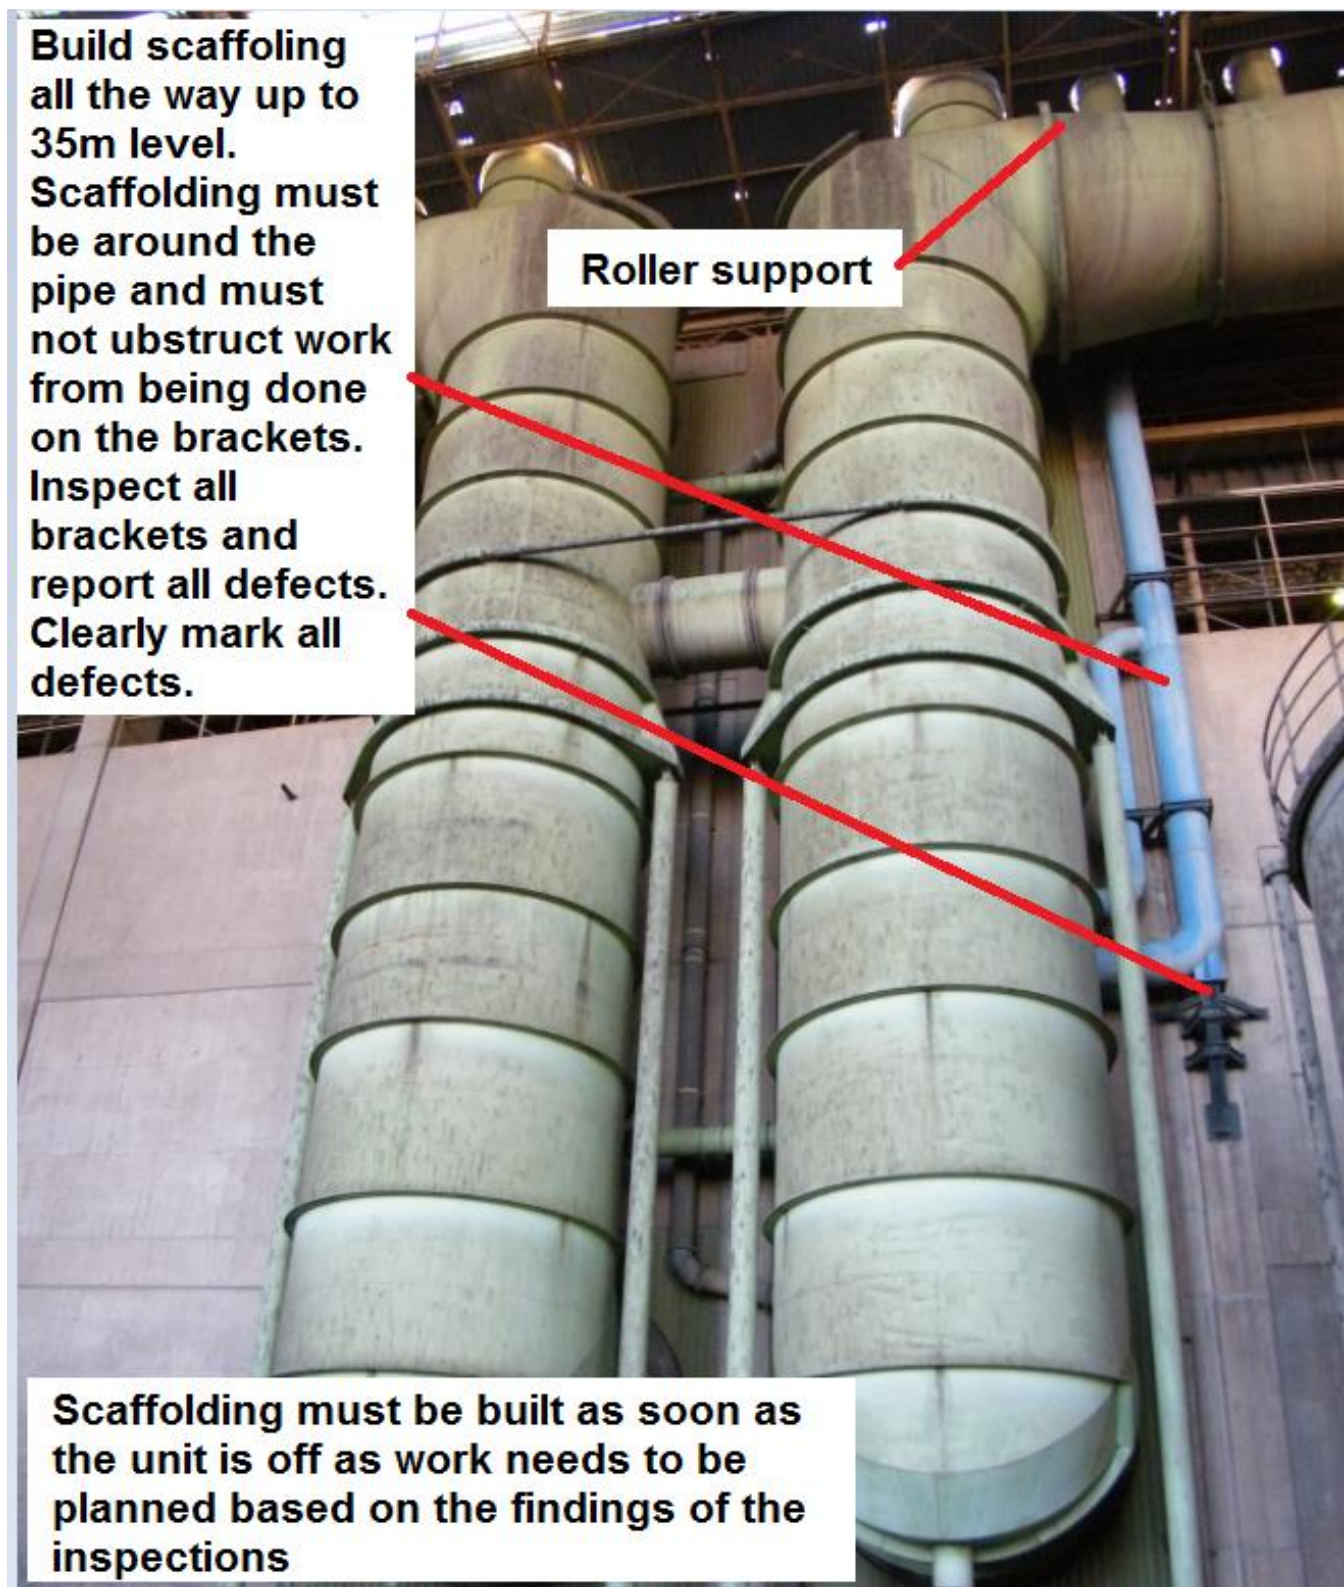
4.1	Inspect and do repairs (if needed) on condensate drain line	Scaffolding contractor to build scaffolding as soon as the unit comes off or prior to the unit shutdown. Scaffolding to be built from 0m to 35m level to allow access to upper support bracket. Scaffolding should be built so as to allow complete access to support brackets. Scaffolding should not obstruct work to be done on the brackets if needed. The contractor should ensure that the scaffolding will not prevent any repair of the brackets if needed	If scaffolding is built too late and repairs are necessary, sufficient time is required to do the repairs. Physical repair work can take up to 1 week depending on the damage. If scaffolding is built in such a manner that obstructs work to be done on the brackets if needed, scaffolding will have to be modified afterwards, increasing the repair duration.	NA	Outage Coordinator	Outage Coordinator and Contractor is to ensure the scaffolding is as per the needs of the contractor to execute the work	NA	This scaffolding generally takes 4 days to built

Using a pressure cleaner, soap and a cloth /brush to clean the pipe and all supporting brackets to inspect the pipe for defects.	Cracks at the wear plates have been identified. Wear plates are subject to impact loading and must be cleaned to allow adequate inspections	Pressure cleaner, soap and rags/brushes, safety harness	Contractor	The contractor will clean the pipe as soon as possible to allow for inspections and repair work if necessary.	X4 Semi-skilled	8
		Thoroughly inspect for visual cracks around wear plates and brackets. Report any defects to the system engineer	If the brackets are defective, the supports will need to be repaired	NA	Outage Coordinator to arrange for NDT	NA	NA	NA

**Build scaffolding all the way up to 35m level. Scaffolding must be around the pipe and must not obstruct work from being done on the brackets. Inspect all brackets and report all defects. Clearly mark all defects.**

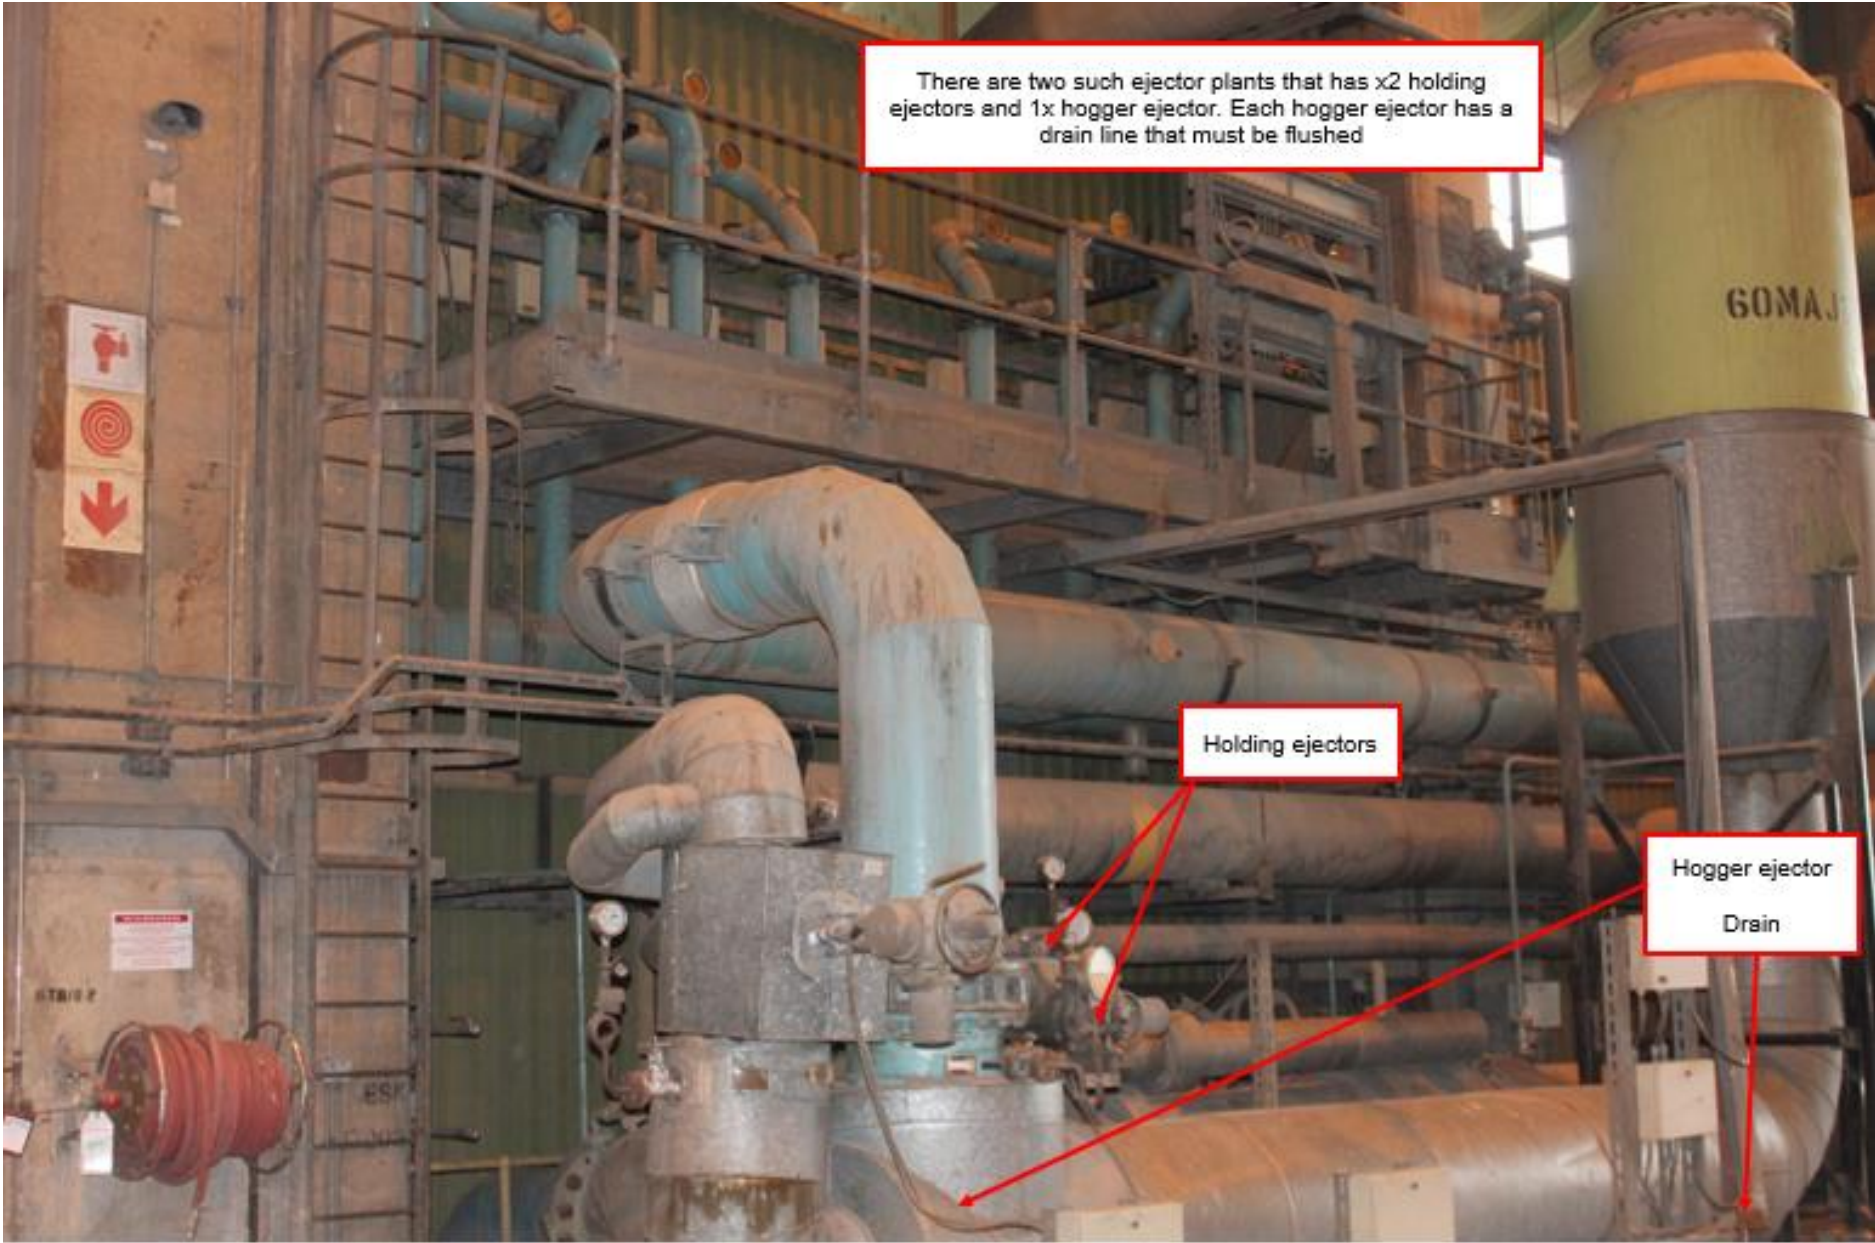
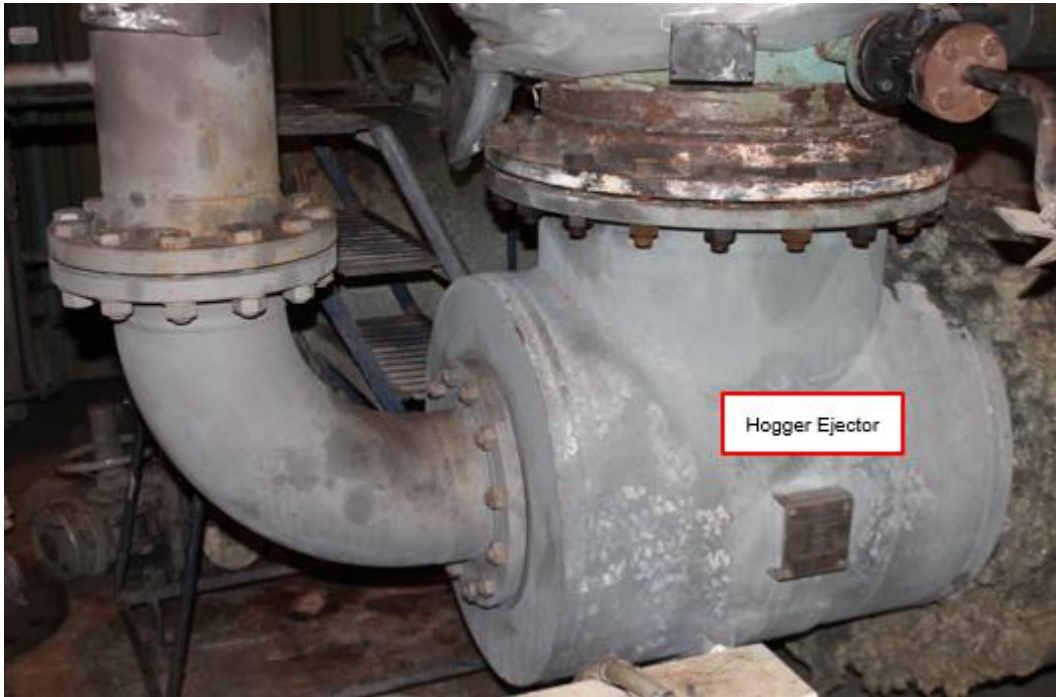
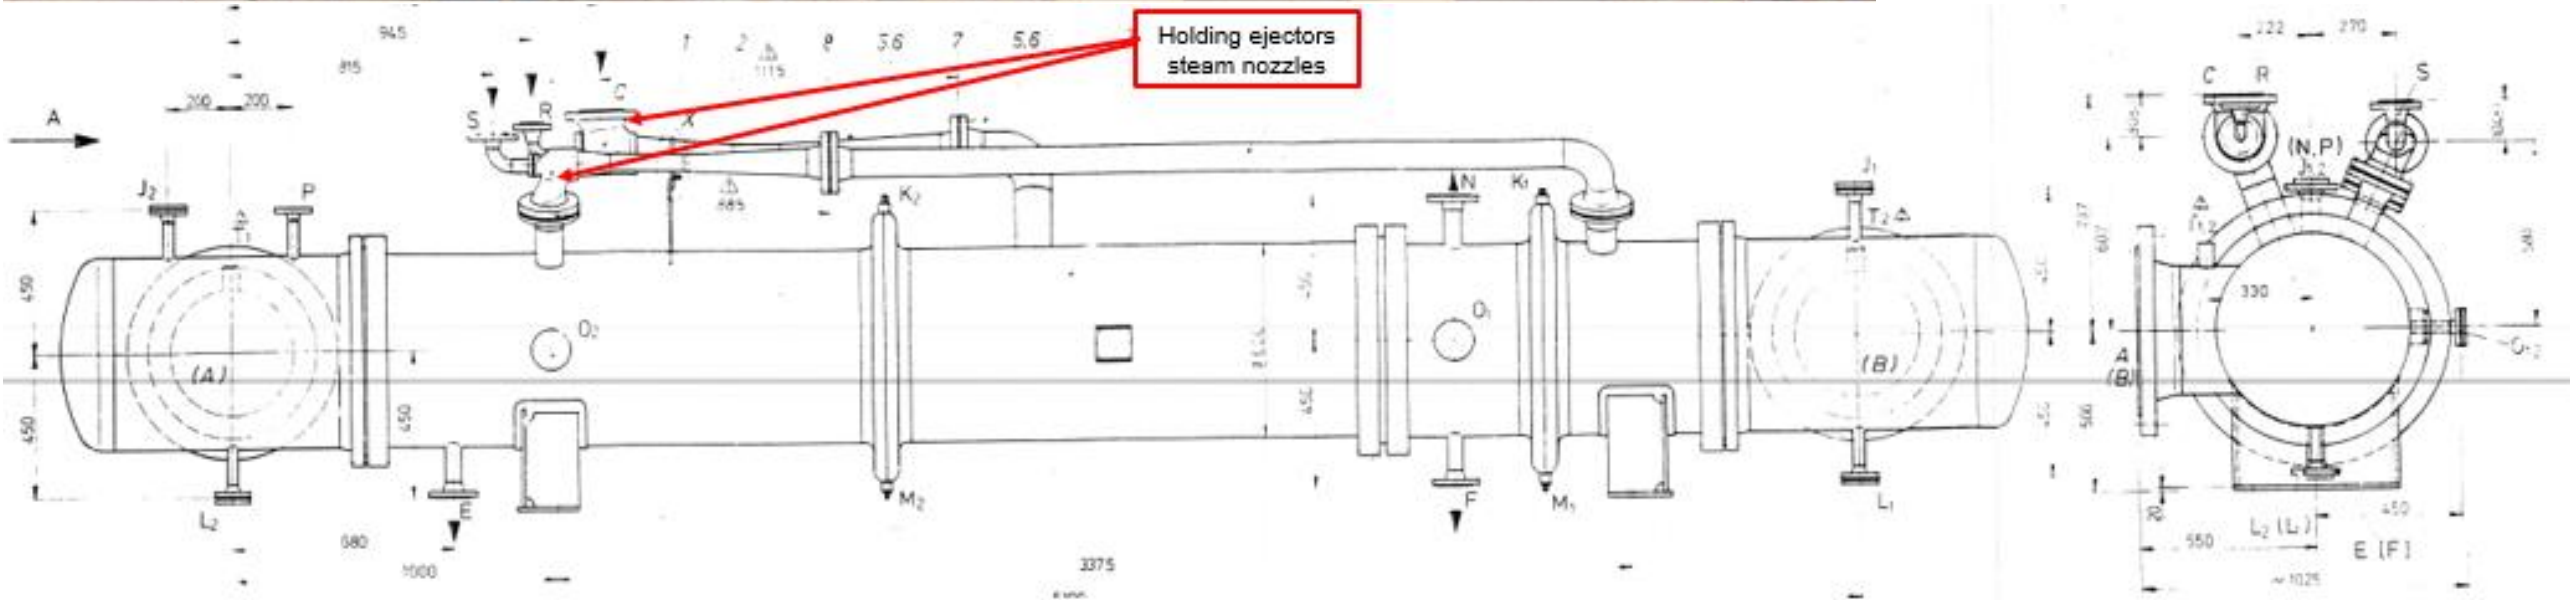
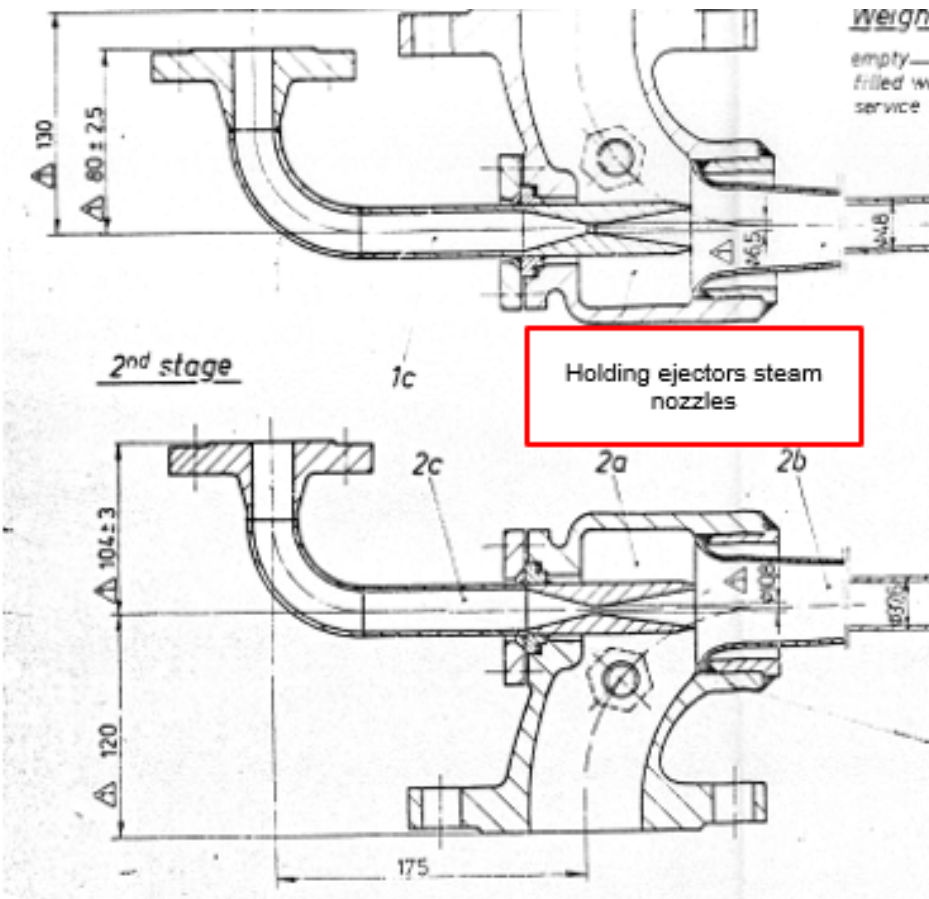
5.1	Inspect and replace if necessary the holding ejectors	Remove lagging on both first and second stage holding ejectors A and B	Defective nozzles result in poor performance of ejectors	NA	Outage coordinator	NA	NA	NA
		Open both the first and second stage holding ejectors A and B and inspect for wear. To be witnessed by Eskom – hold point. If defective/Worn replace steam nozzle		Spanners	Contractor	Report with photographs to be submitted.	X2 Artisans	4
		Measure throat diameter using a No-Go gauge. If steam nozzle does not pass the test, report to system engineer and replace steam nozzle – Maximum acceptance criteria for 1 <sup>st</sup> stage = 6.955mm and for the 2 <sup>nd</sup> stage = 11.556mm Ejectors must be taken to the mechanical workshop		Telescopic snap gauge and vernier		Eng to witness	X1 Artisan	2
		Measure wall thickness on both stages air nozzle on one of the selected ejectors to be specified by engineering		NA	Outage coordinator to arrange for NDT	NA	NA	Can take about 3 days to finalise

Replace all ejector gaskets before re-assembly			Contractor		X2 Artisans	4
5.2	Inspect hogger ejectors	Remove lagging on hogger ejectors A and B	Defective nozzles result in poor performance of ejectors		Outage coordinator	NA	NA	NA
		Open both hogger ejectors A and B and inspect for wear. To be witnessed by Eskom – hold point.		Spanners	Contractor	Report with photographs to be submitted.	X2 Artisans	8
		Remove nozzle and take it to the mechanical workshop and measure throat diameter using a telescoping snap gauge. Max throat diameter is 69.5mm		Telescopic snap gauge and vernier		Eng to witness	X1 Artisan	2
		Replace both hogger ejector gaskets before re-assembly					X2 Artisans	4
		Loosen the Hogger shell drain pipe. Pour water into the pipe and verify at the drain that water flows out freely and that the drain is not blocked.	If the drain is blocked, the hogger shells fills with water and the hogger performance is reduced	Spanners		Eng to witness	X2 Artisans	4
