Eskom	Matimba ACC General Maintenance Contract SOW	Doc. no. NA
		Rev. 1
		Total pages 1 of 30
Matimba Power Station		Reference Document: NA

Outage type	MO/GO/IR	Outage start date	As Per Outage Philosophy
Department	Engineering	System	Air Cooled Condenser

This scope contains the detailed scope of work for the Air Cooled Condenser for execution during MO's, GO's and IR's. The outage commencement date and duration will be according to the outage philosophy.

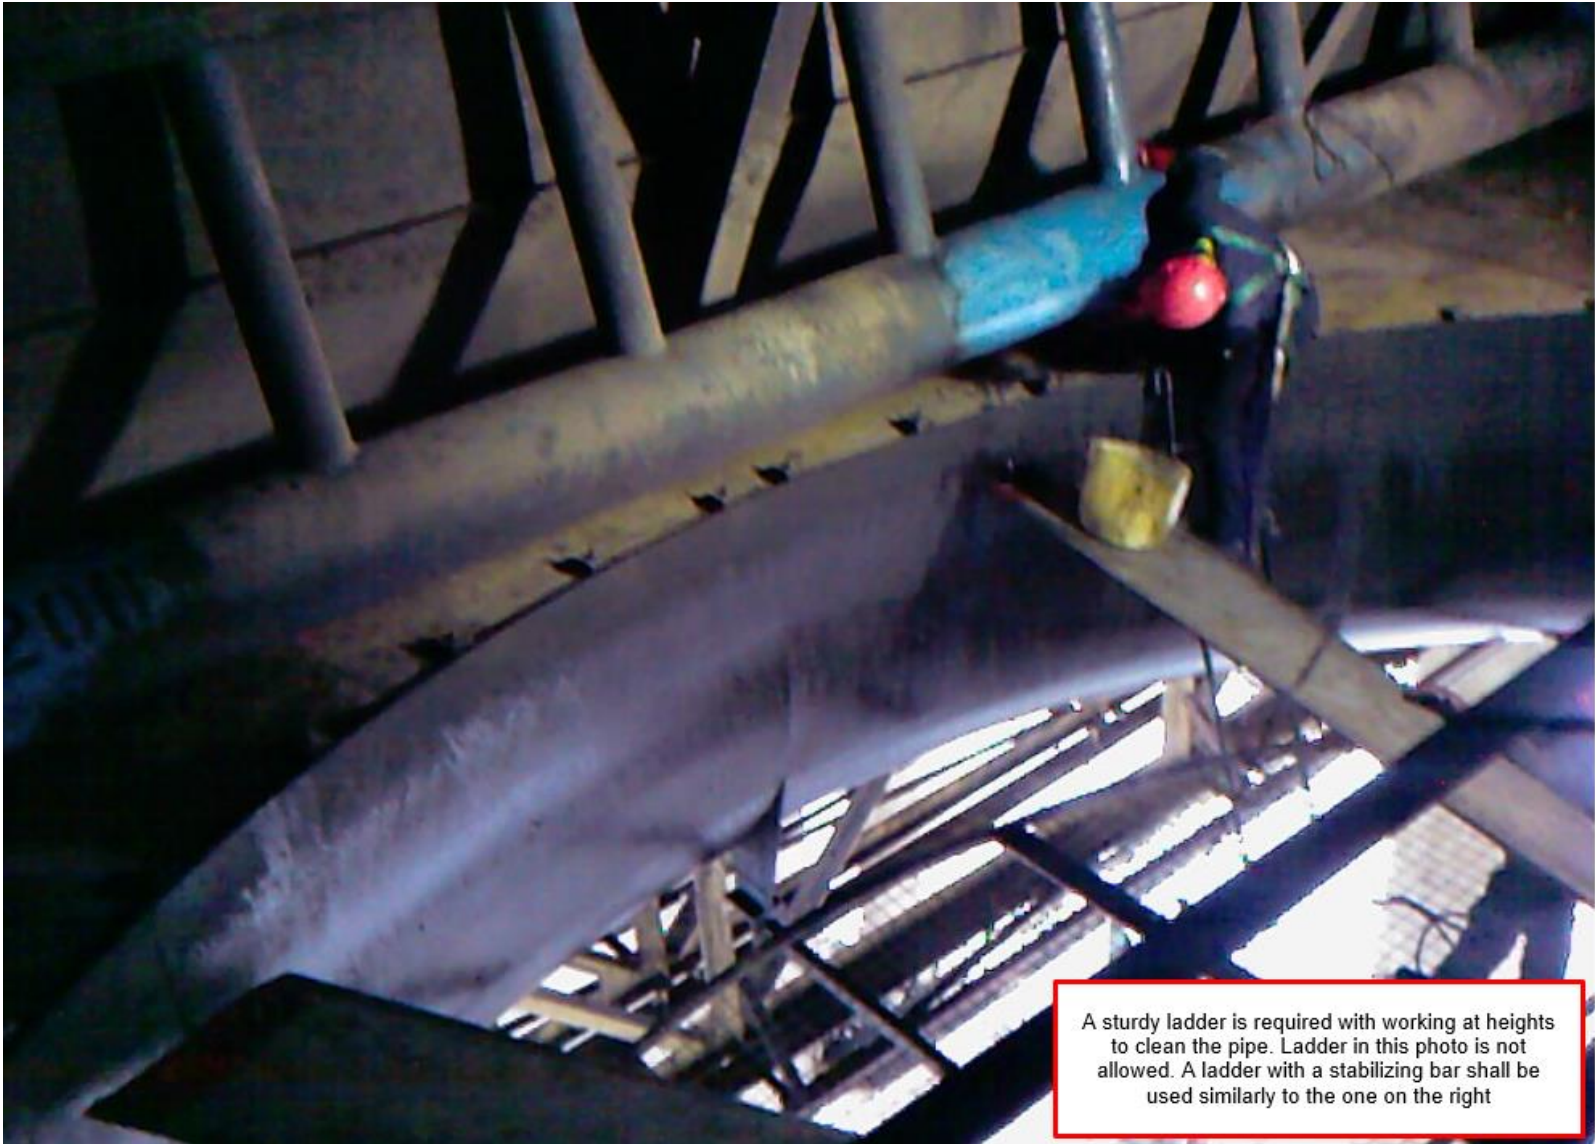
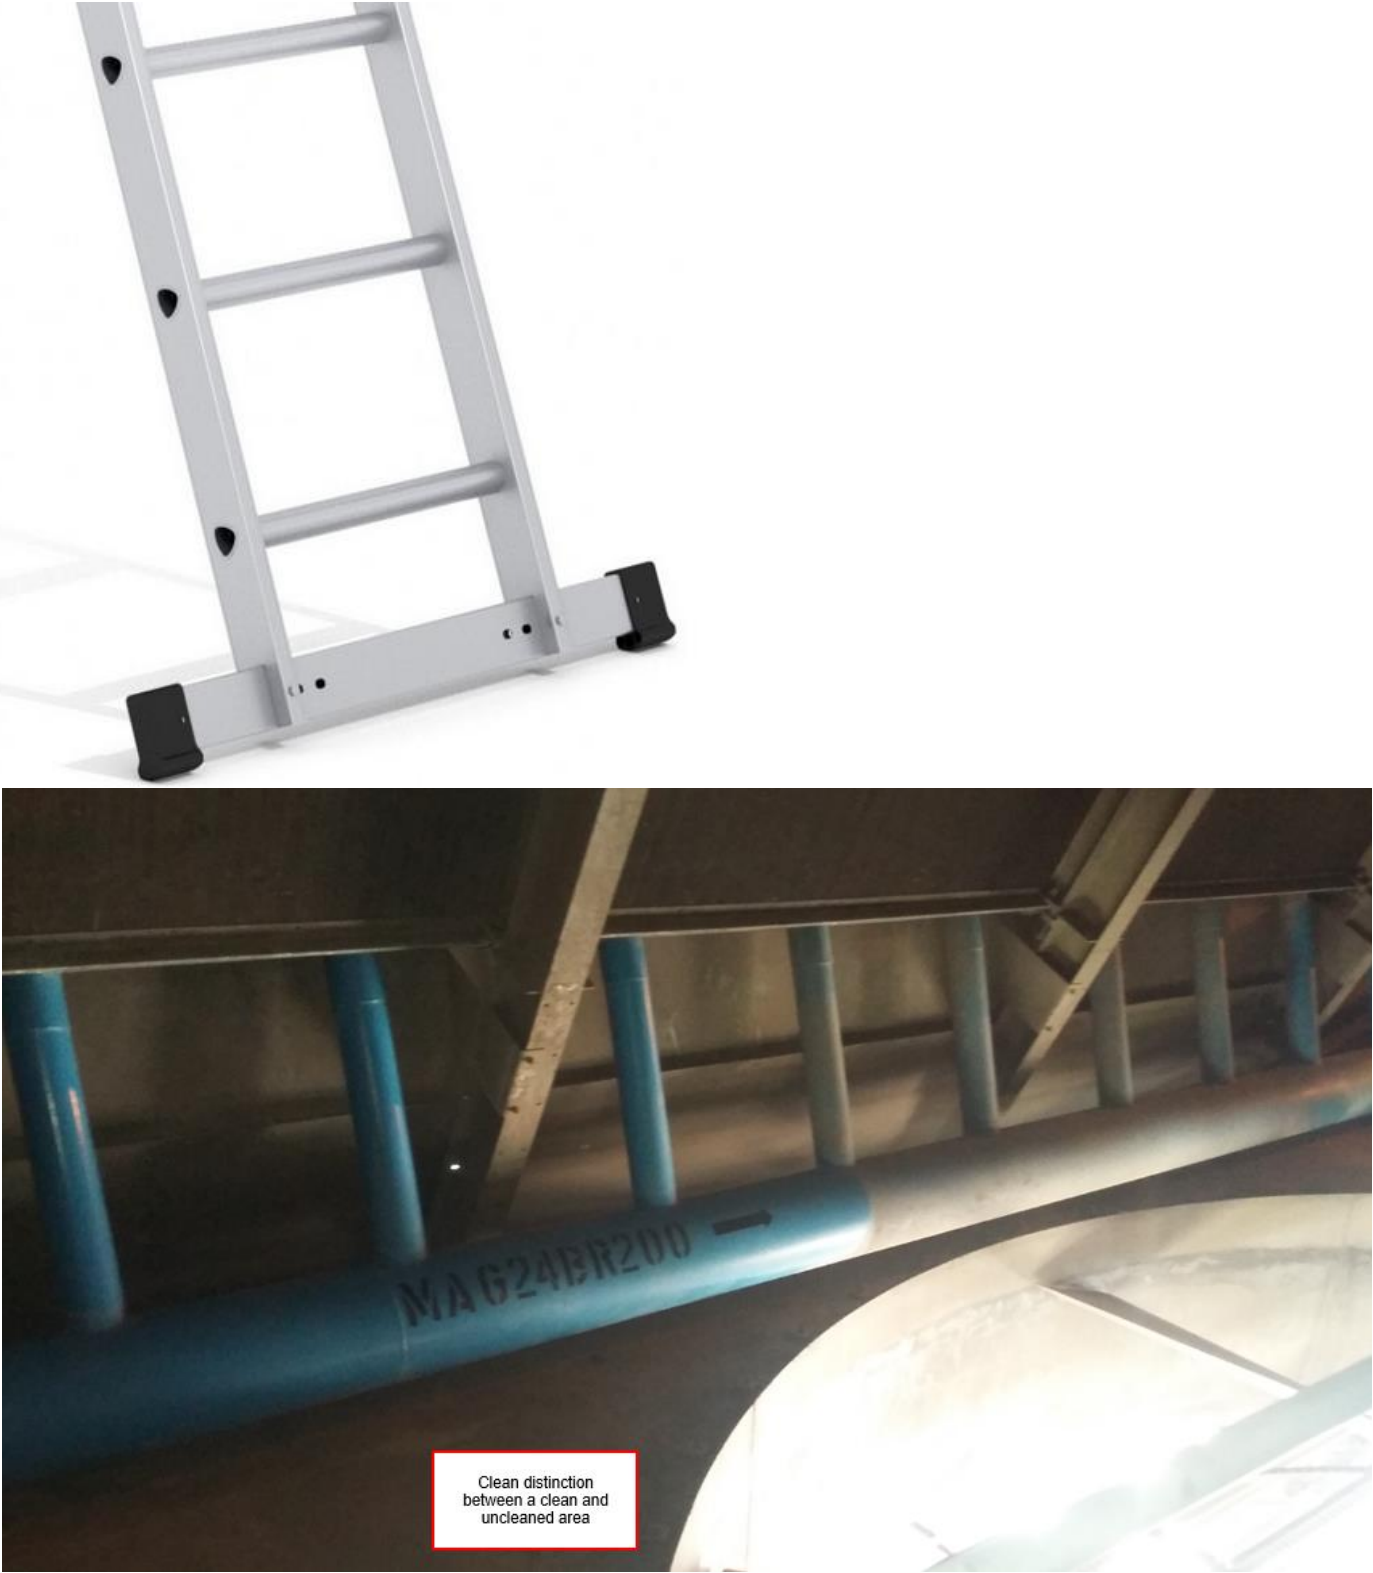
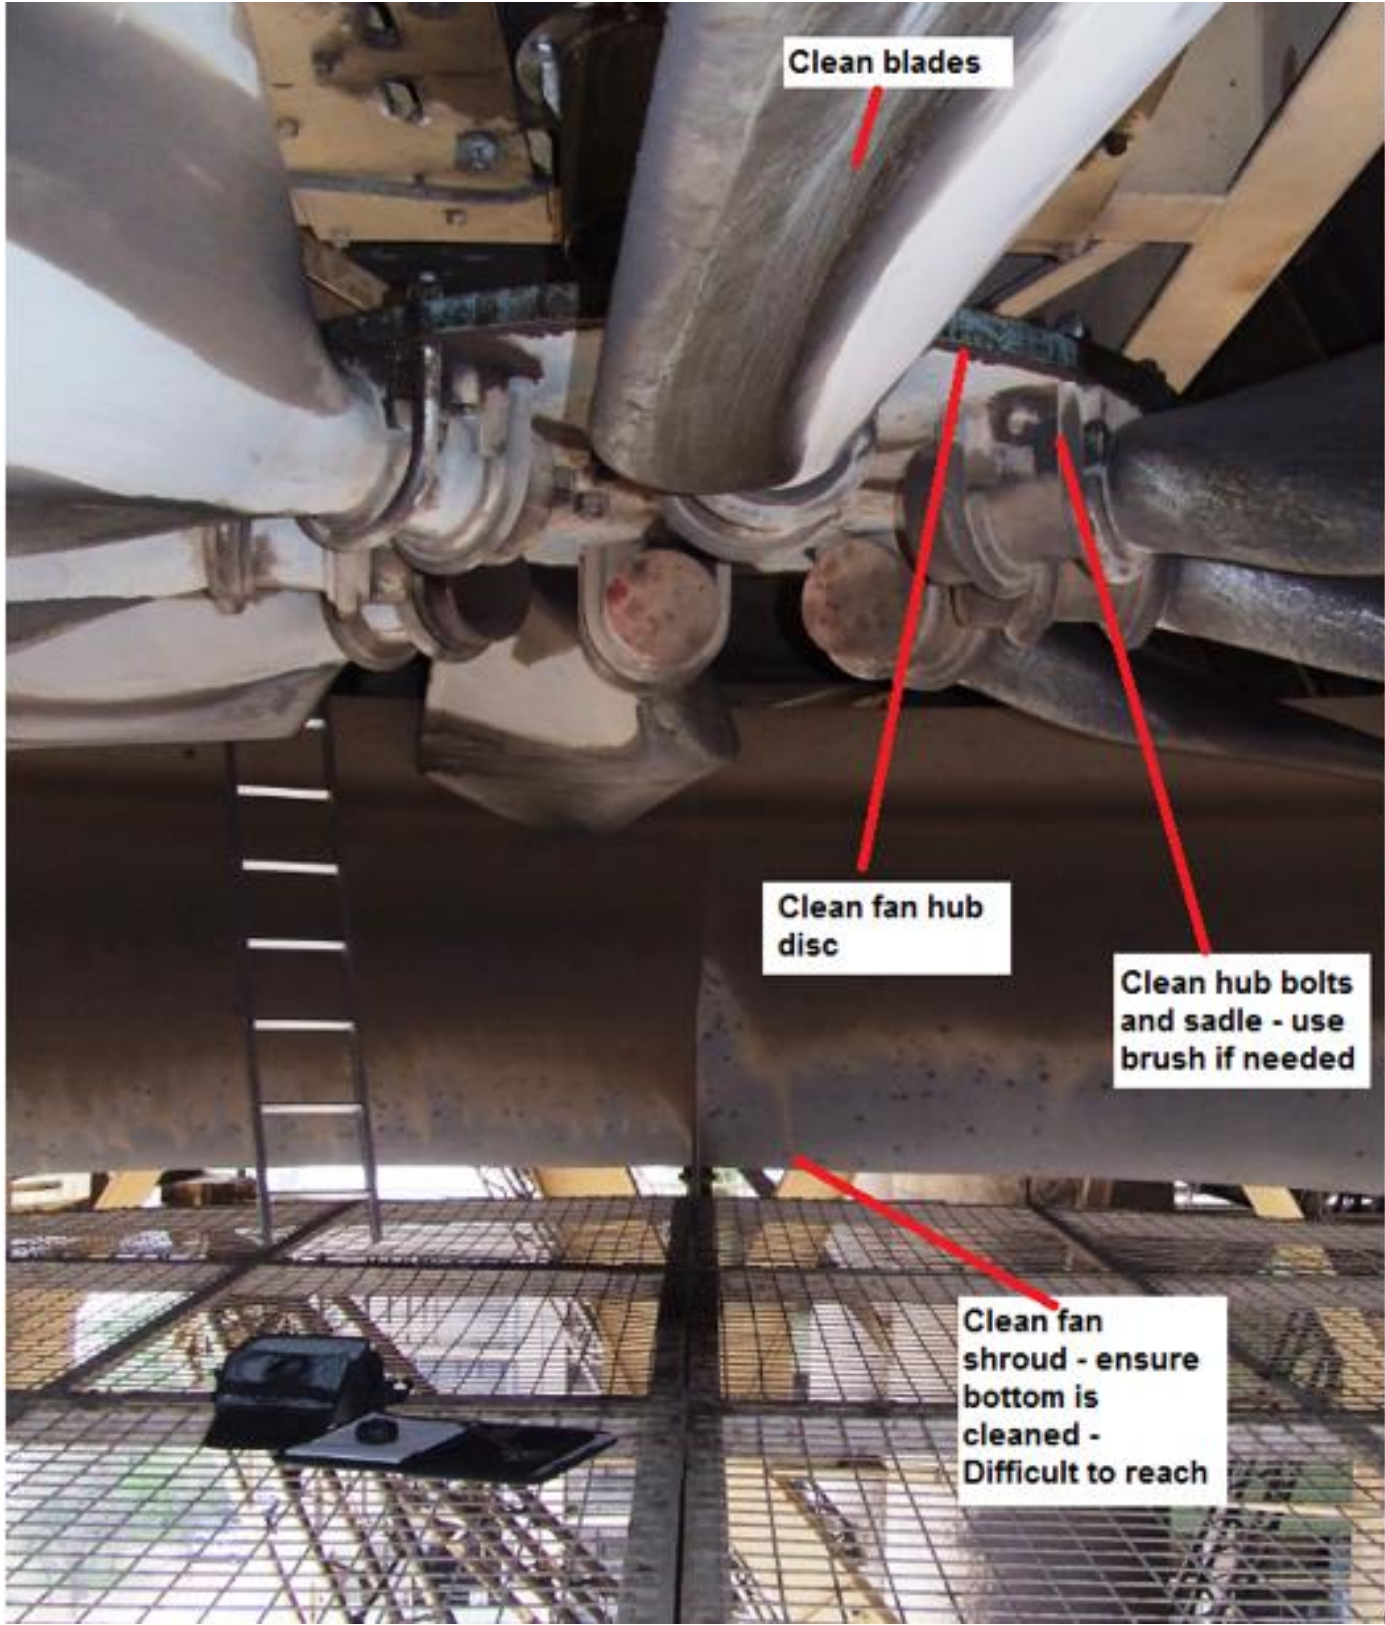
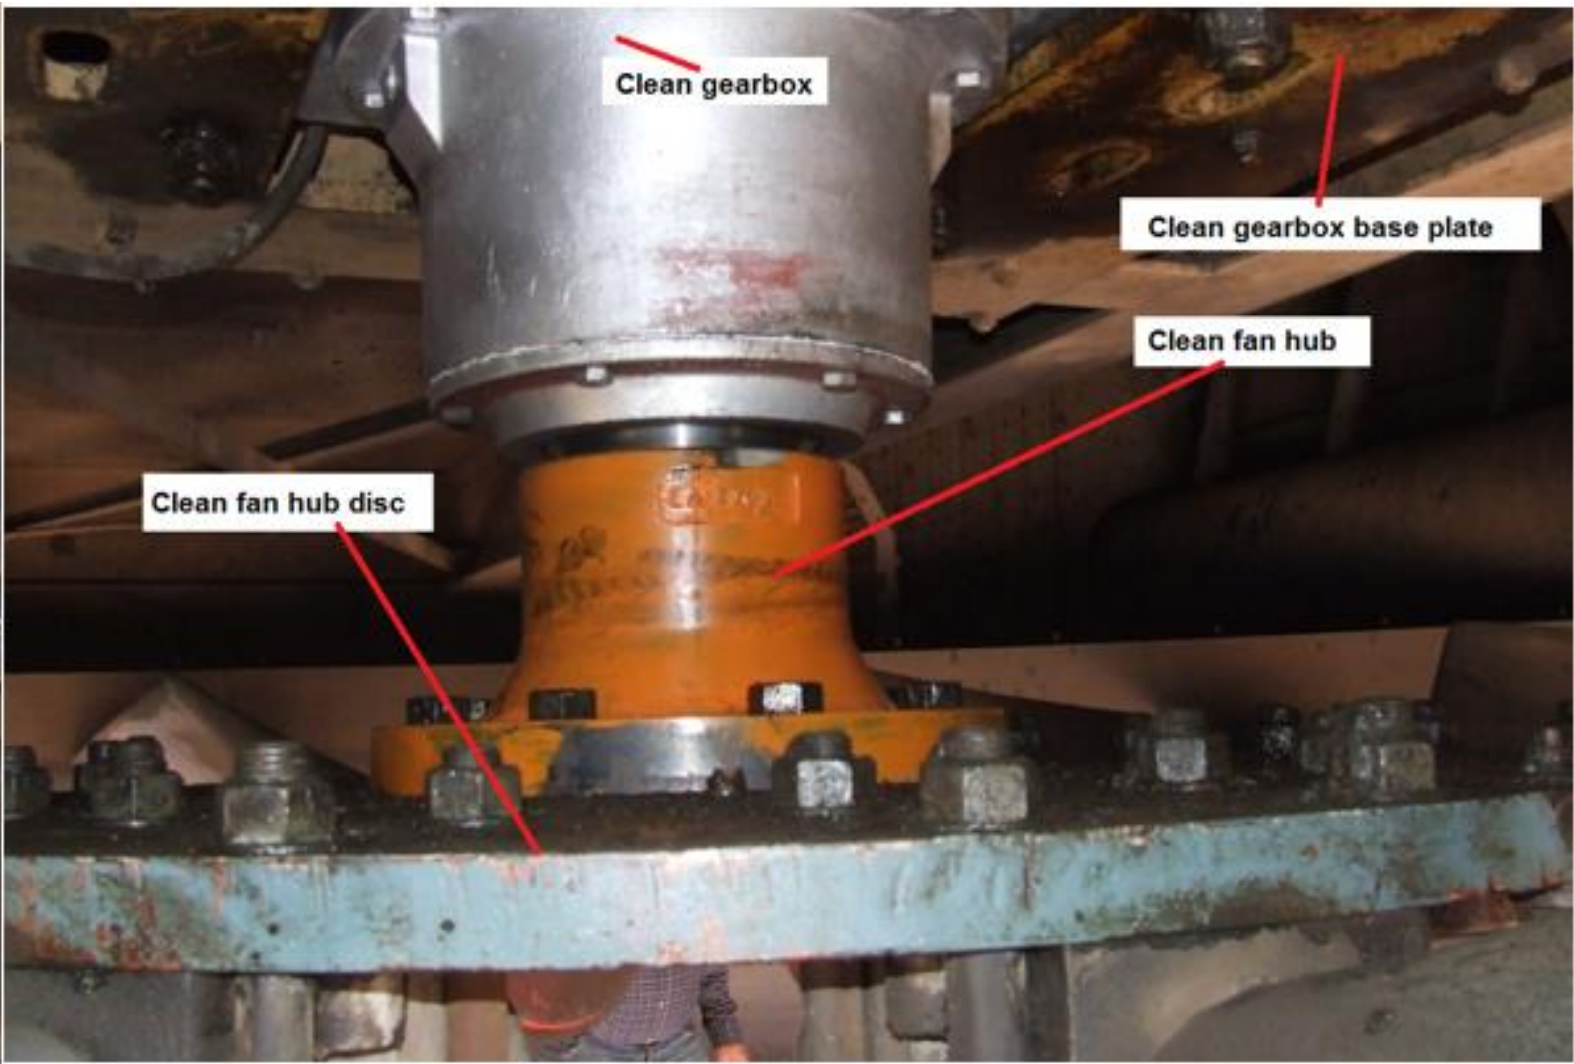
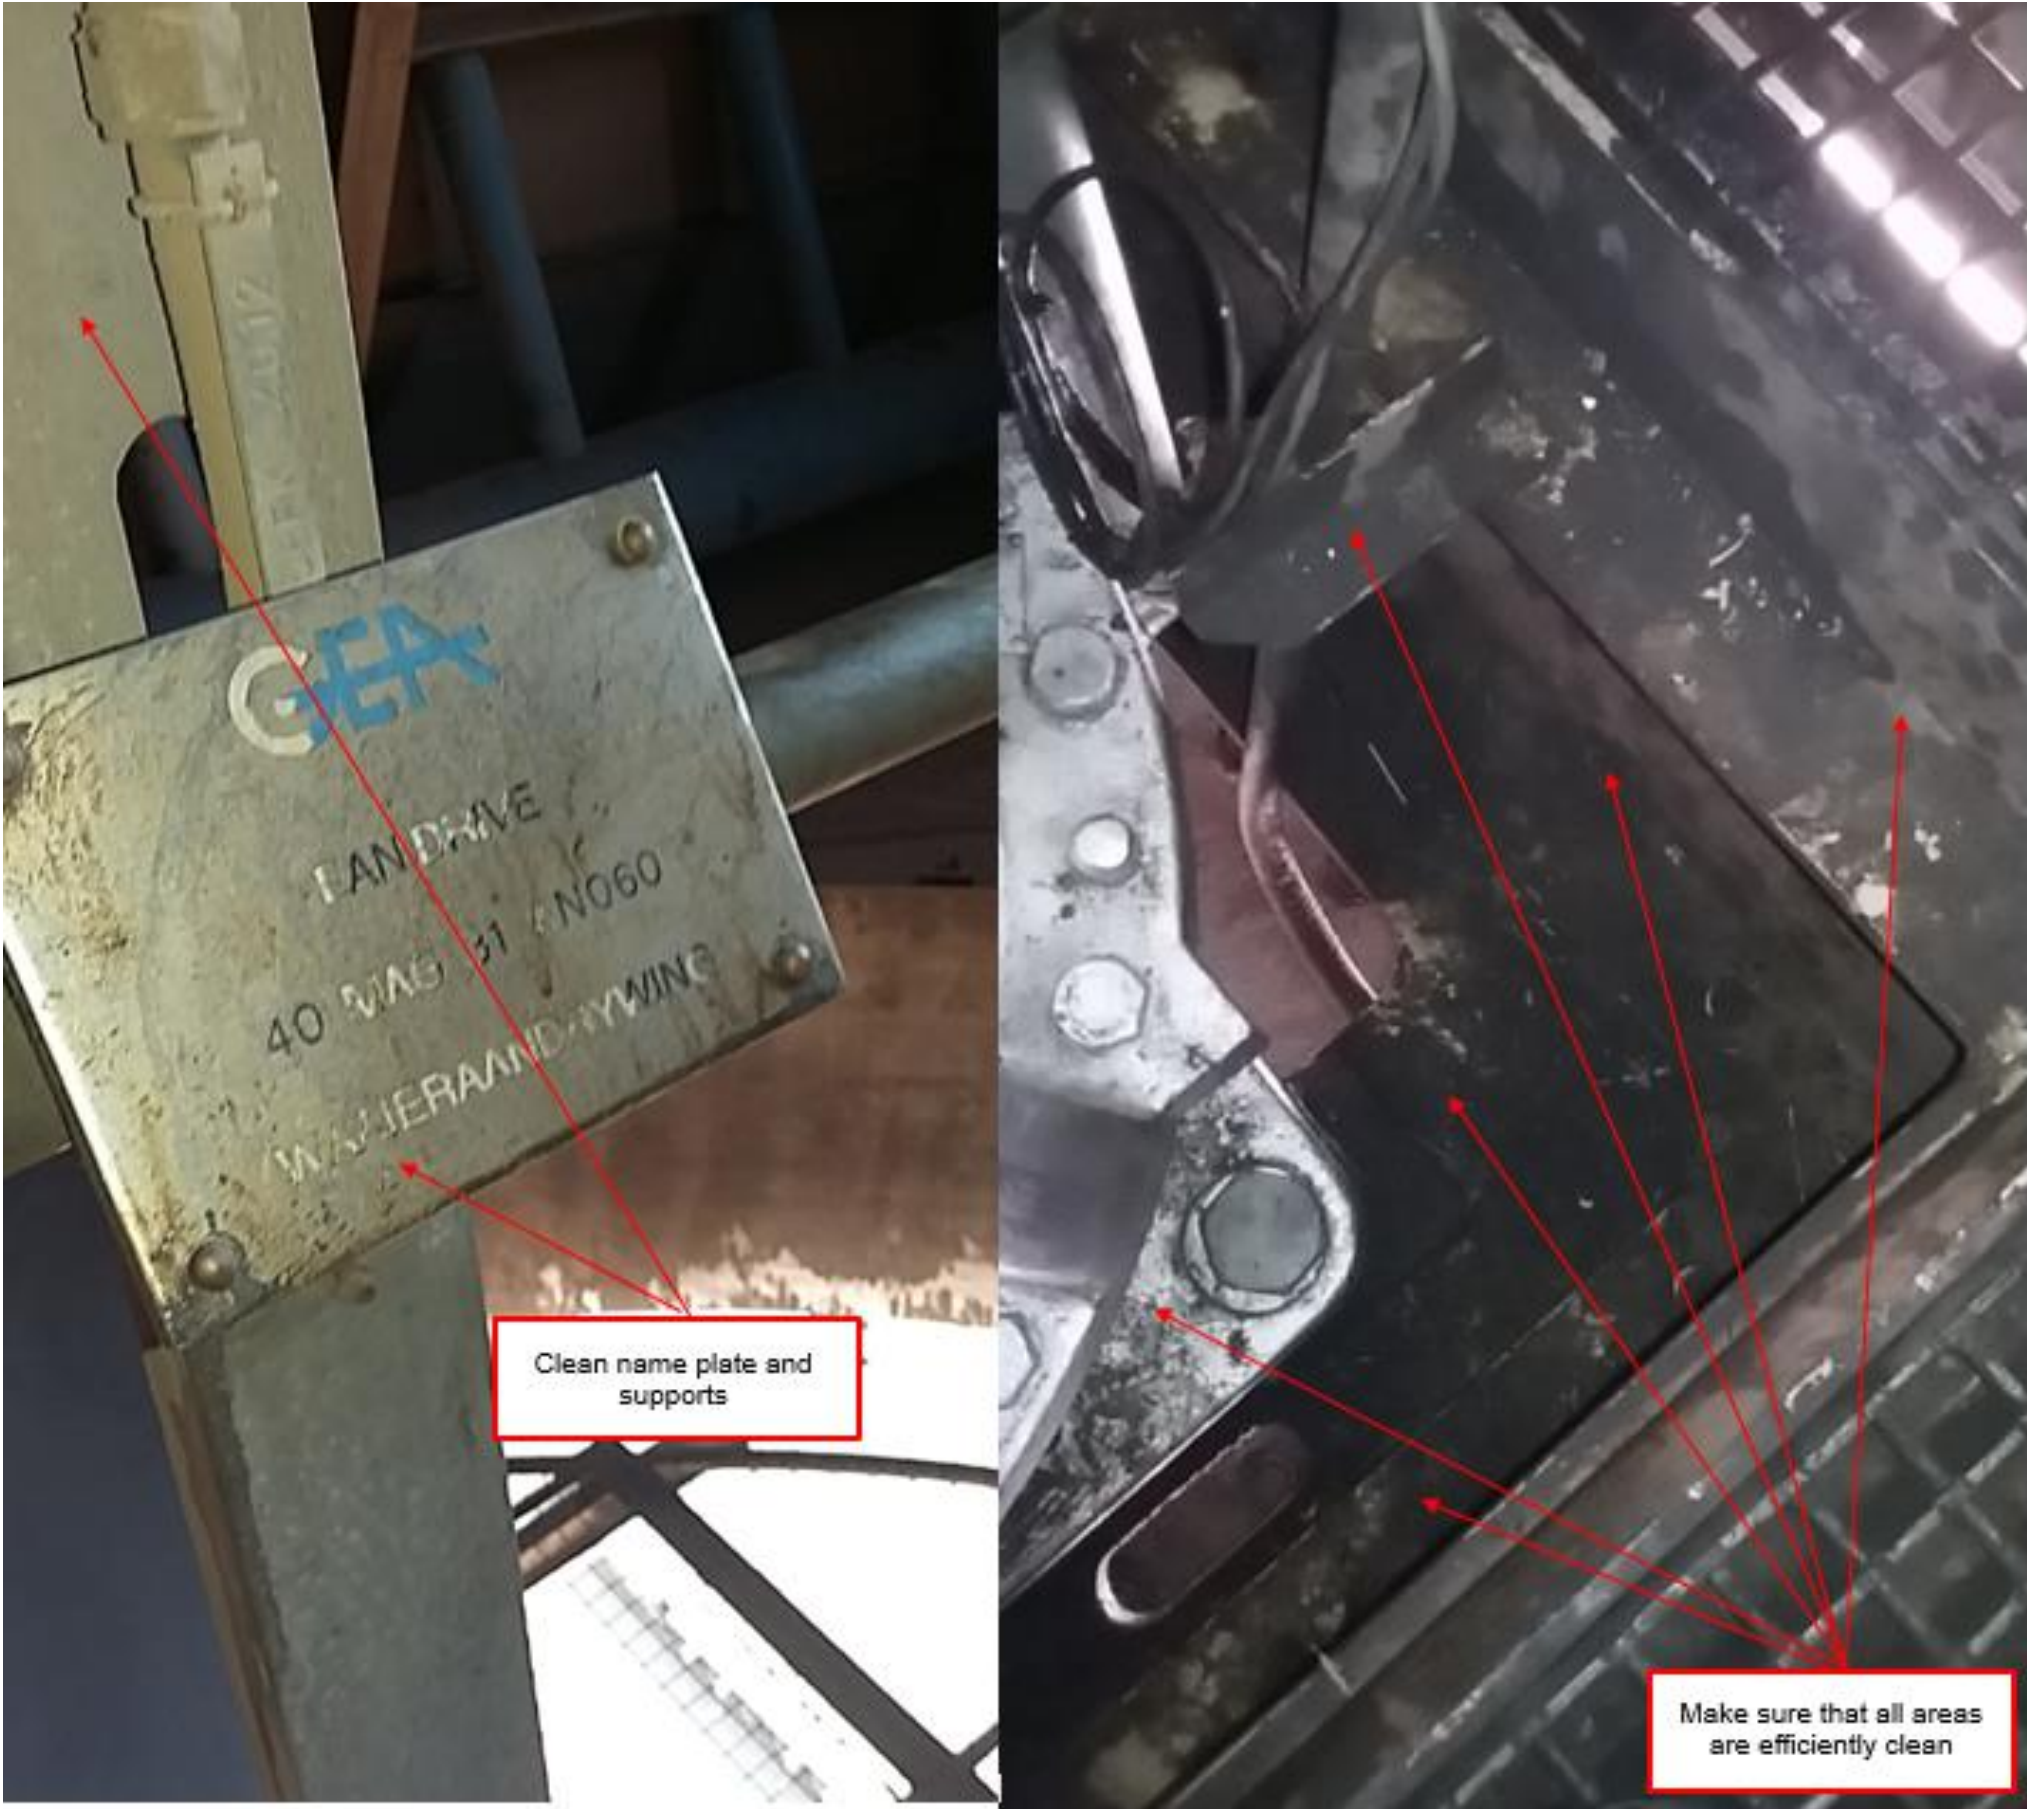
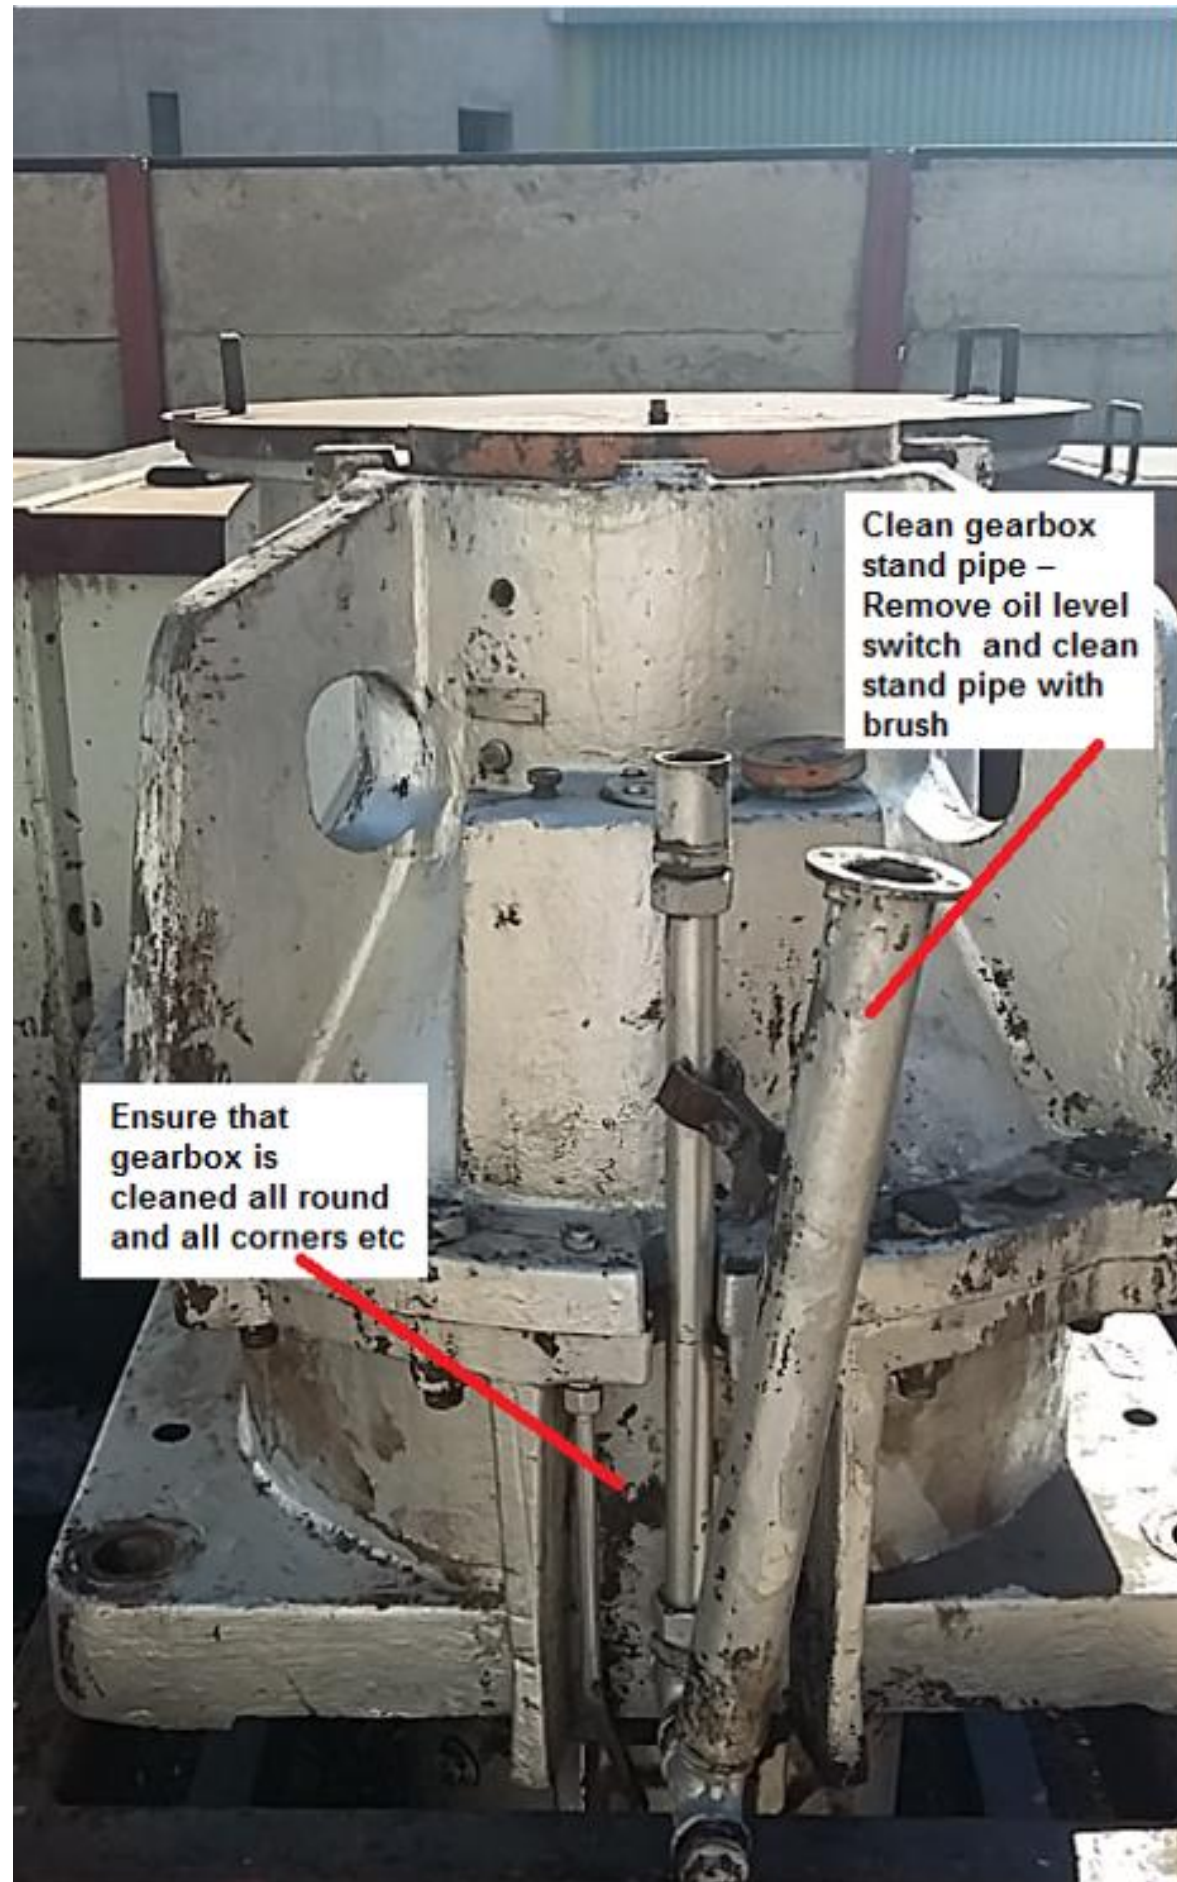
6.1	ACC Cleaning – ACC Platform within plenum	Clean fan deck and blue condensate pipe using high pressure hot water hose. Clean badly fouled areas using soapy water.	This area can also be cleaned after the deck has dried. This area can be cleaned using brooms and pressure lances	<ul style="list-style-type: none"><li>• Safheavy/BH38 degreaser</li><li>• Appropriate ladders</li><li>• Safety harness</li><li>• Fall arresters</li><li>• Plastic suits due to lots of water and dirt</li><li>• High pressure hot water cleaners with the ability to inject/apply soap/degreaser</li><li>• Cloths/rags</li><li>• Cleaning brushes</li><li>• Adequate head lights</li></ul> <p>No person shall be allowed to work on the fan grid without the correct PPE and always being hooked up to the lifeline. Any person found not adhering to this will be reported immediately.</p>	Contractor	QC report with photos and plant inspection once completed	X4 general cleaners	96

6.2	ACC Cleaning – ACC fan units	Clean all ACC gearboxes using high pressure jet – Entire gearbox including its cubicle should be cleaned	Apply degreaser on the gearboxes as well as the base plates and the fan unit structure. (Area where the gearbox sits)				X4 general cleaners	36		
			Take care when using the high pressure jet at the top of the gearbox as there could be water ingress at the motor opening and or oil breather filters. The area at the motor flange should be cleaned using soapy water and a cloth/brush							
			Due care should be taken to first inspect the gearbox for any openings. The Flender XSBN output shaft cover lid has a bolt which often comes out or is missing. Ensure there is not an opening							
		Clean ACC gearbox base plate using high pressure jet ensuing all dirt is removed	The entire base plate must be cleaned as well as the vertical walls in the cubicle where the gearbox is mounted				X4 general cleaners	36

Clean ACC fan blades on both sides using degreaser and high pressure jet and brush if necessary	The entire blade must be cleaned including the U-bolts				X4 general cleaners	96		
		Clean ACC fan hub base unit – Ensure the entire hub is cleaned using degreaser and a high pressure jet.	Clean both sides of the hub. This includes the U-bolts and output shaft coupling				X4 general cleaners	36		
		Clean ACC fan cowling using degreaser and high pressure jet with brushes					X4 general cleaners	96

6.3	ACC Cleaning – ACC rails and bridge	Clean all rails, name plates, electrical boxes (Ensure electrical isolation) and door handles using degreaser and water using a brush and rags						X4 general cleaners	48

6.4	Clean ACC flood lights	Use a safe ladder and using the 2 man ladder rule, clean the flood lights using soap and cloths. Be careful not to get water into the light electrical box – Ensure that the lights are electrically isolated						X4 general cleaners	16

6.5	ACC Cleaning – ACC Walkways	After clearing the permits, walk ACC and remove all general waste. Clean ACC walkway using high pressure hose on areas contaminated with oil– Be careful not to drop any objects such as metal, wire, bottles etc – 3 walkways to be cleaned each 85m long. 2x at 45m level and 1 x at 35m level.	Walkway should be left clean and there should be no objects left that could fall off at any time and no oil on the floor or rails. The walkways can be cleaned using high pressure water when the outage starts and then just litter etc can be cleaned after the permits have been cleared.						X4 general cleaners	16

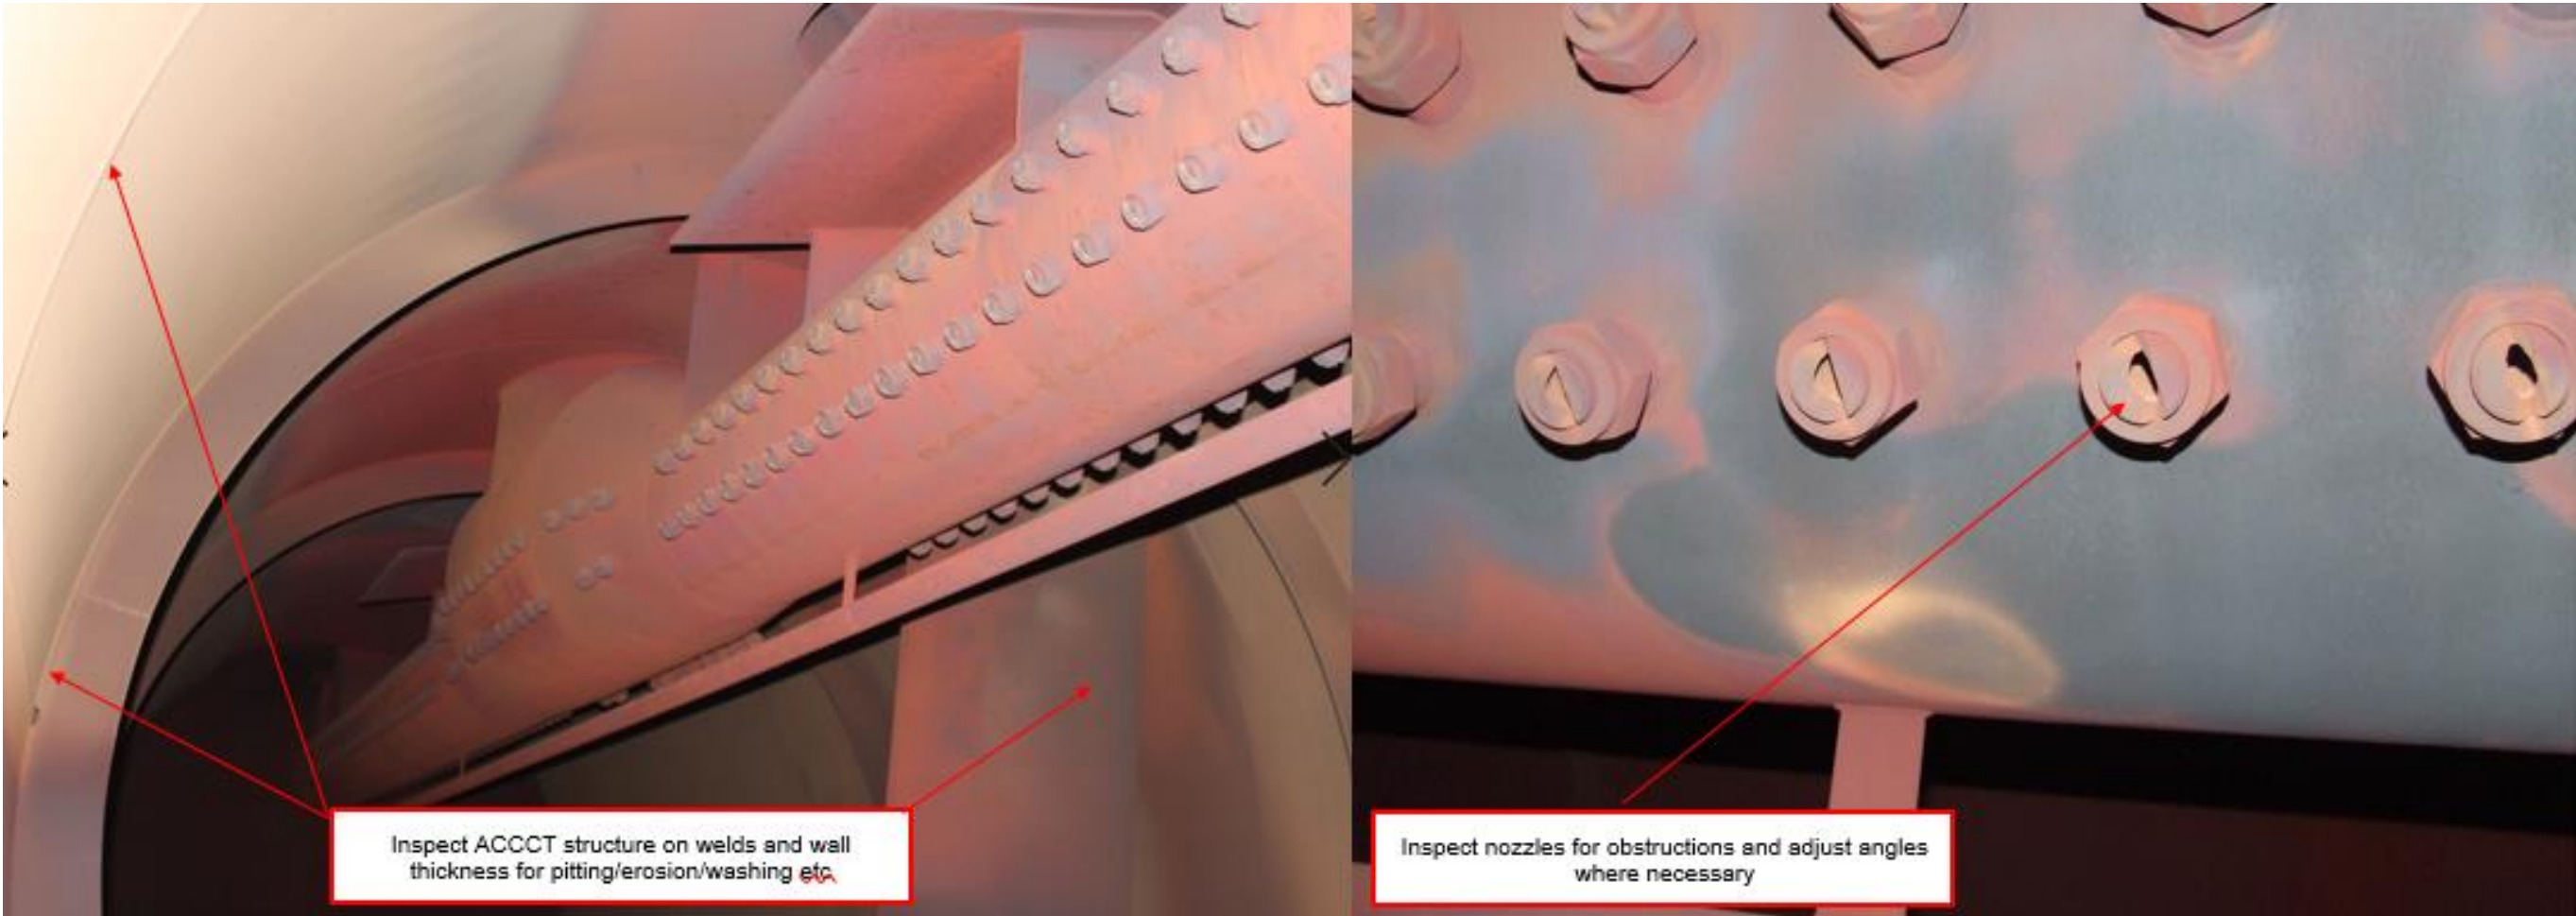
7.1	Build scaffolding at ACCCT	Built scaffolding to get access to the manhole cover	Gain access		Outage coordinator	NA	NA	NA
	Inspect ACCCT	Open ACCCT	Scaffolding will need to be built to access the manhole	Spanners, hammer	Contractor Contractor	Report with photographs to be submitted.	X2 Artisans	1
		Inspect tank structural condition –Check for active corrosion/ pitting/washing inside the tank		Sufficient illumination – adequate torches must be used			X2 SAIW welding inspector	2
		Inspect the header nozzles for blockages and unblock if necessary		Sufficient illumination – adequate torches must be used and spanners			X2 Artisans	1
		Adjust nozzles as required	Nozzles must be oriented correctly				X2 Artisans	2
		Scrape off any debris left from the gasket	Surface area must be smooth with no material remaining	Scrapers and 100 grid sand paper			X1 Semi-skilled	0.5
		Cut, install gaskets and close the manhole					X2 Artisans	1

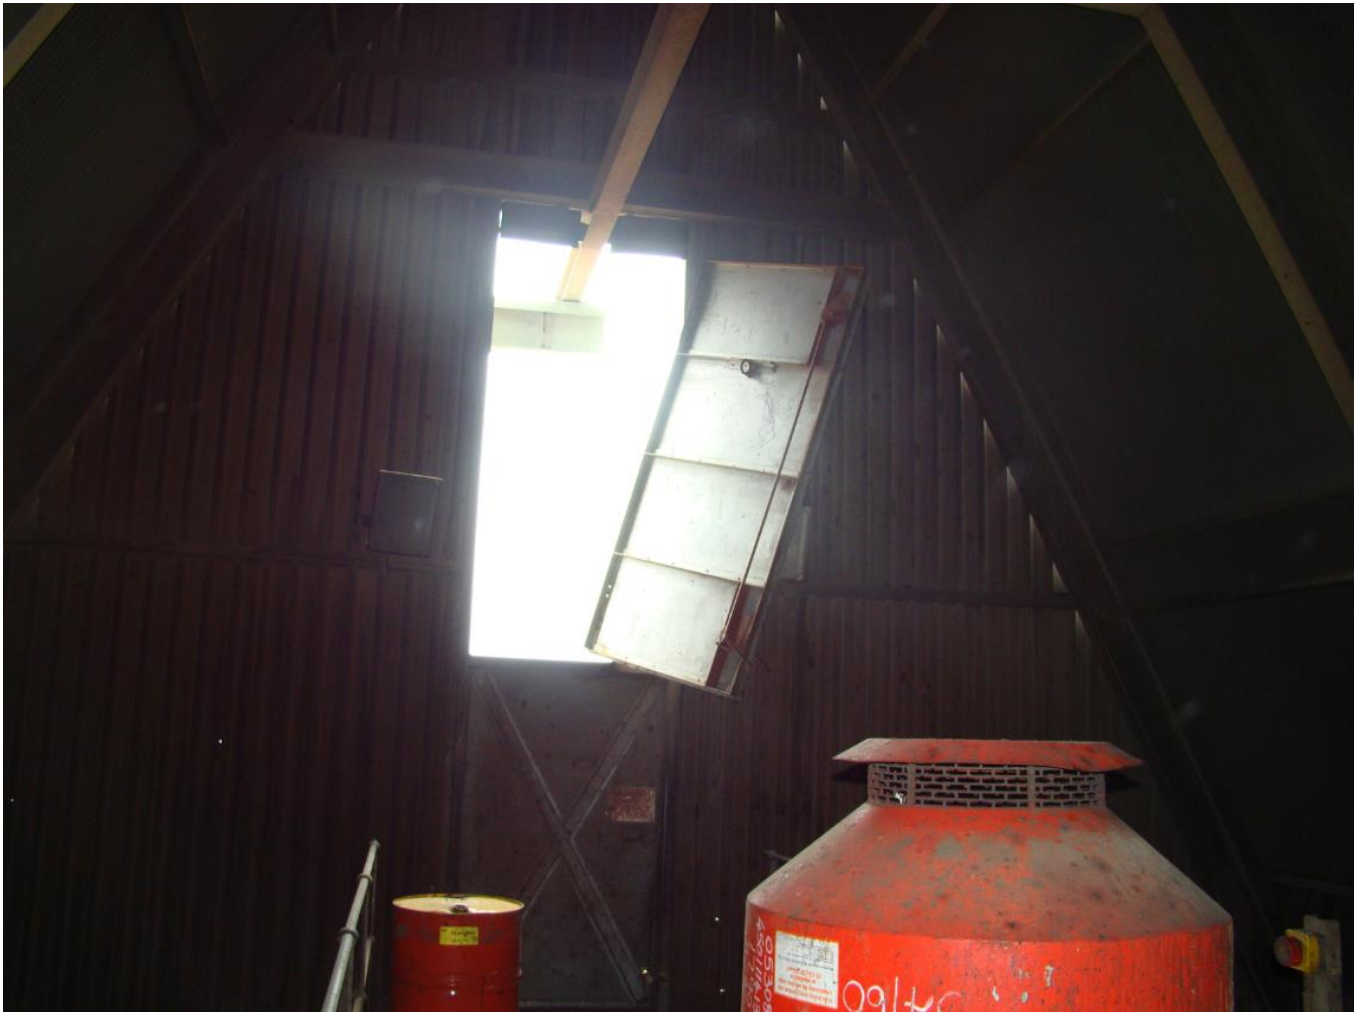
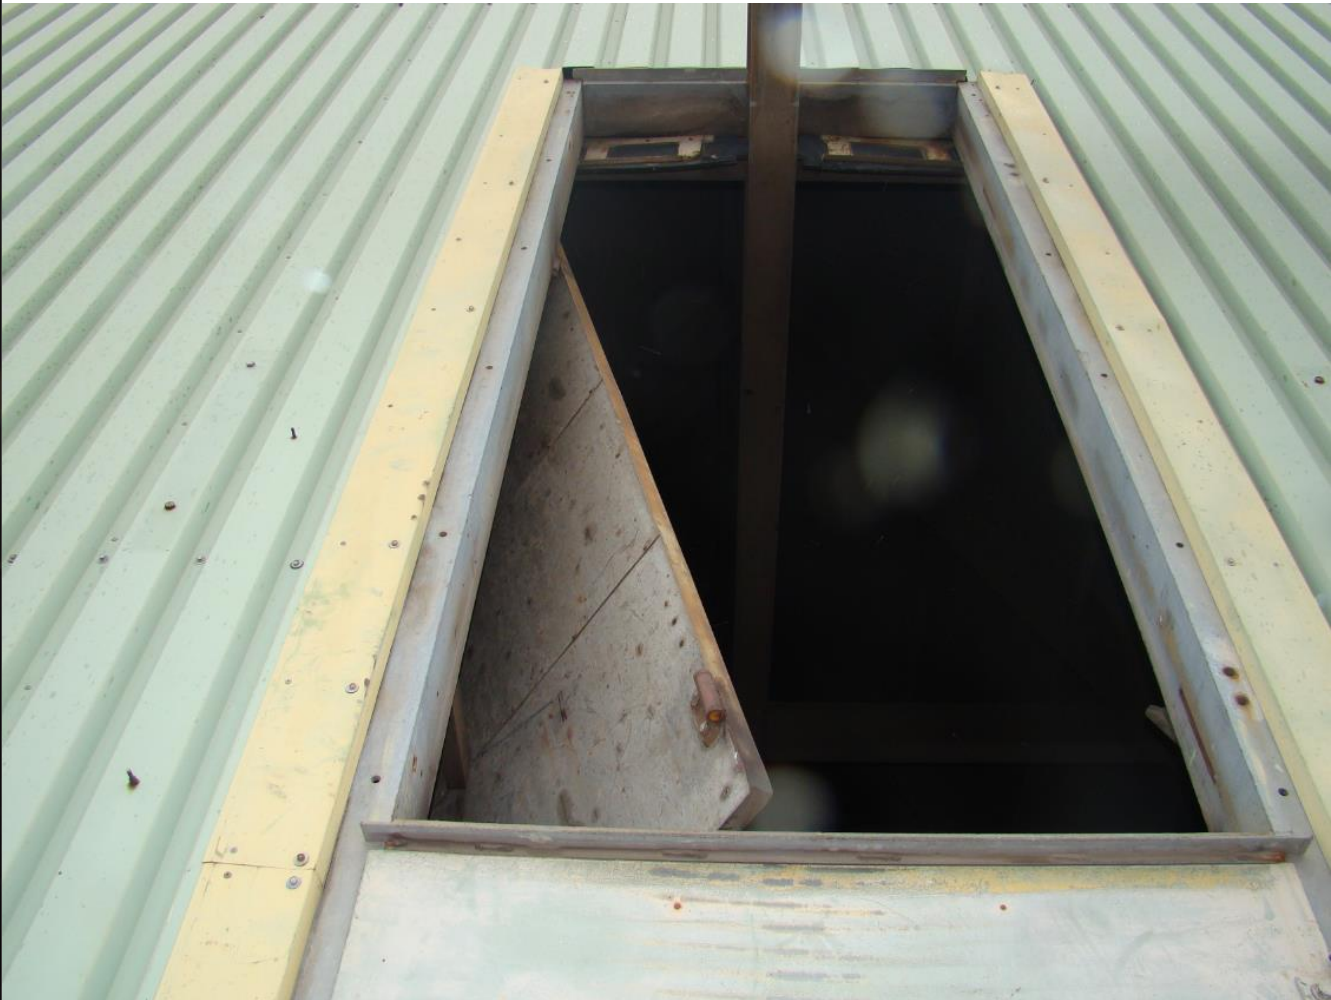
8.1	Inspect, refurbish and close all ACC doors	Function test and close all doors manually. This task must be done early in the outage to allow time for repair/replacement.	All doors must be functional and safe and should not fail with the fans on. All doors must be closed  Report all defective doors to the outage coordinator. Scaffolding will need to be built		Contractor	Report with photographs to be submitted.	X2 Semi-skilled	4
		Any door defective must be removed and refurbished or a new door made – This task is based on engineering instruction after the report has been submitted to engineering – Estimated 3 doors defective that will need to be removed per unit during an outage. Missing doors must also be replaced. Contractor to use their own rigging equipment to remove the doors.	The doors must be refurbished, re-installed and closed	As required	Contractor	QC report	X2 Semi-skilled X2 Riggers	3h to remove or install
