Title: **Detailed Design Report for  
Athene Hillside Impala 1 &  
2 132kV Bypass  
Refurbishment**

Document Unique Identifier: **LES0558**

Project Unique Identifier: **LES-GP-077**

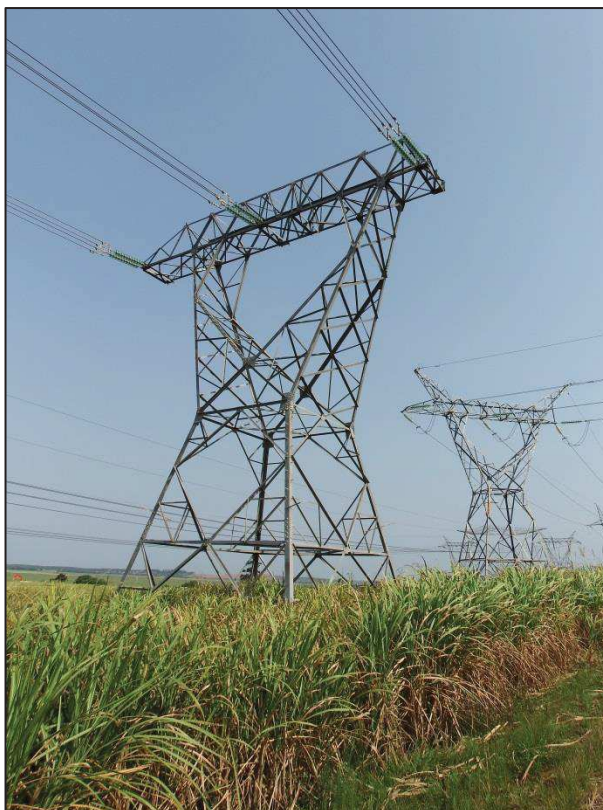
**Figure 1: 433D Tower Type**

Tower Number	Tower Type	Conductor Attachment Height (m)	Estimated Weights Based on Standard Tower Heights (Steel, Plates, Nuts and Bolts)(Contractor to verify weights)
1	433D (no earthpeak)	17.3	13 tonne
2	224B (no earthpeak)	14.9	5.2 tonne
3	224C (no earthpeak)	14.9	10.88 tonne
4	224C	14.9	11.2 tonne

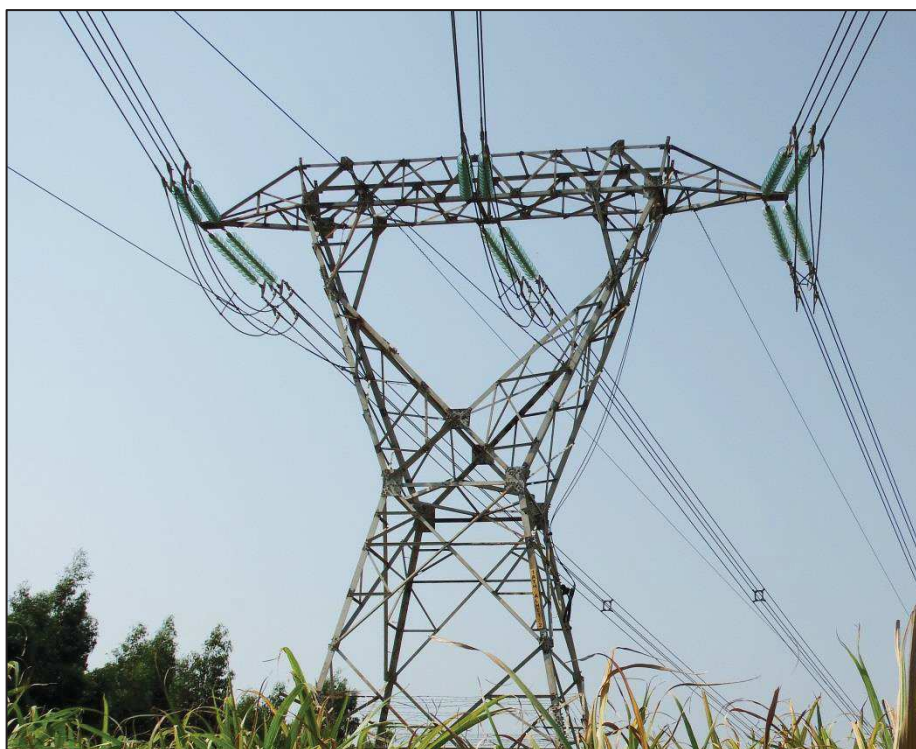
**Figure 2: 224B Tower Type**

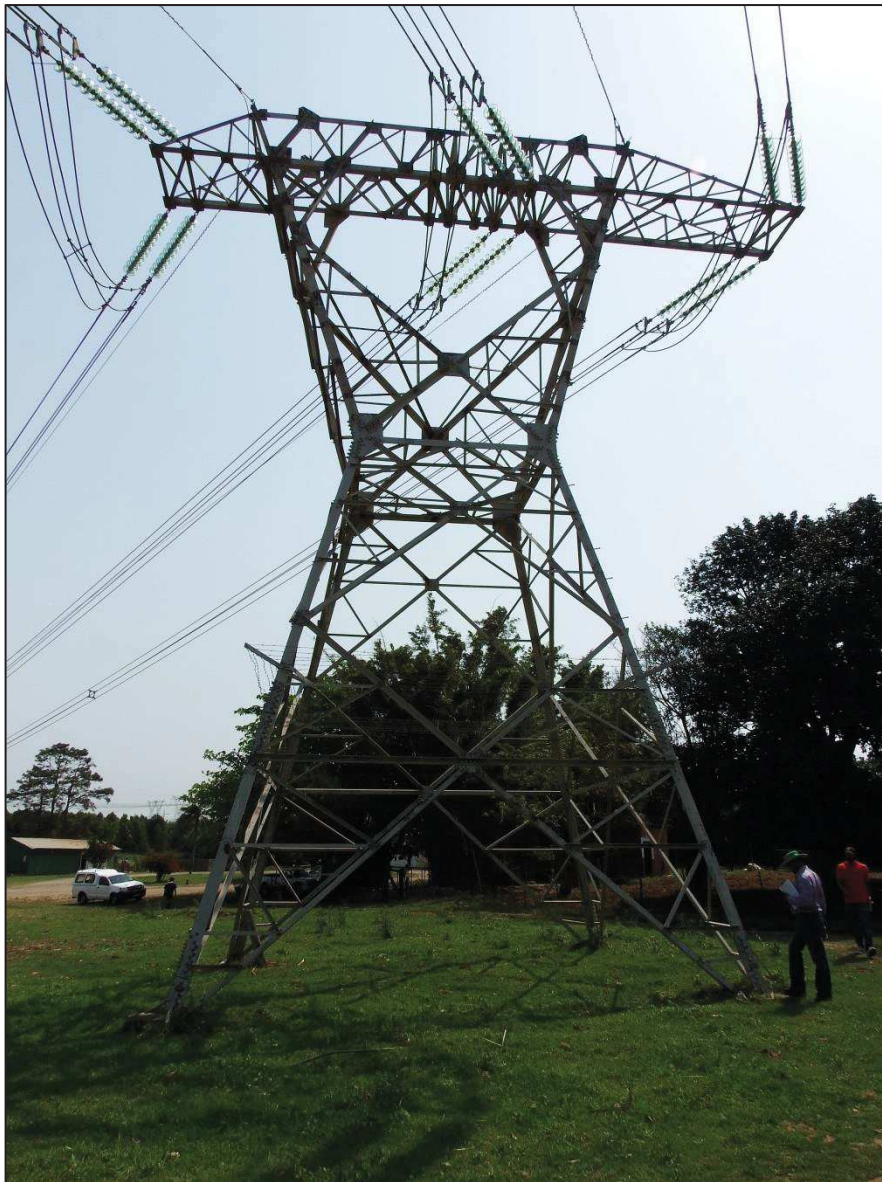
**Figure 3: 224C Tower Type (Without Earthpeaks)**

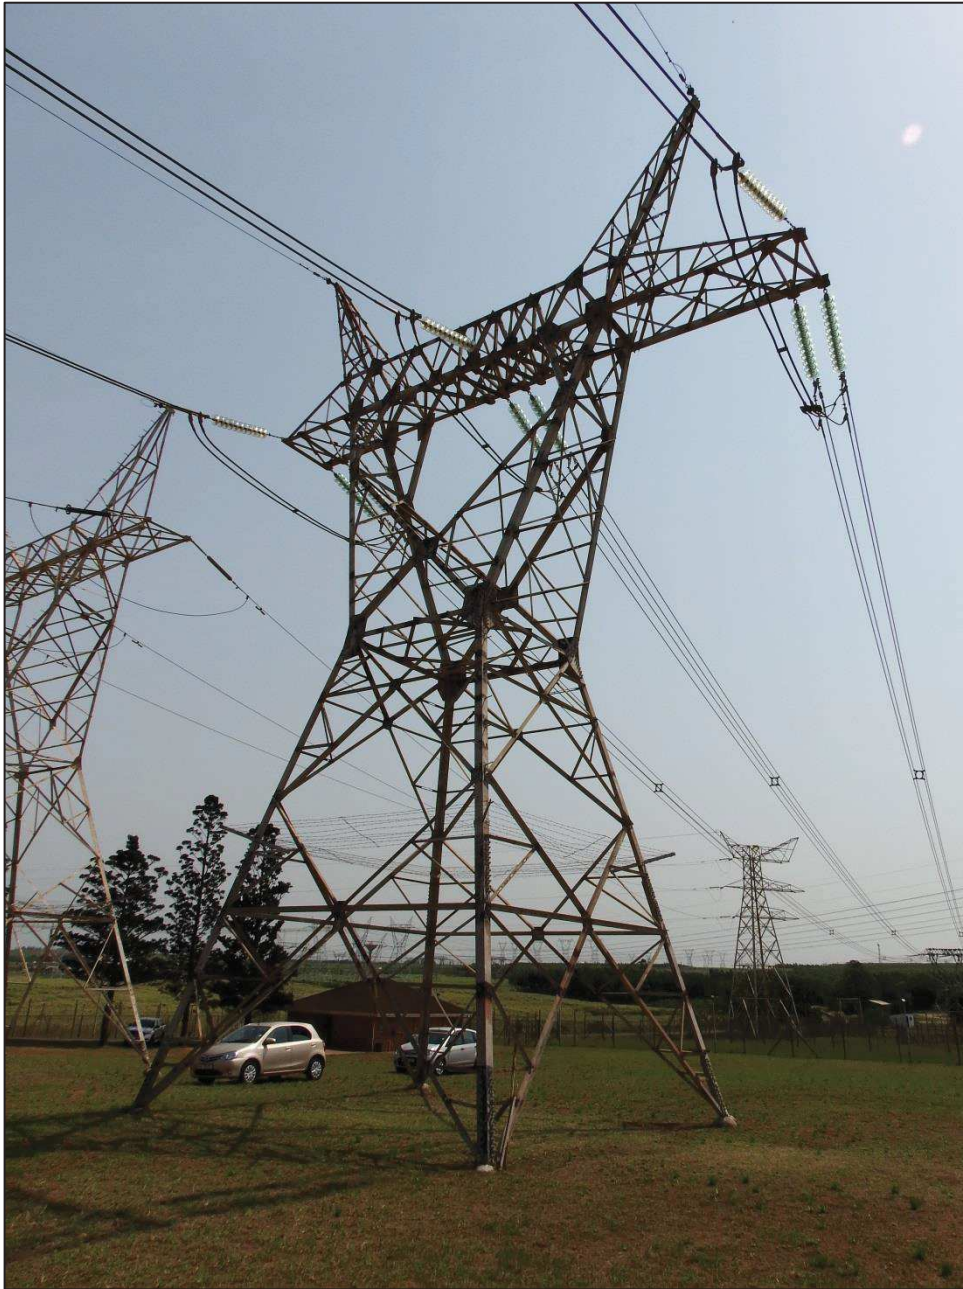
Figure 4: 224C Tower Type (With Earthpeaks)

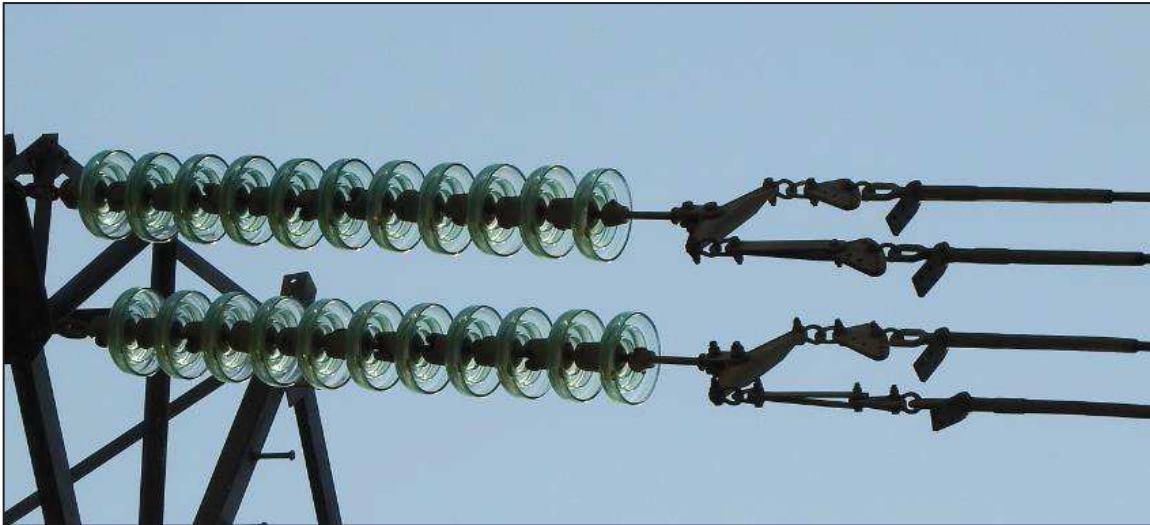
Figure 5: Tower 1 Strain Assembly

Tower Number	Assembly Type	Items to be Replaced (Starting from landing plate)	Quantity per Tower (3 Phases)	
1	Strain (see Figure 5)	1 - Ball Oval Eye (300kN)	Item no.	Quantity
		2 - Live Line Socket Tongue (300kN)	1	6
		3 - Double Extension Link (300kN)	2	6
		4- Triangular Yoke Plate (300kN)	3	3
		5- Shackle(210kN)	4	3
		6- Twisted Shackle (210kN)	5	12
		7- Sag Adjuster (210kN)	6	12
		8 - Shackle (210kN)	7	6
		9 - Cranked Extension Link (300kN)	8	12
		10- Compressed Dead End Assembly with Jumper Flags for Tern	9	6
			10	12

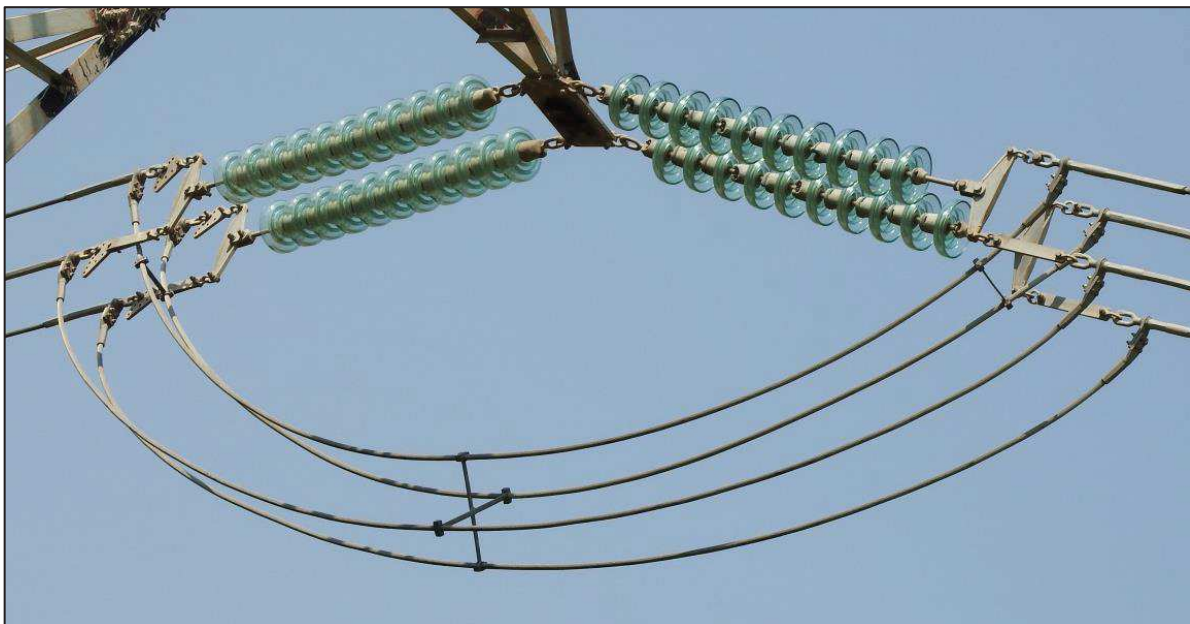
Figure 6: Tower 2, 3 & 4 Strain Assembly

2	Strain (see Figure 6)	1 - Ball Oval Eye (300kN) 2 - Live Line Socket Tongue (300kN) 3 – Double Extension Link (300kN) 4- Triangular Yoke Plate (300kN) 5- Shackle(210kN) 6- Twisted Shackle (210kN) 7- Sag Adjuster (210kN)  8 - Shackle (210kN) 9 – Cranked Extension Link (300kN)  10- Compressed Dead Assembly with Jumper Flags for Tern	Item no.	Quantity
			1	12
			2	12
			3	6
			4	6
			5	24
			6	24
			7	12
			8	24
			9	12
			10	24
3	Strain (see Figure 6)	1 - Ball Oval Eye (300kN) 2 - Live Line Socket Tongue (300kN) 3 – Double Extension Link (300kN) 4- Triangular Yoke Plate (300kN) 5- Shackle(210kN) 6- Twisted Shackle (210kN) 7- Sag Adjuster (210kN)  8 - Shackle (210kN) 9 – Cranked Extension Link (300kN)  10- Compressed Dead Assembly with Jumper Flags for Tern	Item no.	Quantity
			1	12
			2	12
			3	6
			4	6
			5	24
			6	24
			7	12
			8	24
			9	12
			10	24

4	Strain (see figure 6)	1 - Ball Oval Eye (300kN) 2 - Live Line Socket Tongue (300kN) 3 – Double Extension Link (300kN) 4- Triangular Yoke Plate (300kN) 5- Shackle(210kN) 6- Twisted Shackle (210kN) 7- Sag Adjuster (210kN)  8 - Shackle (210kN) 9 – Cranked Extension Link (300kN)  10- Compressed Dead Assembly with Jumper Flags for Tern	Item no.	Quantity
			1	6
			2	6
			3	3
			4	3
			5	12
			6	12
			7	6
			8	12
			9	6
			10	12
			4	Strain (see figure 7)
1	3			
2	3			
3	3			
4	3			
5	3			
6	6			
7	6			
Gantry	Strain (see figure 8)	1 – Shackle 210kN 2 – Turnbuckle – Clevis Oval Eye (210kN) 3 – Ball Oval Eye (210kN IEC 20mm) 4- Socket Clevis (210kN) 5- Triangular Yoke Plate (300kN) 6- Shackle (210kN)  7-Compressed Dead End Assembly for Bull	Item no.	Quantity
			1	3
			2	3
			3	3
			4	3
			5	3
			6	6

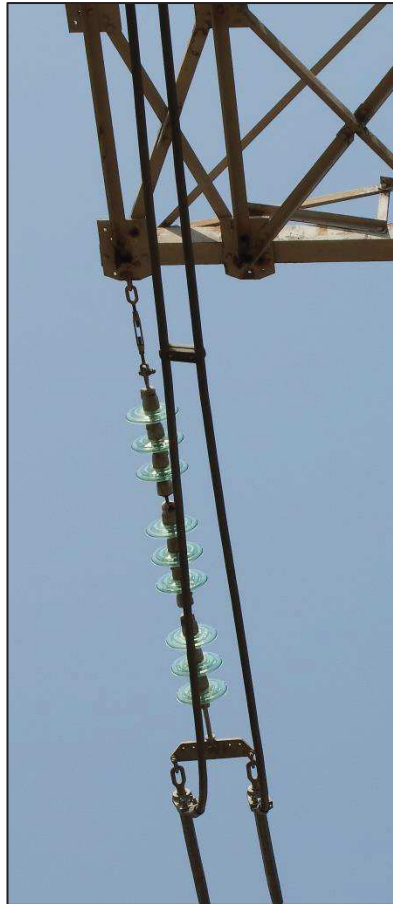
**Figure 7: Single Insulator Assembly at Tower 4**

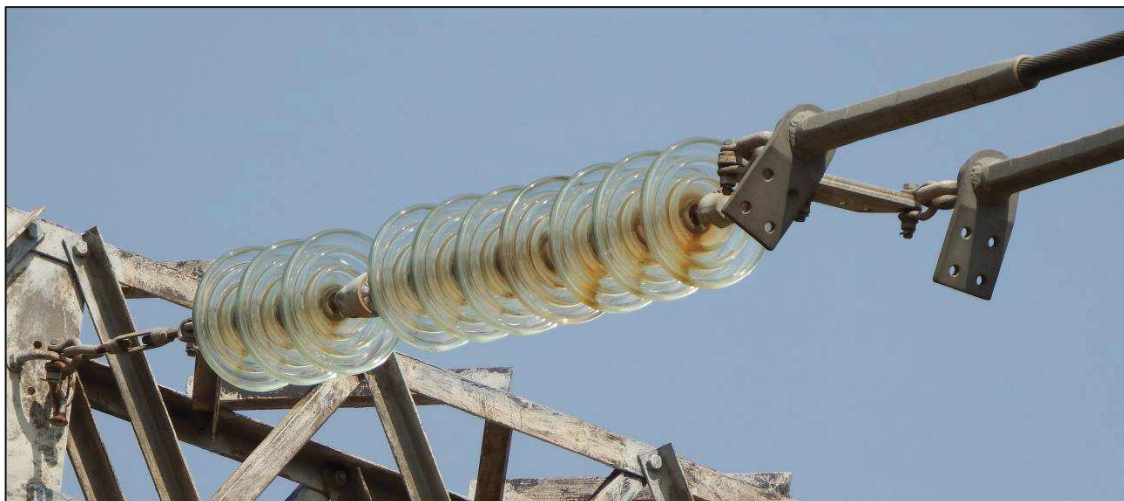
**Figure 8: Strain Assembly at Gantry**

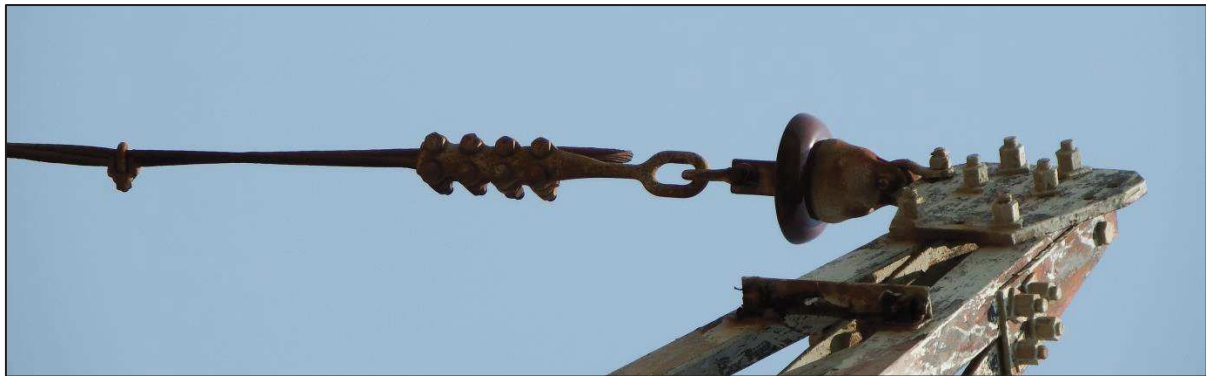
**Figure 9: Insulated Earthwire Assembly**

<table><tr><td>7</td><td>6</td></tr></table>		7	6										
7	6															
4	Insulated Earthwire Strain (see figure 9)	1 – Shackle 120kN 2 – Composite Earthwire Insulator (120kN) 3 – Shackle(120kN) 4- Strain Clamp ( 11.5mm-13.5mm) 5- Wire Rope Clamp for 19/2.7	<table><tr><td>Item no.</td><td>Quantity</td></tr><tr><td>1</td><td>2</td></tr><tr><td>2</td><td>2</td></tr><tr><td>3</td><td>2</td></tr><tr><td>4</td><td>2</td></tr><tr><td>5</td><td>4</td></tr></table>		Item no.	Quantity	1	2	2	2	3	2	4	2	5	4

Item no.	Quantity															
1	2															
2	2															
3	2															
4	2															
5	4															
Gantry	Insulated Earthwire Strain (see figure 9)	1 – Shackle 120kN 2 – Composite Earthwire Insulator (120kN) 3 – Shackle(120kN) 4- Strain Clamp ( 11.5mm-13.5mm) 5- Wire Rope Clamp for 19/2.7	<table><tr><td>Item no.</td><td>Quantity</td></tr><tr><td>1</td><td>2</td></tr><tr><td>2</td><td>2</td></tr><tr><td>3</td><td>2</td></tr><tr><td>4</td><td>2</td></tr><tr><td>5</td><td>4</td></tr></table>		Item no.	Quantity	1	2	2	2	3	2	4	2	5	4

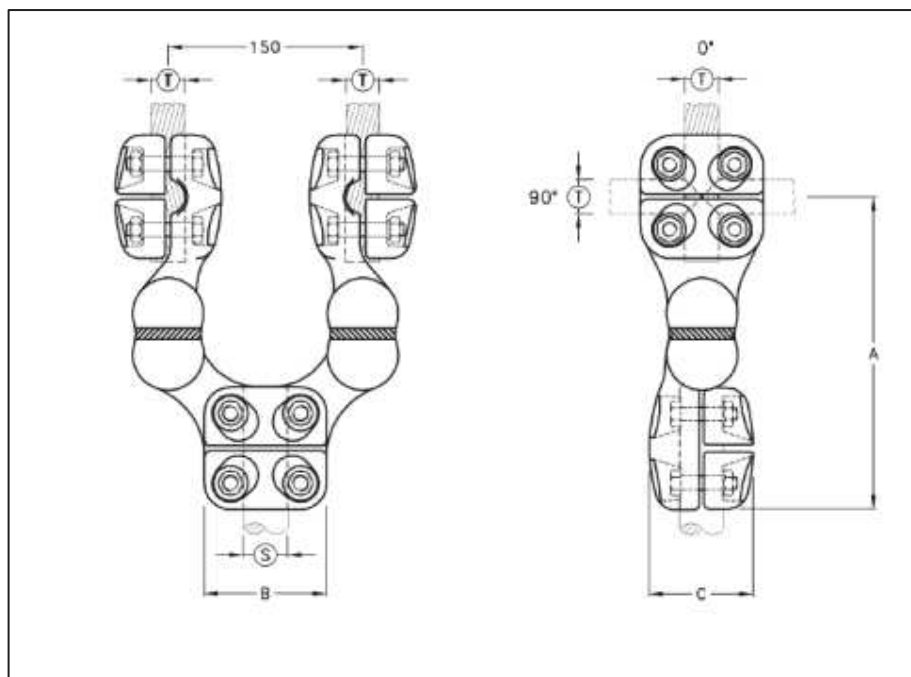
The droppers and dropper clamps for both lines need to be replaced. The current conductor being used for the droppers is Bull. Modified clamps will be used for the droppers. The clamps will be modified to accommodate the conductor spacing of 450mm.

Y-7/8	C21443	26	38.3	1600	0°+90°	253	95	82	4.90kg
-------	--------	----	------	------	--------	-----	----	----	--------

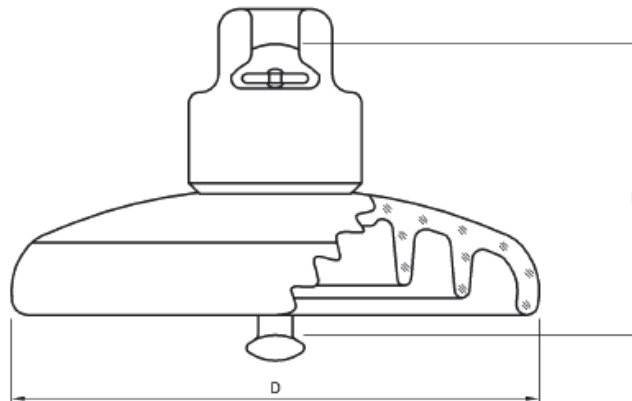
**NB. U190 insulators have been discontinued and will be replaced with U300. The number of discs per insulator string will be 10 to cater for the difference in the length the discs of the U190.**

**Toughened Glass Insulator**  
**Socket/Ball Type**

Type No	Catalogue Number	Nominal Diameter D	Nominal Spacing H	Nominal Creepage Distance	Standard Coupling I.E.C.	U.T.S. (kN)	Impulse Withstand Voltage Positive	Impulse Withstand Voltage Negative	Power Frequency Withstand Voltage Wet	Power Frequency Puncture Voltage	Unit Weight
U70BL	B940013	255	146	305	16	70	100kV	103kV	43kV	110kV	3.70kg
U120BS	B940023	255	146	305	16	120	100kV	103kV	43kV	110kV	4.00kg
U210B	B940033	280	170	380	20	210	110kV	110kV	45kV	130kV	7.00kg
U300BS	B940143	320	195	485	24	300	130kV	130kV	50kV	130kV	10.9kg
