Athene Hillside Impala 1 & 2 132kV Bypass Refurbishment Project

The Athene Hillside Impala 1 & 2 132kV Bypass Lines are situated in the Richards Bay area, a marine and industrial environment (highly corrosive), resulting in the tower members, bolts and hardware being heavily corroded. Some of the members have corroded to the extent that some members have actually fallen off the tower. Corrosion of the tower members, bolts and hardware decreases its mechanical strength thus decreasing the mechanical integrity of tower as a whole which in turn increases the risk of hardware failure and tower failure. In order to eliminate the aforementioned risk it was decided that the Athene Hillside Impala 1 & 2 132kV Bypass Lines be refurbished.

- The scope of the refurbishment will include replacement of six towers (four 224 C towers and two 224 B towers), refurbishment of two beams (433D tower type) and the replacement of all insulators and hardware. The scope of work will also include the replacement of the 2 x 24 core ADSS on Line 1 with 2 x 48 core ADSS.

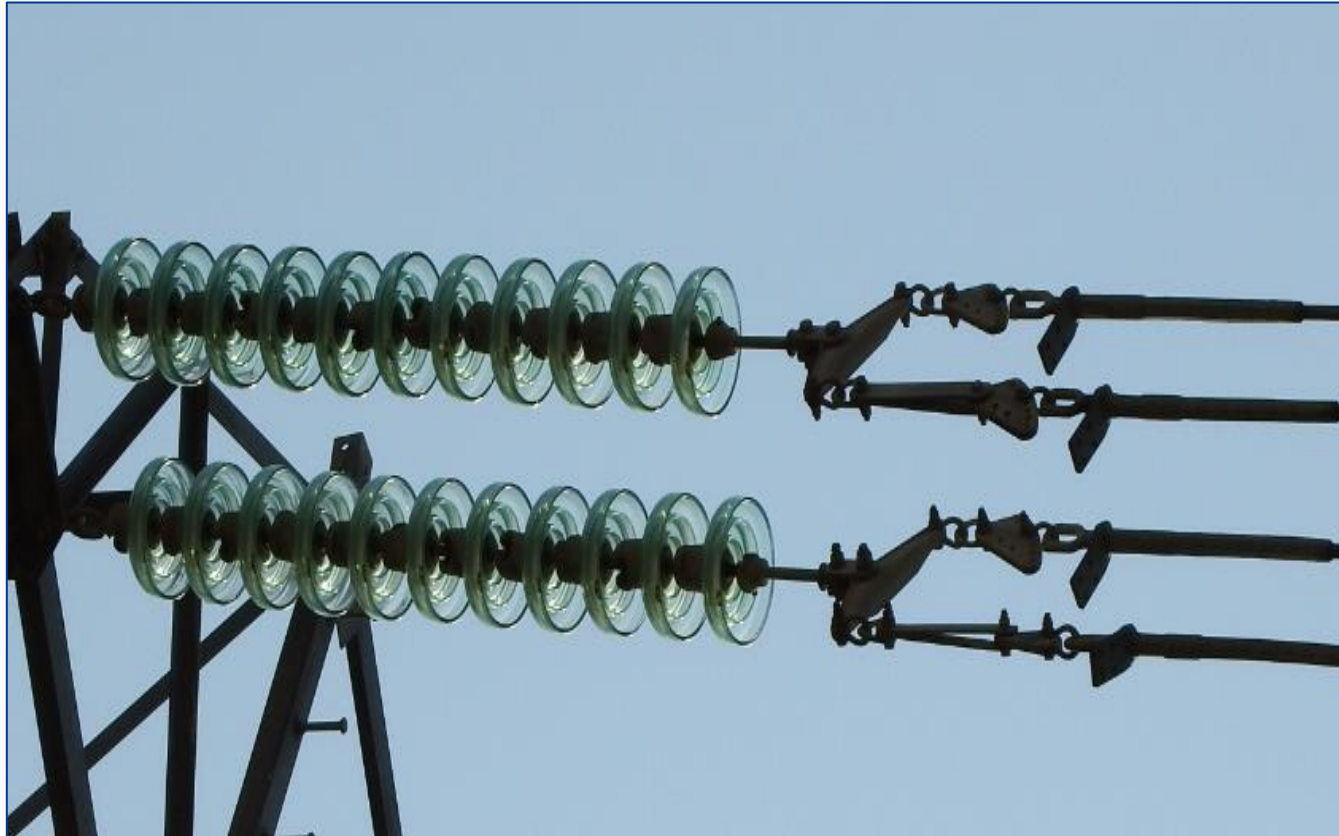
- Ball Oval Eye (300kN)
- Live Line Socket Tongue (300kN)
- Double Extension Link (300kN)
- Triangular Yoke Plate (300kN)
- Shackle(210kN)
- Twisted Shackle (210kN)
- Sag Adjuster (210kN)
- Shackle (210kN)
- Cranked Extension Link (300kN)

Hardware: Standard Strain Assemblies and Standard ADSS Strain Assemblies

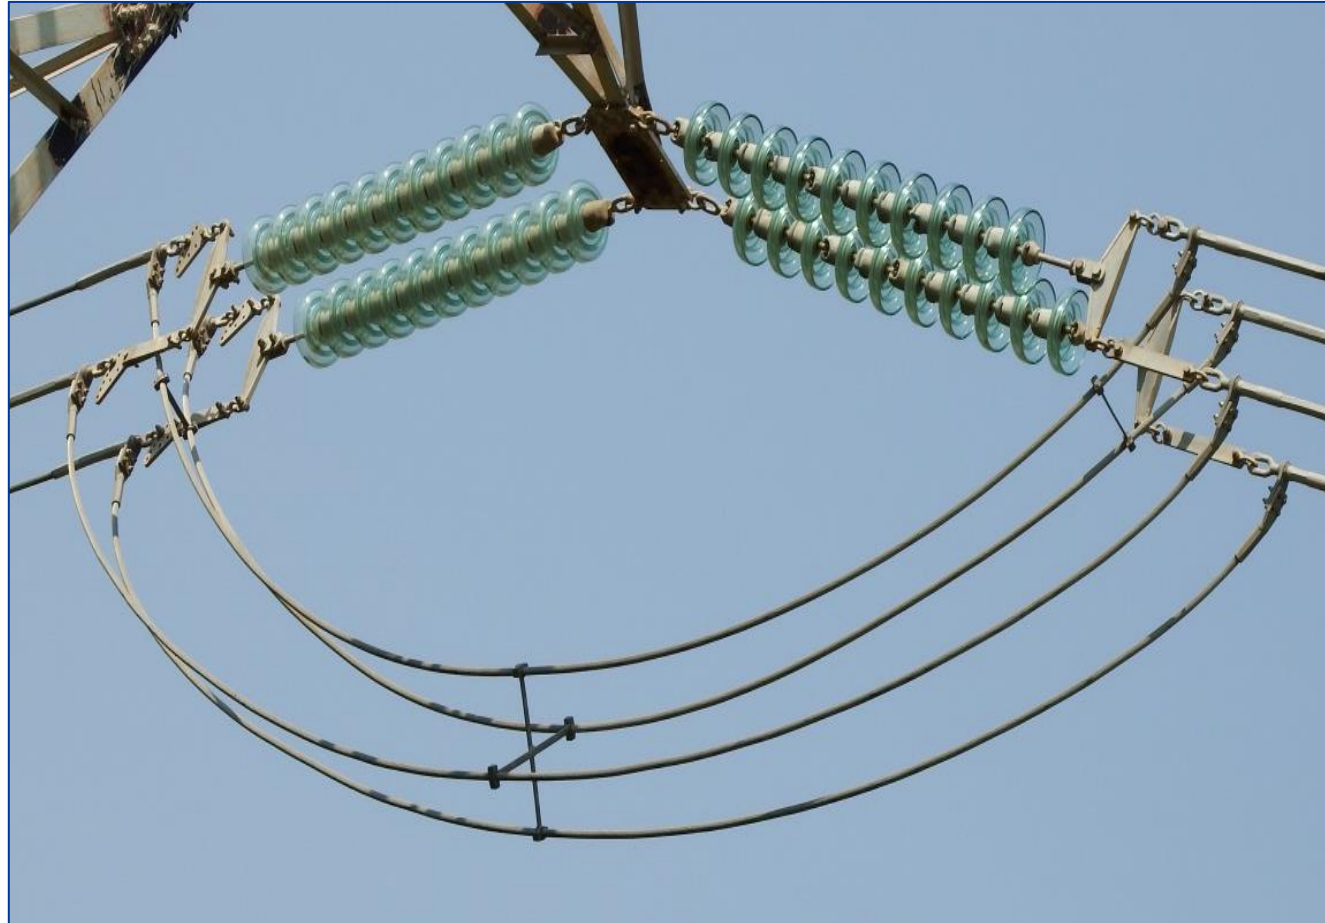
- Ball Oval Eye (300kN)
- Live Line Socket Tongue (300kN)
- Double Extension Link (300kN)
- Triangular Yoke Plate (300kN)
- Shackle(210kN)
- Twisted Shackle (210kN)
- Sag Adjuster (210kN)
- Shackle (210kN)
- Cranked Extension Link (300kN)

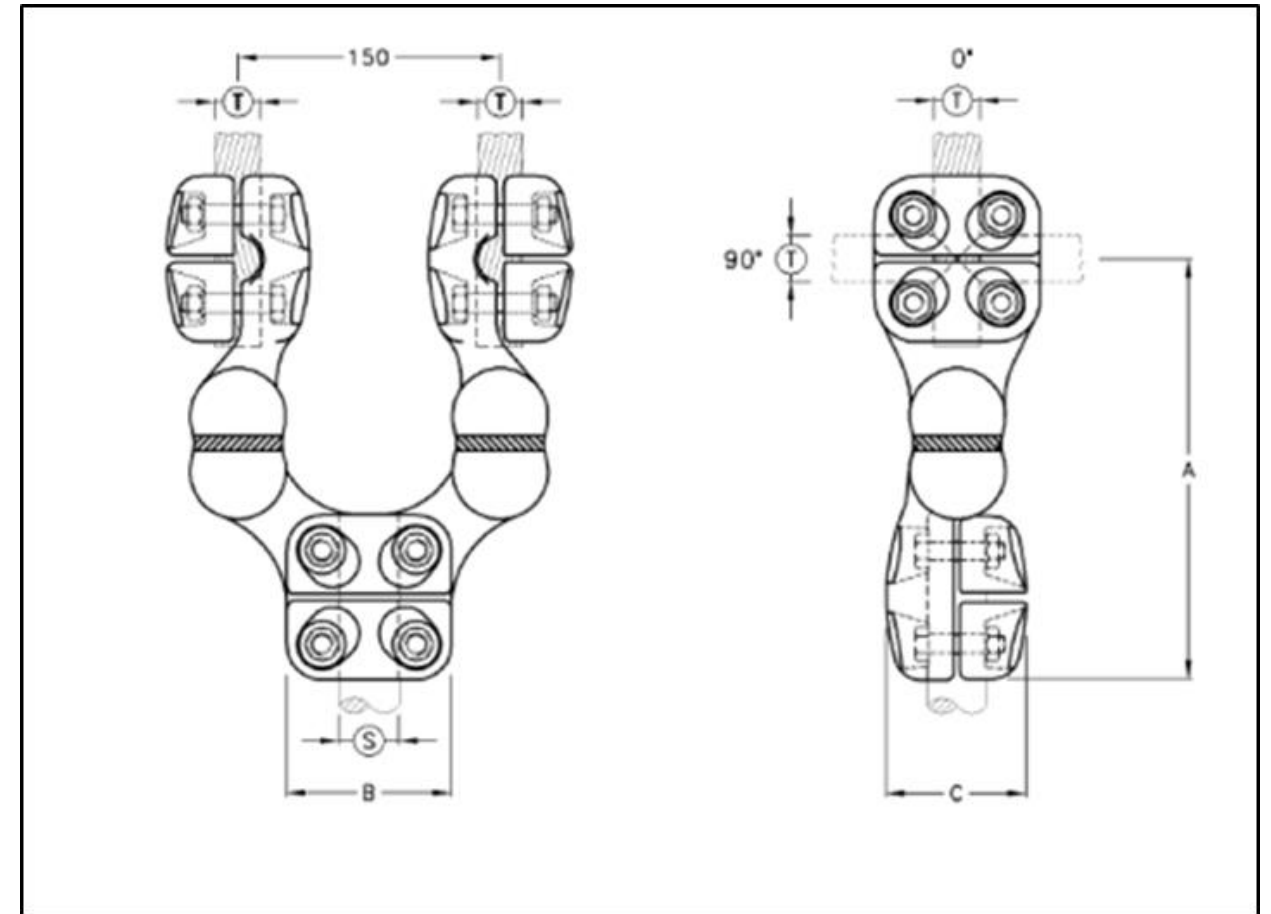
New Dropper Arrangement-
McWade Modified Y-7/8

It must be noted that jumper flags will be refurbished.

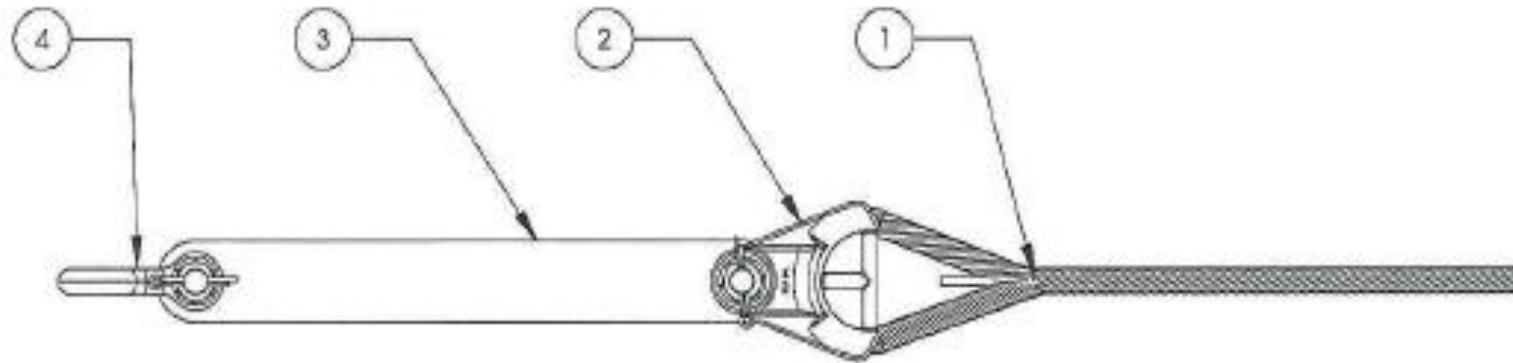
The hardware assembly for the ADDS Fibre is as follows:

1. Fiberlign Dead End Assembly
2. Thimble Clevis 120kN
3. Extension Link 350mm, 120kN
4. Shackle 120kN

16 Assemblies will be required
