CLIENT: Eskom

PROJECT: Bravo

FIGURE 6a: Stability analysis -fill overlying diabase

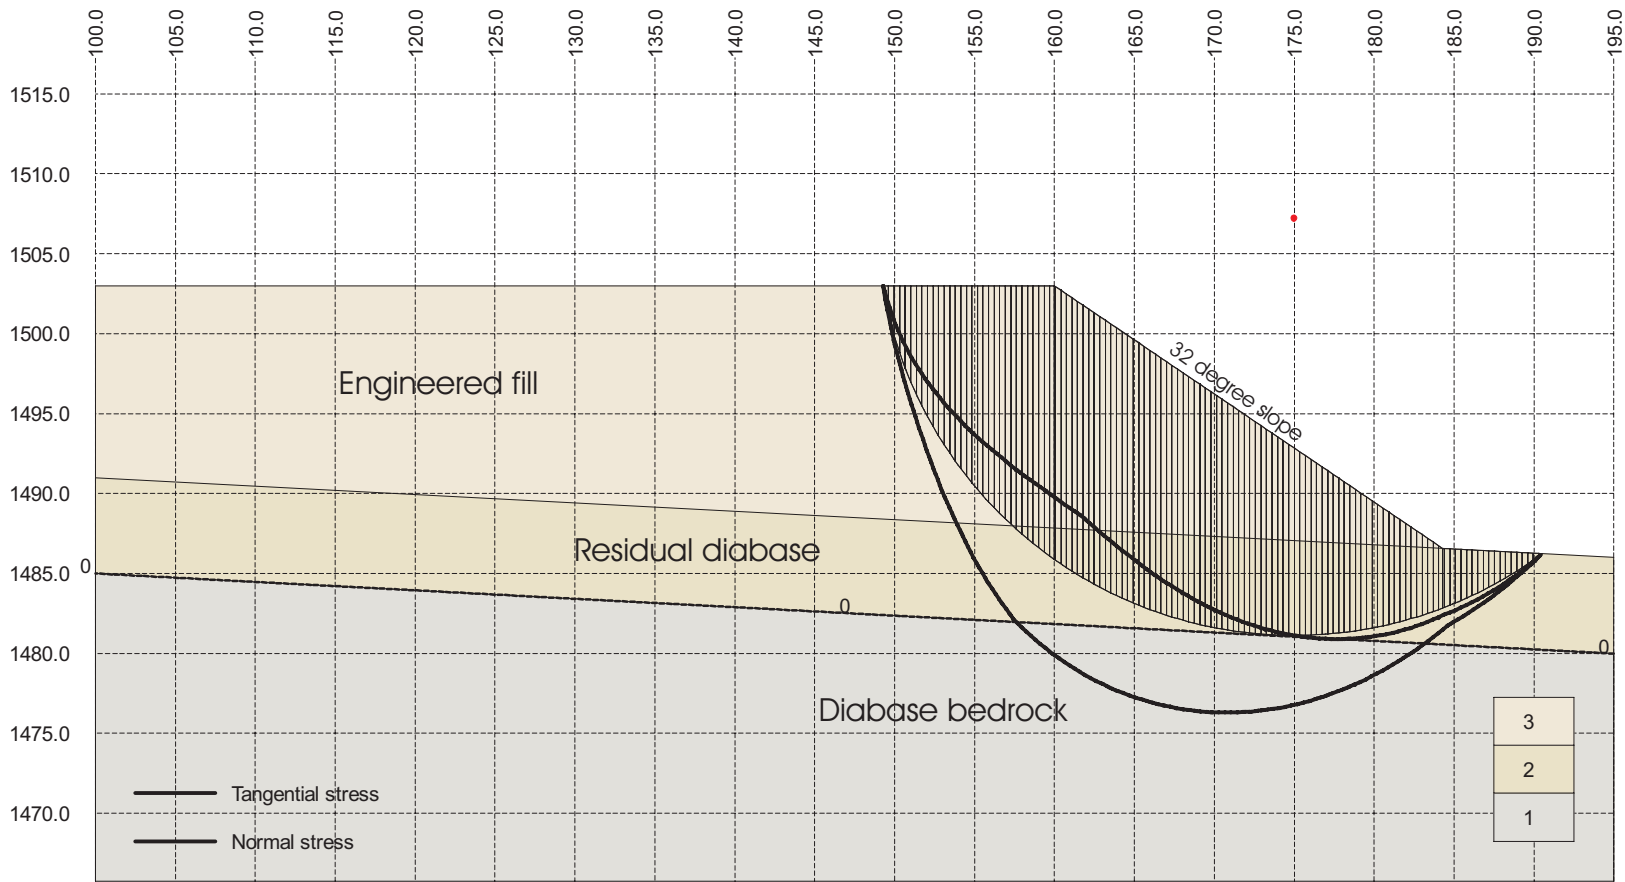
# Factor of Safety: 1.02
